Arboricultural Assessment Of Trees at 2 North Lodge,
Chester le Street, Co. Durham, DH3 4AZ

Report 1037

14 January 2023

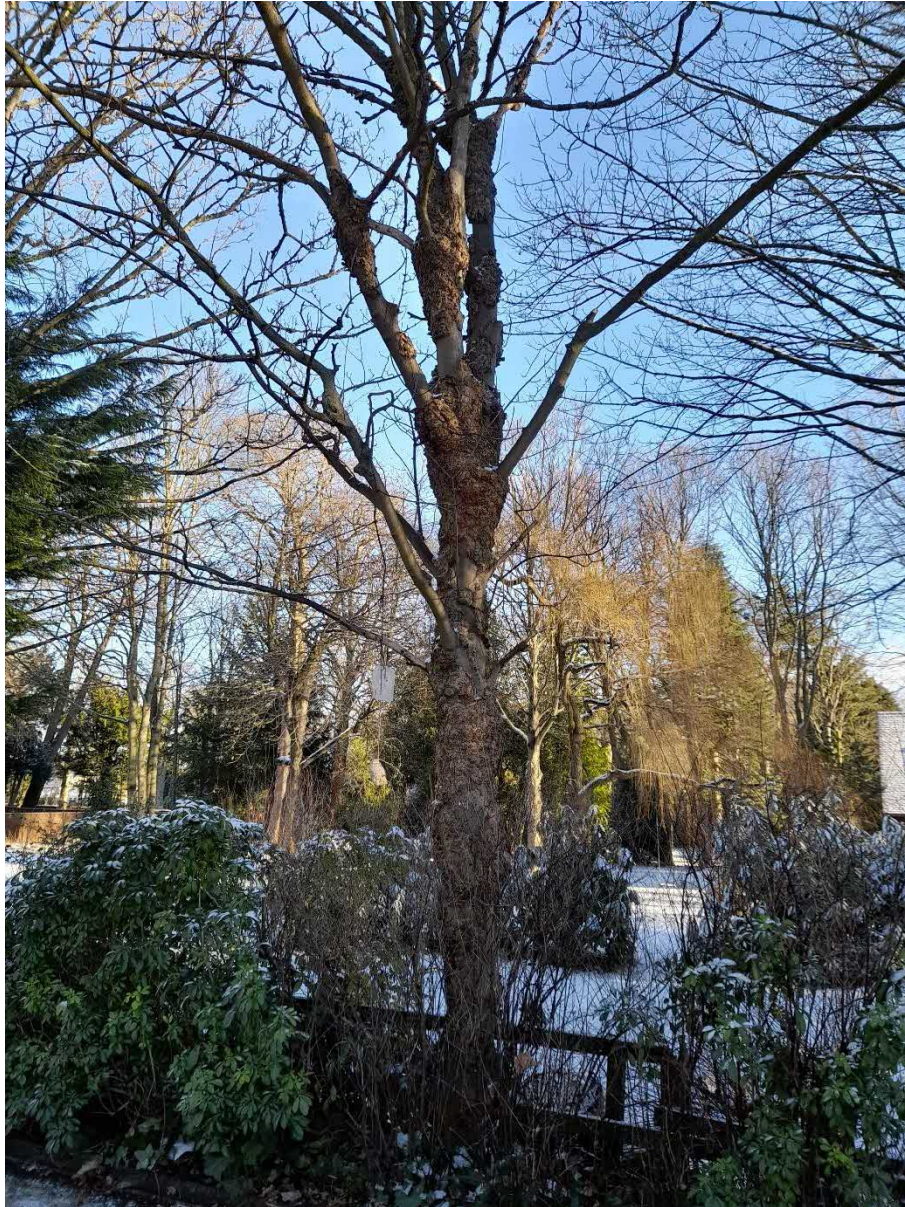
Photo 7 – T478.

Tree No.	Species Common Name Genus species	Height (M)	Crown Spread (M)				Trunk Dia. (MM)	Age	Physiological Condition	Structural Condition	Estimated Remaining Contribution (Years)	Tree Quality Assessment	Observations	Suggested works	Ultimate Size For Species (M)		Works Priority
			N	S	E	W									Height	Spread	
T477	Beech (<i>Fagus sylvatica</i>)	24	12	12	12	12	1550	Mature	Good	Poor	10+	C1	Stem divides above 1.5m. 1x branch fused at 3m. Fungal brackets visible at base (<i>Meripilus giganteus</i>) in 3 locations	Apply for consent to fell	30	25	A
T478	Sycamore (<i>Acer pseudoplatanus</i>)	9	3	3	3	3	220	Semi mature	Poor	Poor	<10	U	Low vitality. Declining. Stem divides above 1.5m. Major deadwood in crown.	Apply for consent to fell	22	16	C
T479	Sycamore (<i>Acer pseudoplatanus</i>)	12	3	5	2	6	500	Semi mature	Fair	Good	20+	B1	Stem divides above 1.5m. 1x major deadwood branch in crown.	Remove deadwood	22	16	C
