Buildings at East Field House
Mickleton
Co Durham

archaeological building recording

report 5173
October 2019

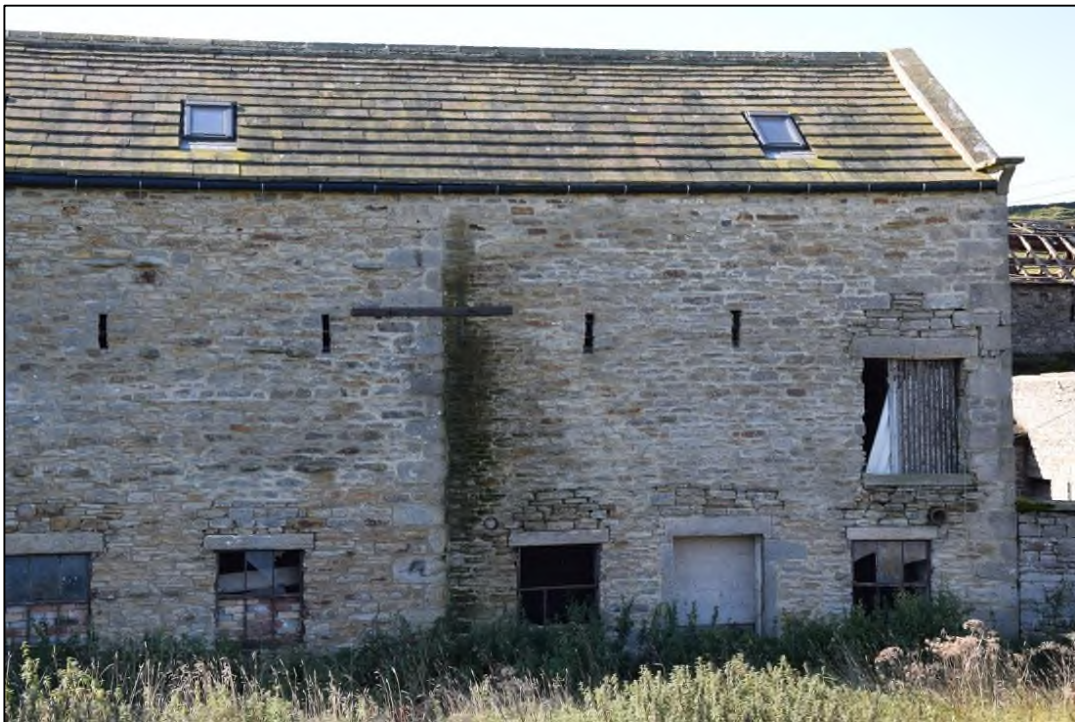
Photograph 12: The north face of the extension, with the reinforcing iron band across the junction

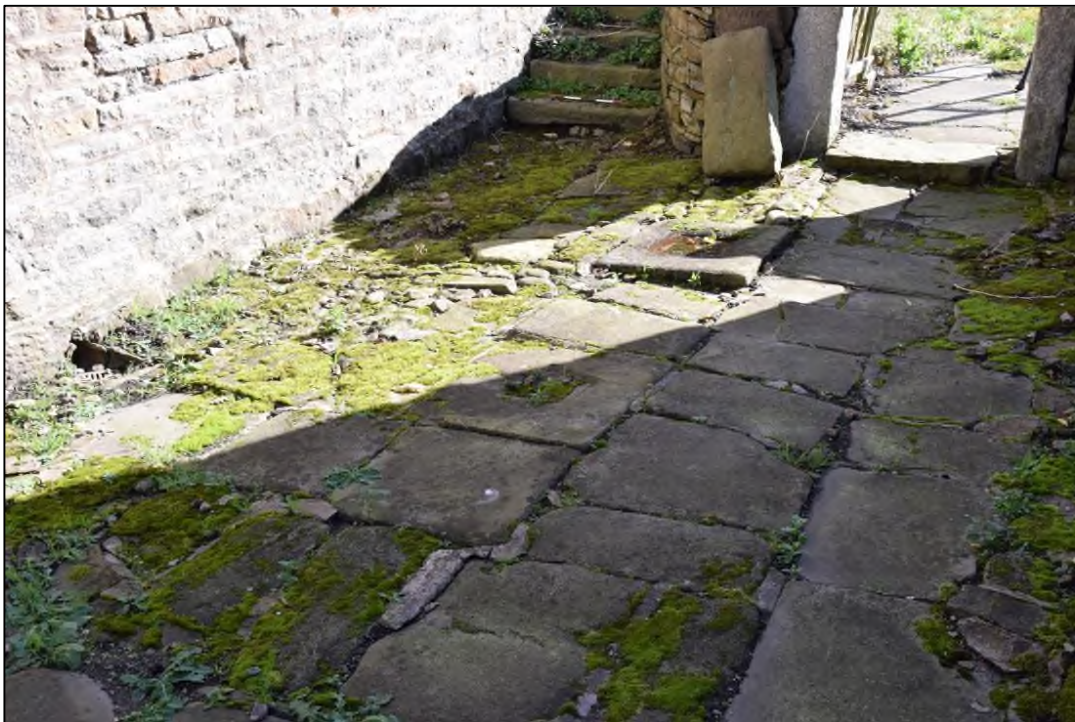
- 5.7 There is no evidence in any of the walls of external structures attached to the building. However, the narrow paved yard at the south of the building has the marks of two uprights, perhaps of iron, which probably relate to a shed or shelter over the western of the ground-floor doors (Photograph 14).

Photograph 14: The paved yard between building 1 and the eastern house has two recesses for uprights outside the old door, the blocking of which can be seen at the top left

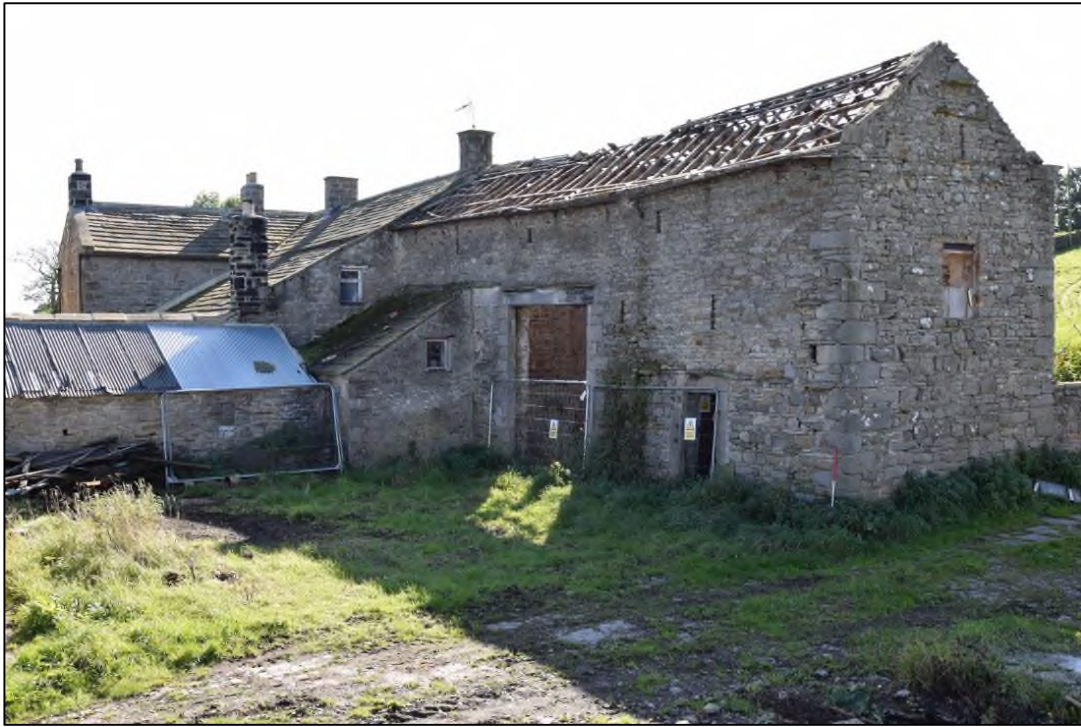
Photograph 27: Building 2, with the L-plan block of houses and their outshut rear extension beyond. The low lean-tos are building 3, outside the study area

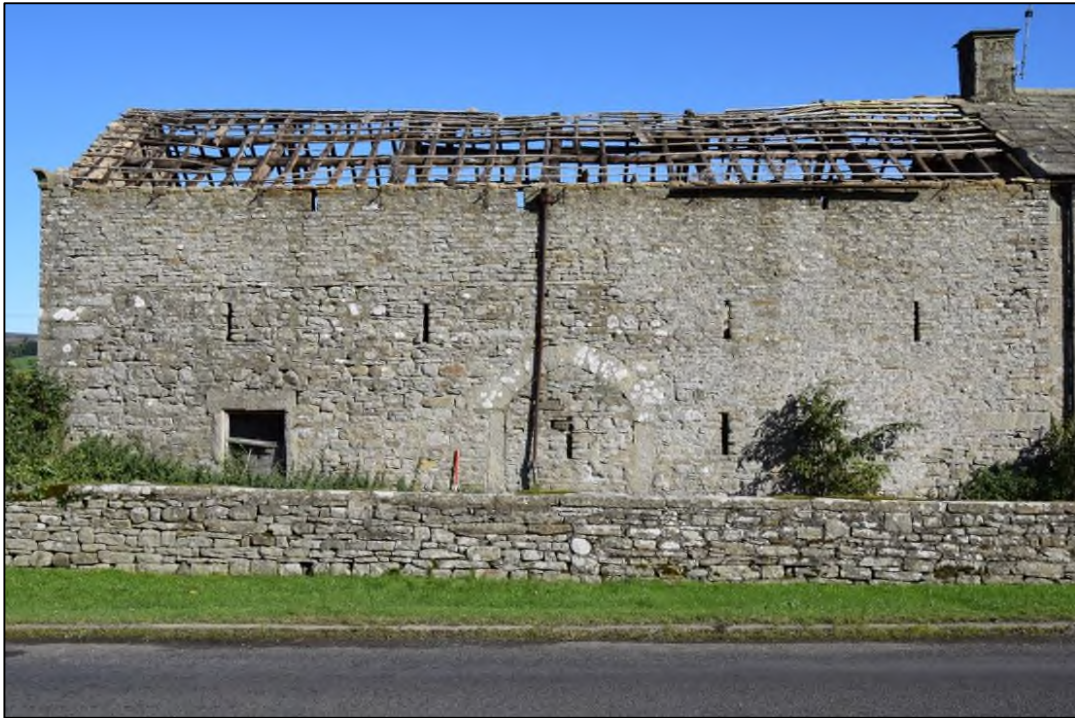
- 5.10 The south face has a large central door, older than the one on the north wall; it has a pointed stone arch (Photograph 31). It is now closed up and there is a breather in the middle of the blocking. A row of four breathers slits run across the middle of the face and there is a smaller door at the west end. Above the slits, the change in masonry is very clear. From the west end to the centre, the whole of the upper third

Photograph 31: The south face of building 2. The change in fabric can be seen as a neat horizontal line above the left-hand pair of breather slits

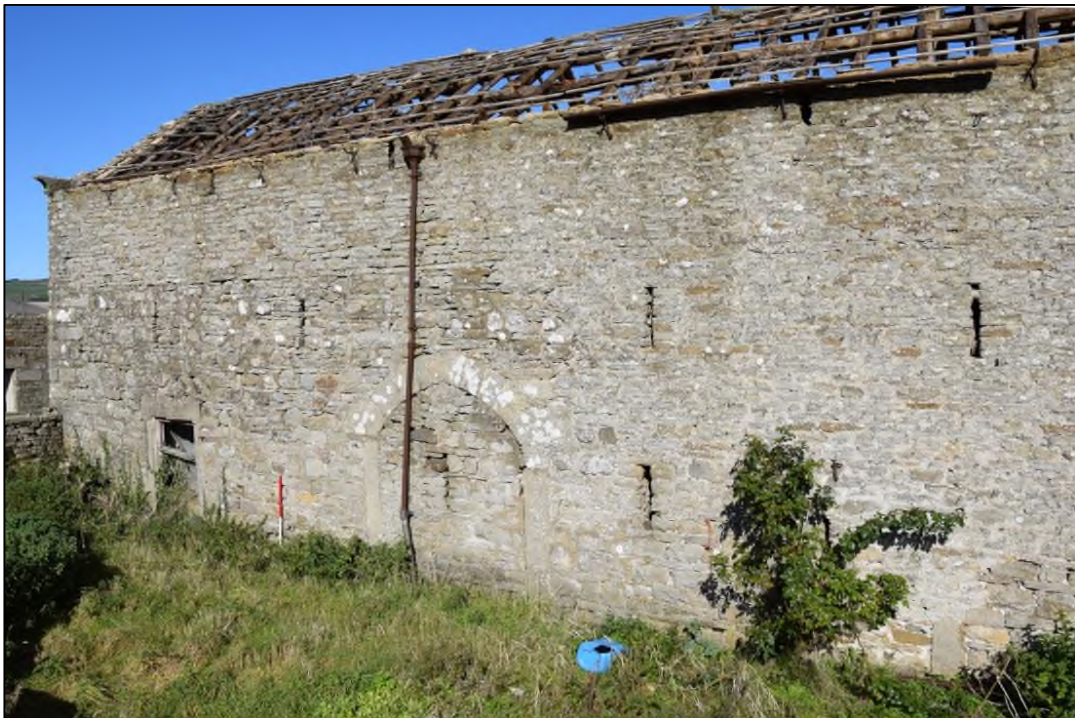
of the face has been rebuilt in thin courses of stone. The newer masonry extends to almost the full height of the wall east of the central door and it cuts across the lower part of a small door, the twin to the surviving example at the west end (Photograph 32). The difference between the two phases of masonry is very clear on either side of the main door (Photograph 33). The small west door has monolithic jambs and lintel and was partly blocked to create a window (Photograph 34); only the lower parts of the jambs of the east door survive (Photograph 35).

Photograph 32: The small door at the far end was matched by another at the east; the lower jamb can be seen below the shrub at the right

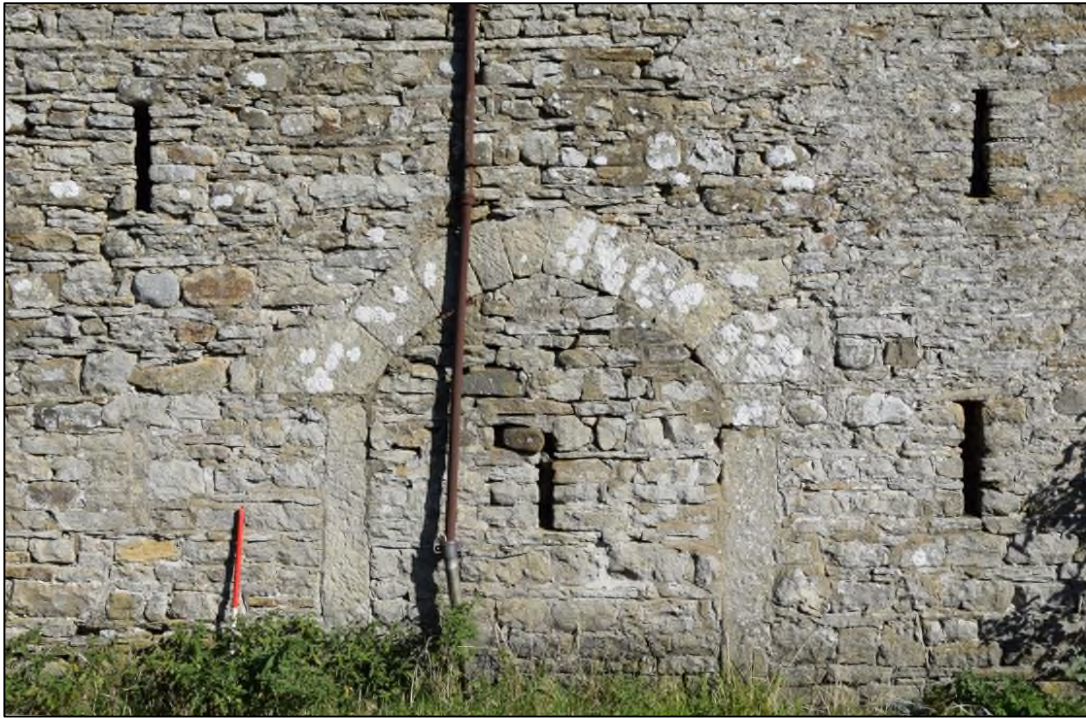
Photograph 33: Detail of the central door, with its unusual pointed arch. The break in the masonry runs diagonally above the right-hand side of the arch

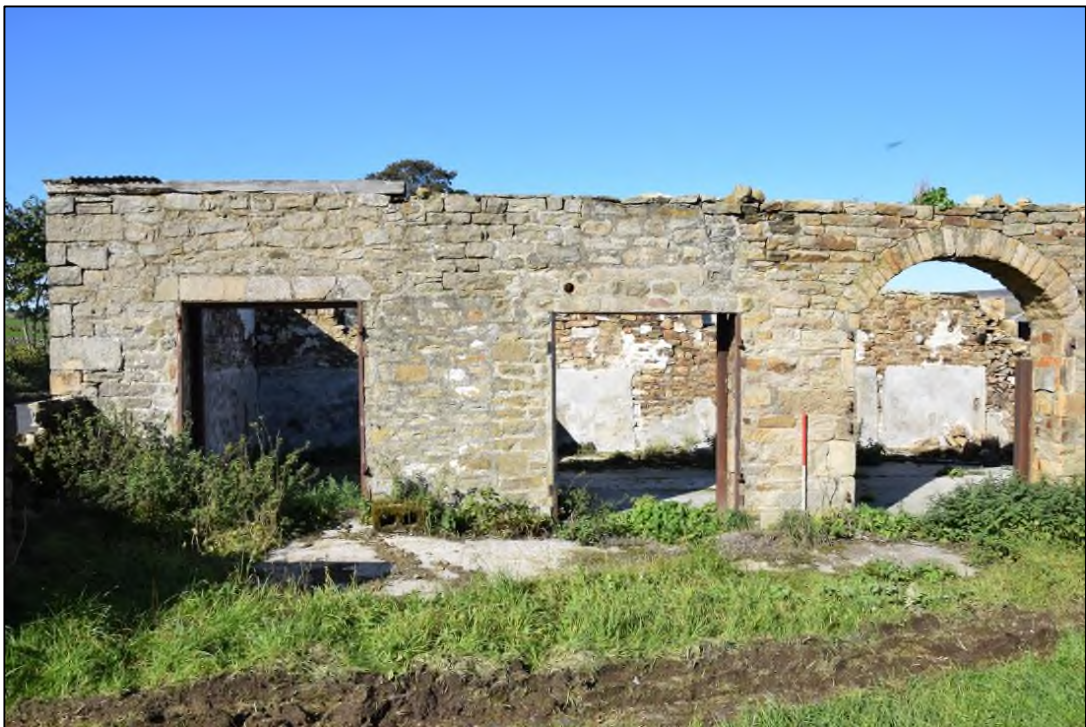
- 5.12 This small building is now a roofless shed (Photograph 47). A photograph of the site in 1964 shows it as a two-storey building with a windowless gable end facing the road (Tucker 2018, 2). The structure shows significant alterations. The two large doors at the south end of its east face are supported by steel beams (Photograph 48); a larger arched door to the north is also a recent construction, with a window to its north (Photograph 49). Most of the north end has been demolished, as has a later single-storey shed that adjoined it (Photograph 50). There are modern windows at the head of the west wall, one of which abuts an older blocked door (Photographs 51, 52). Four low breather slits, all blocked up, can be seen in the south wall (Photograph 53). Like the buildings already described, this was last used as a cow byre; one of the stall partitions remains in place and the marks of another four can be seen on the floor and the west wall (Photographs 54, 55). The stubs of two floor joists for a low ceiling can be seen at the north end of this wall; they are not matched on the opposite side of the building, showing that the upper wall at the north-east corner has been rebuilt (Photographs 56, 57). The same is true of the upper wall above each of the eastern doors (Photographs 58-61). Mid-20th-century plaster and a tethering staple remain on the south wall (Photograph 62).

Photograph 48: Steel frames support the doors at the south end of the building's east face

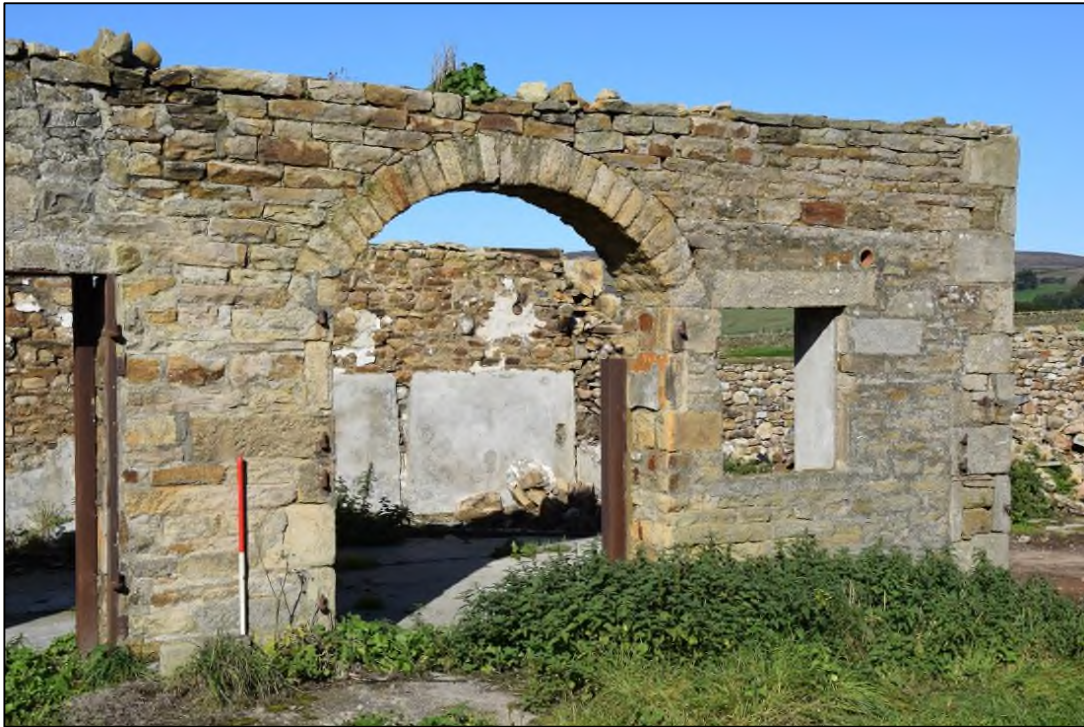
Photograph 49: The arched opening, superficially similar to a hemmel door, is a later addition to the building

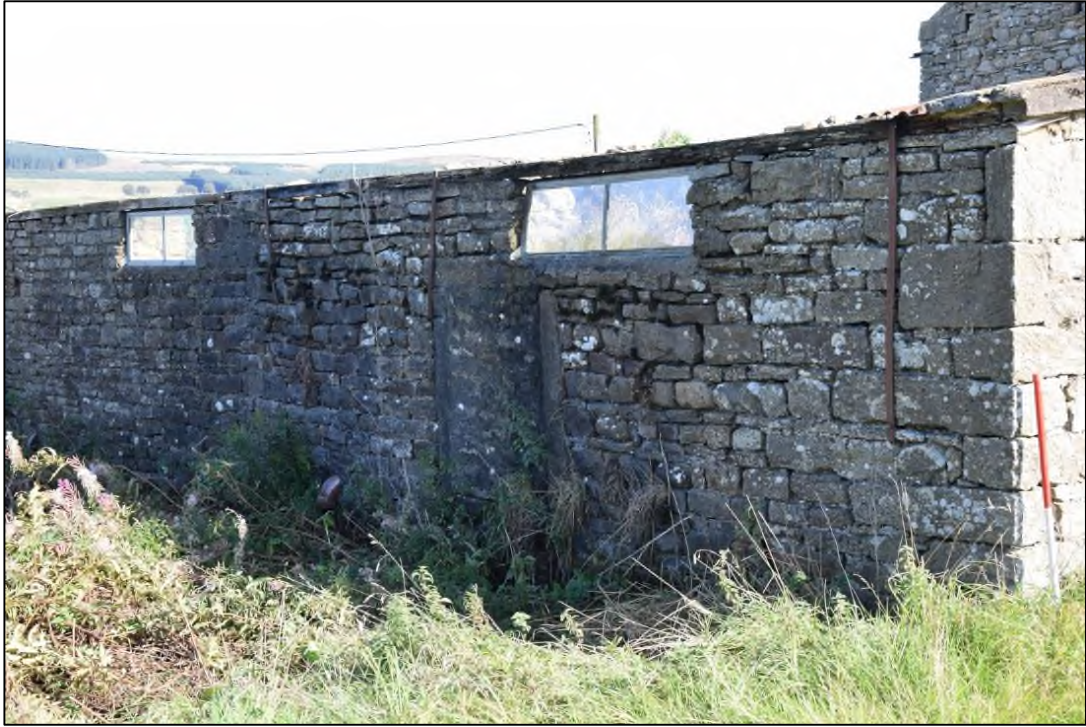
Photograph 51: The west face of building 4, with recent high windows above a blocked door

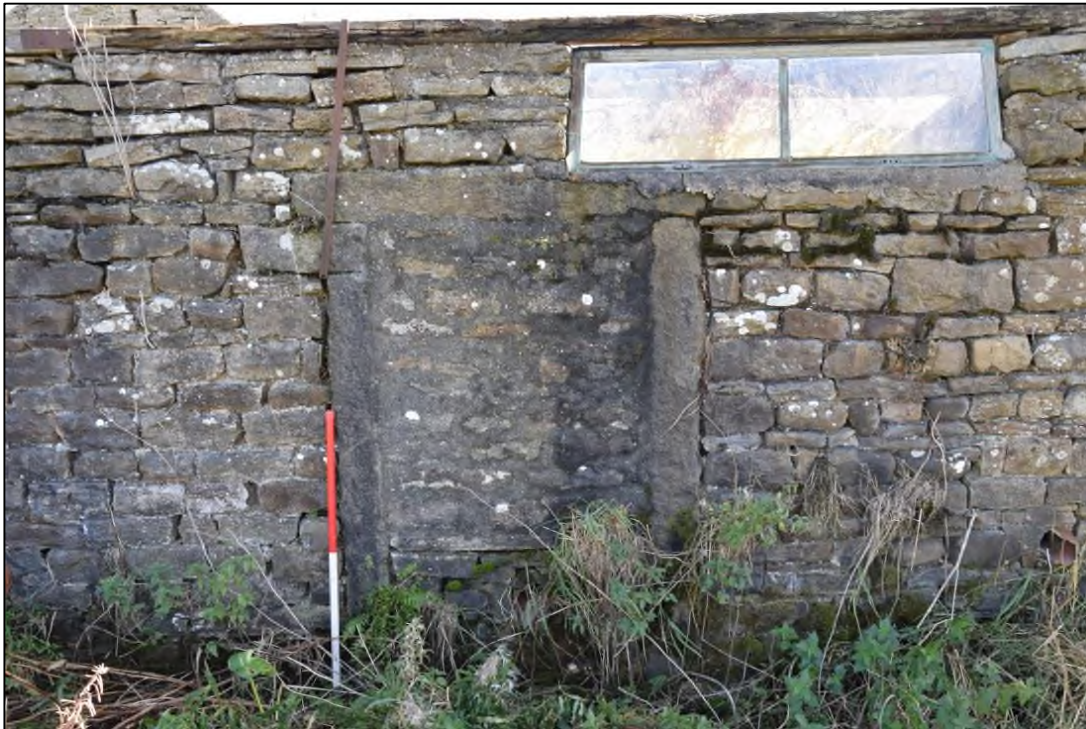
Photograph 52: Detail of the blocked door, later reduced to a window, in the west face of building 4

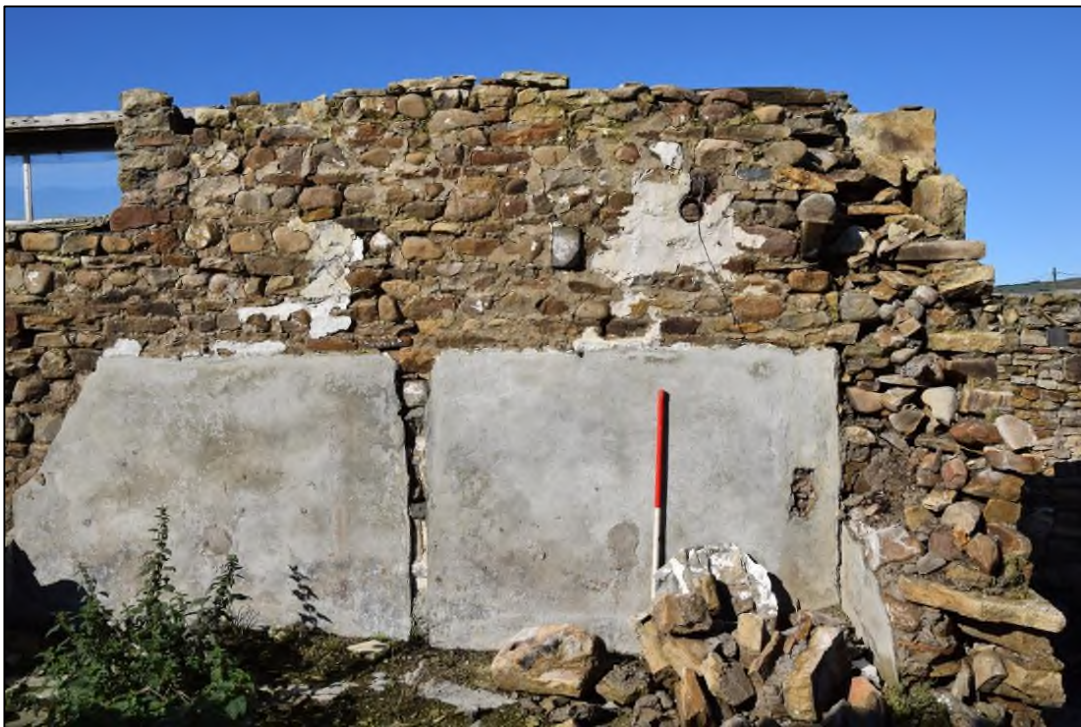
Photograph 55: The row of concrete stalls ran the full length of the small shed

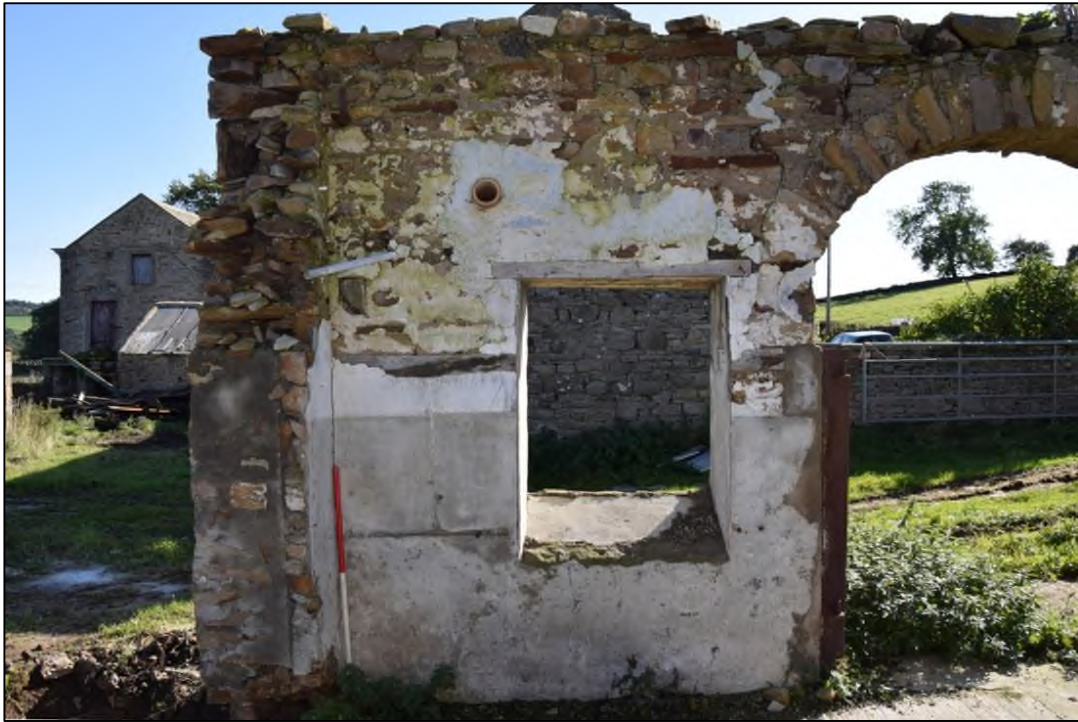
Photograph 56: The stubs of two joists can be seen above the cement render at the north-west corner of building 4

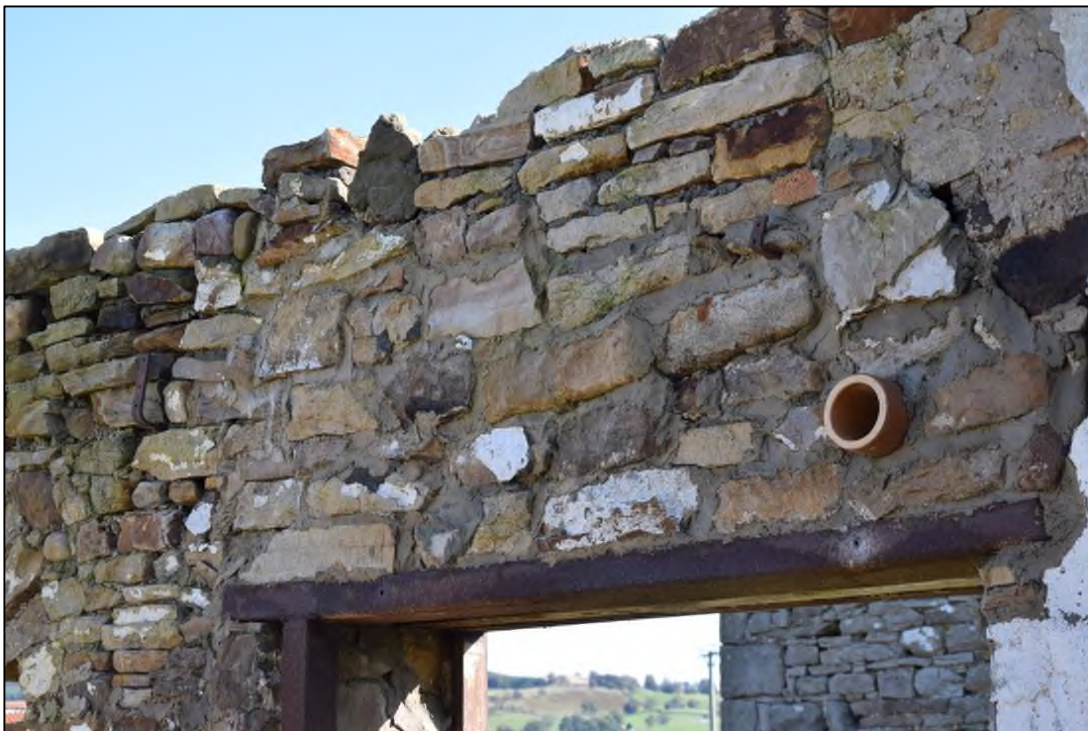
Photograph 59: Detail of steelwork and reset masonry above the south door

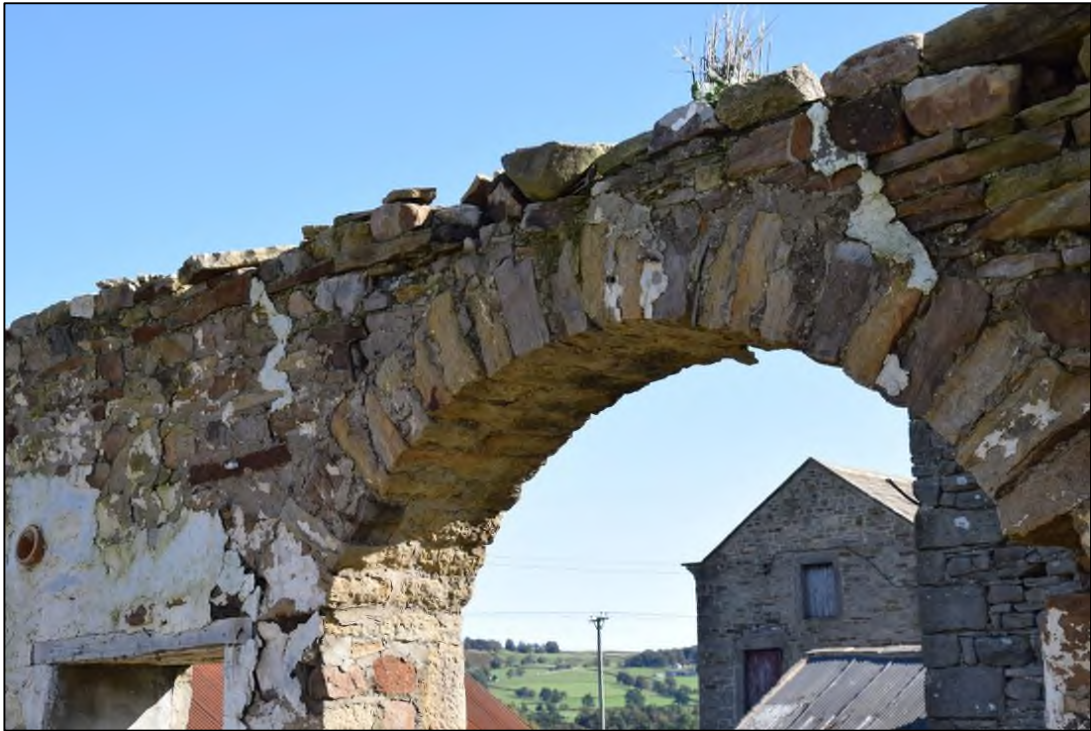
Photograph 60: The same pattern is seen over the middle door of building 4

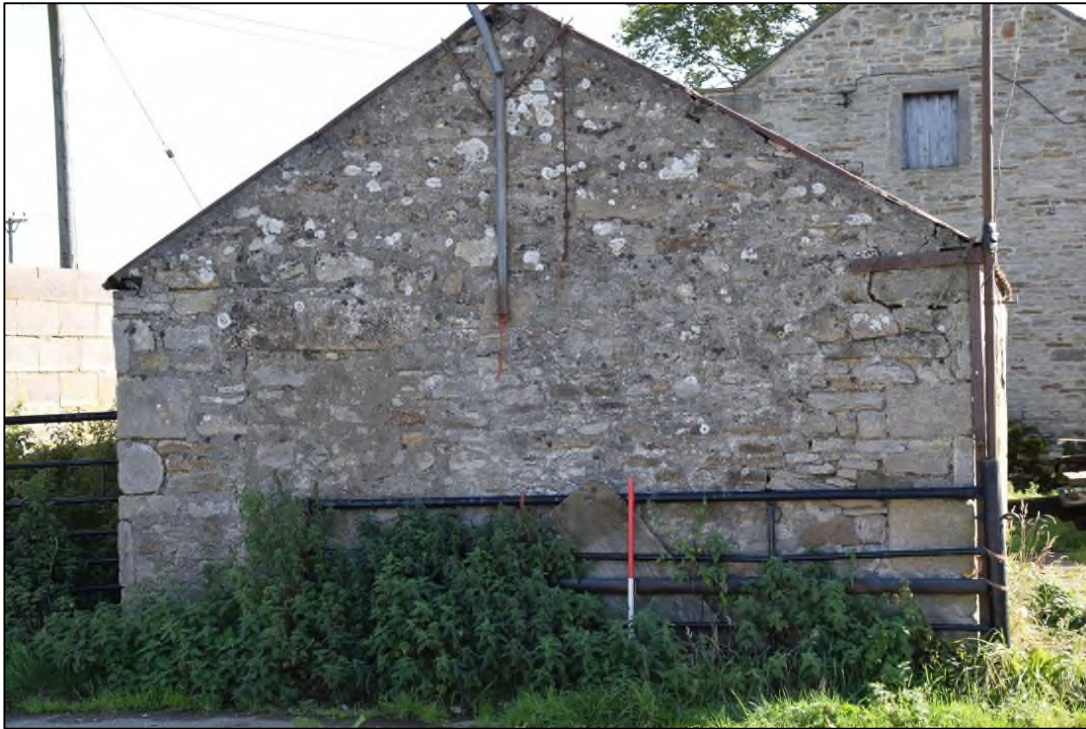
Photograph 64: The south face of building 5

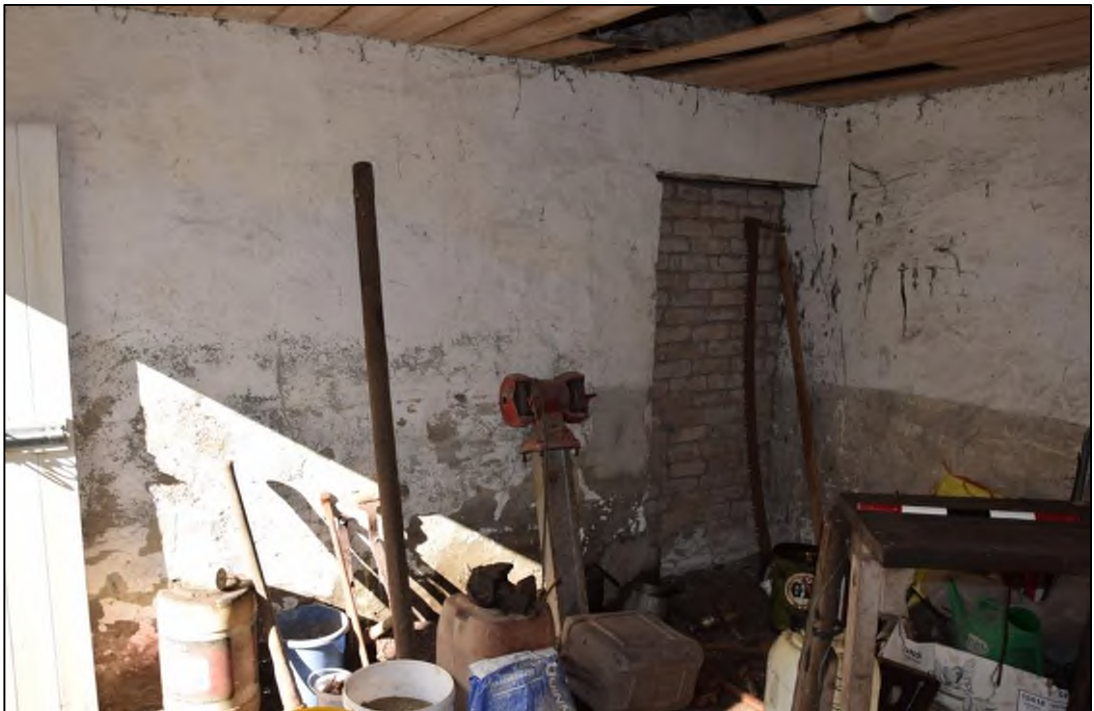
Photograph 67: The interior of the west room has traces of the old door near the far corner

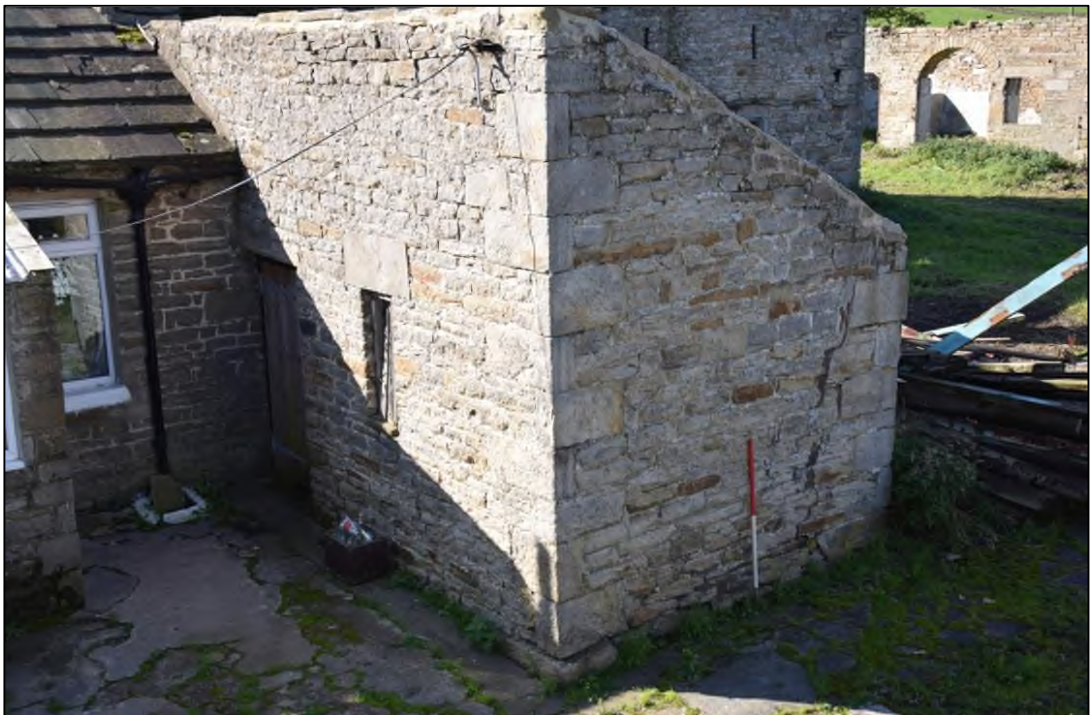
Photograph 69: The window and door of the eastern room; note the ceiling, absent from the other room
