# Arboricultural Consultancy for Lloyds Bank

Insured	Dr and Mrs Bennett	Address	Hawthorn House, Main Street, Nocton, LN4 2BH		
Client	Subsidence Management Services	Contact	Ian Domigan	Claim No.	IFS-LBG-SUB-22-0103204
ES Ref	SA-251162	Consultant	Giles Mercer	Contact No.	0330 380 1036
Report Date	28/12/2022

# GEOTECHNICAL

Hawthorn House, Main Street, Nocton, LN4 2BH

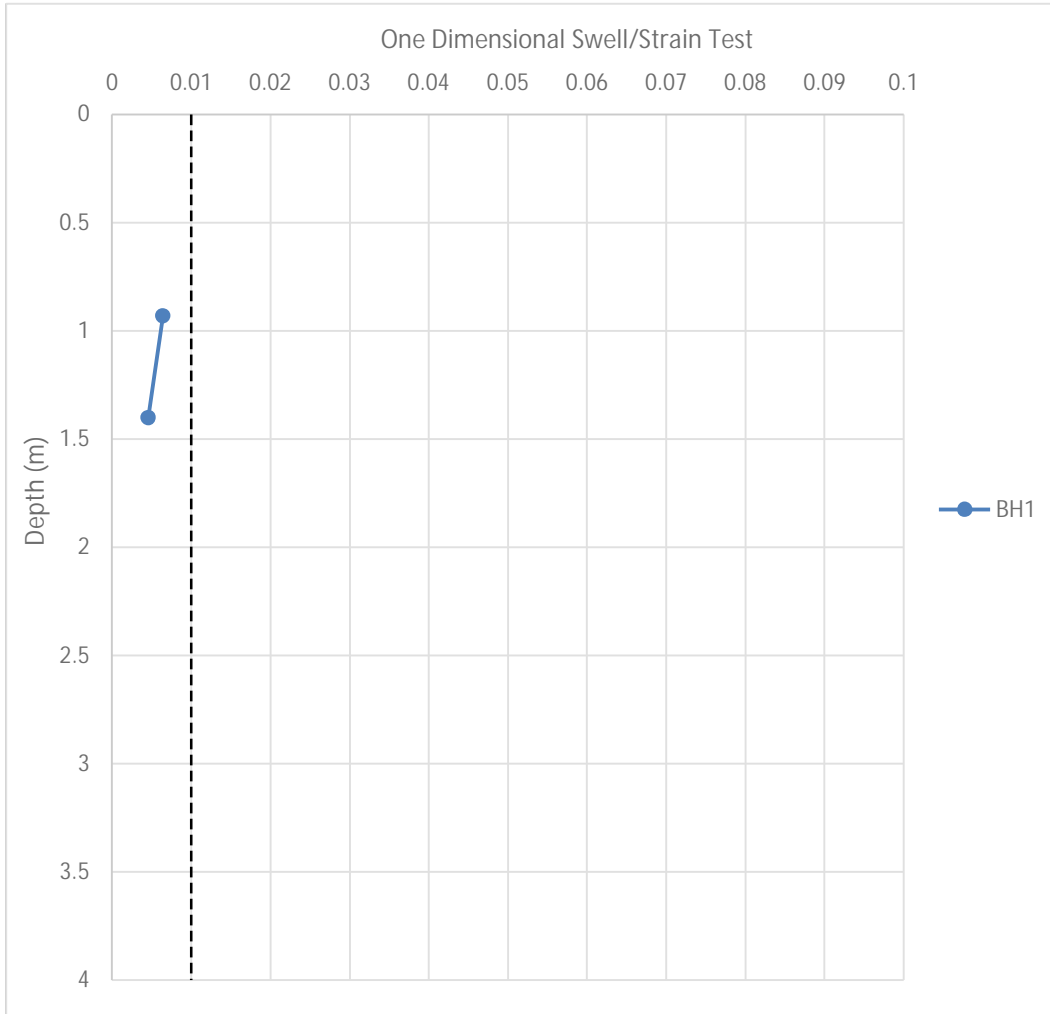
### Summary of Oedometer Testing for BH1

Lab Ref	Depth (m)	Strain	Heave (mm)	Remarks
1	0.93	0.0064	0	
2	1.4	0.0046	0

BH 1 estimate of heave 0mm
