## Former Hambly's Garage, Pelynt, Looe, Cornwall

### Phase 1 Preliminary Risk Assessment Report

#### Report No. 21011-R1

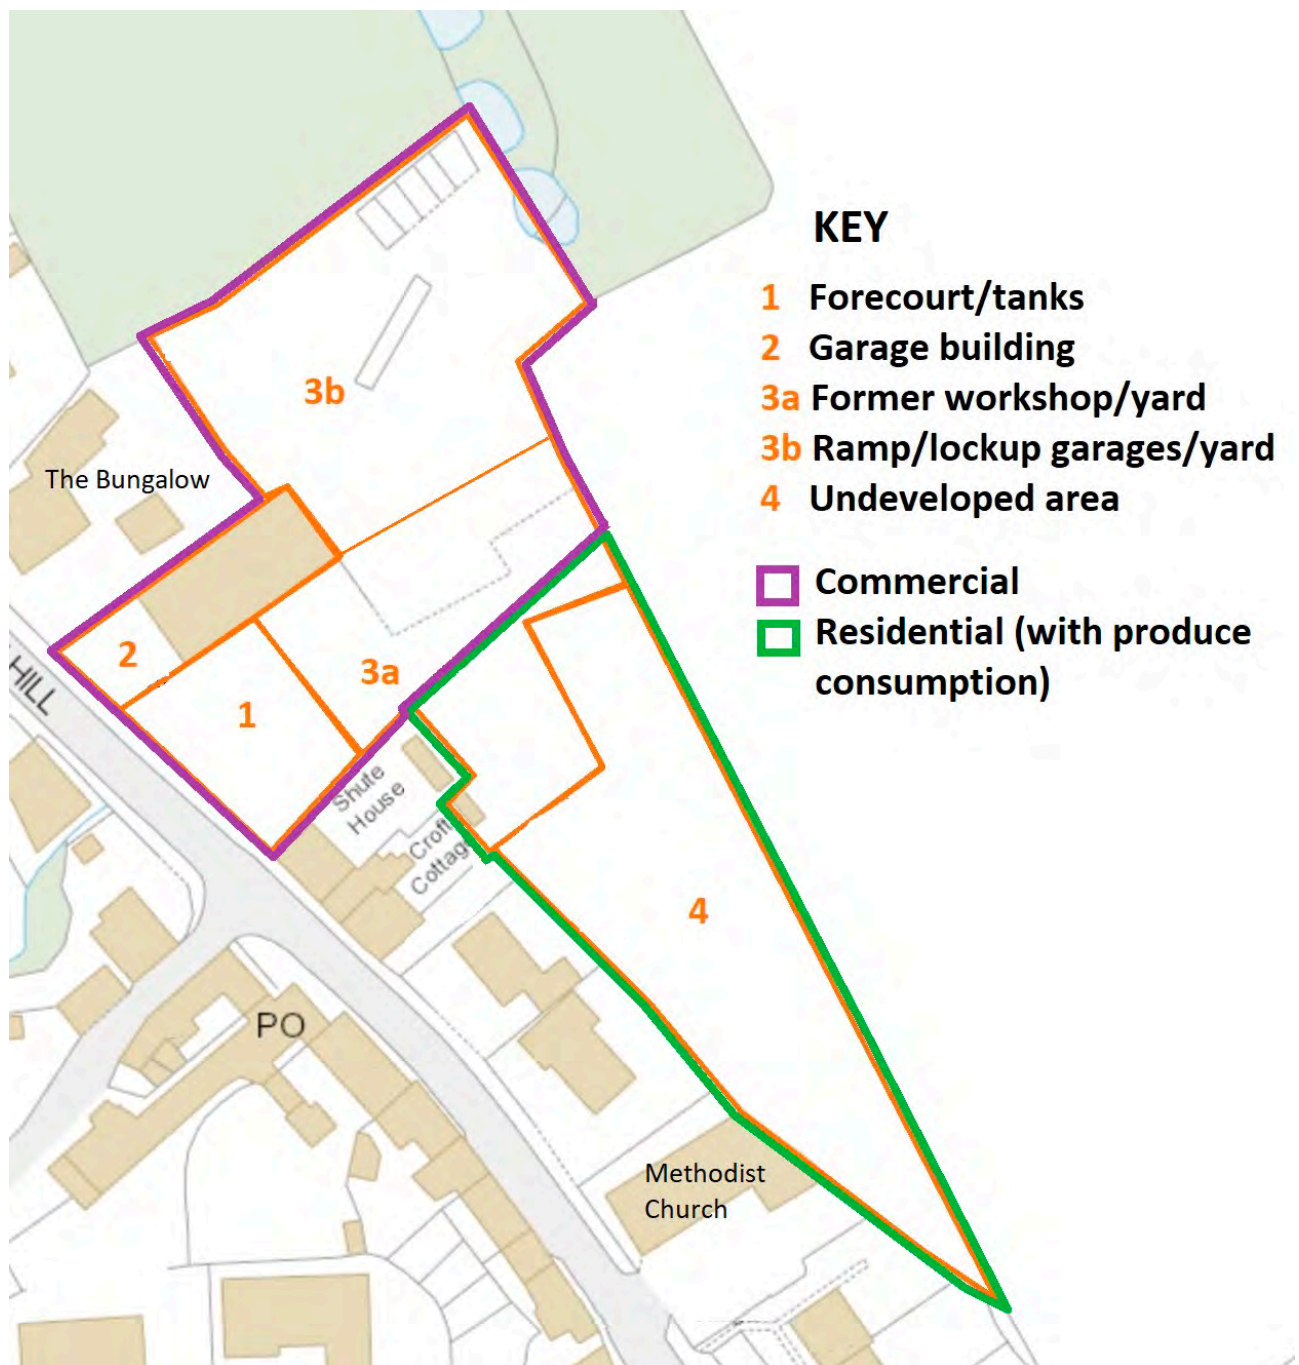
**Figure 3: Site Plan showing Assessment Areas and Proposed Development End Uses**

Figure 2 provides a spatial representation of key features of the site and Figure 3 shows the subdivision of the site into assessment areas.

In terms of standard end-uses defined for contamination assessment, the proposed development may be defined as part Commercial, a low sensitivity end-use, and part Residential (with consumption of home grown produce), a high sensitivity end-use. Figure 3 shows the spatial layout of the different end uses.

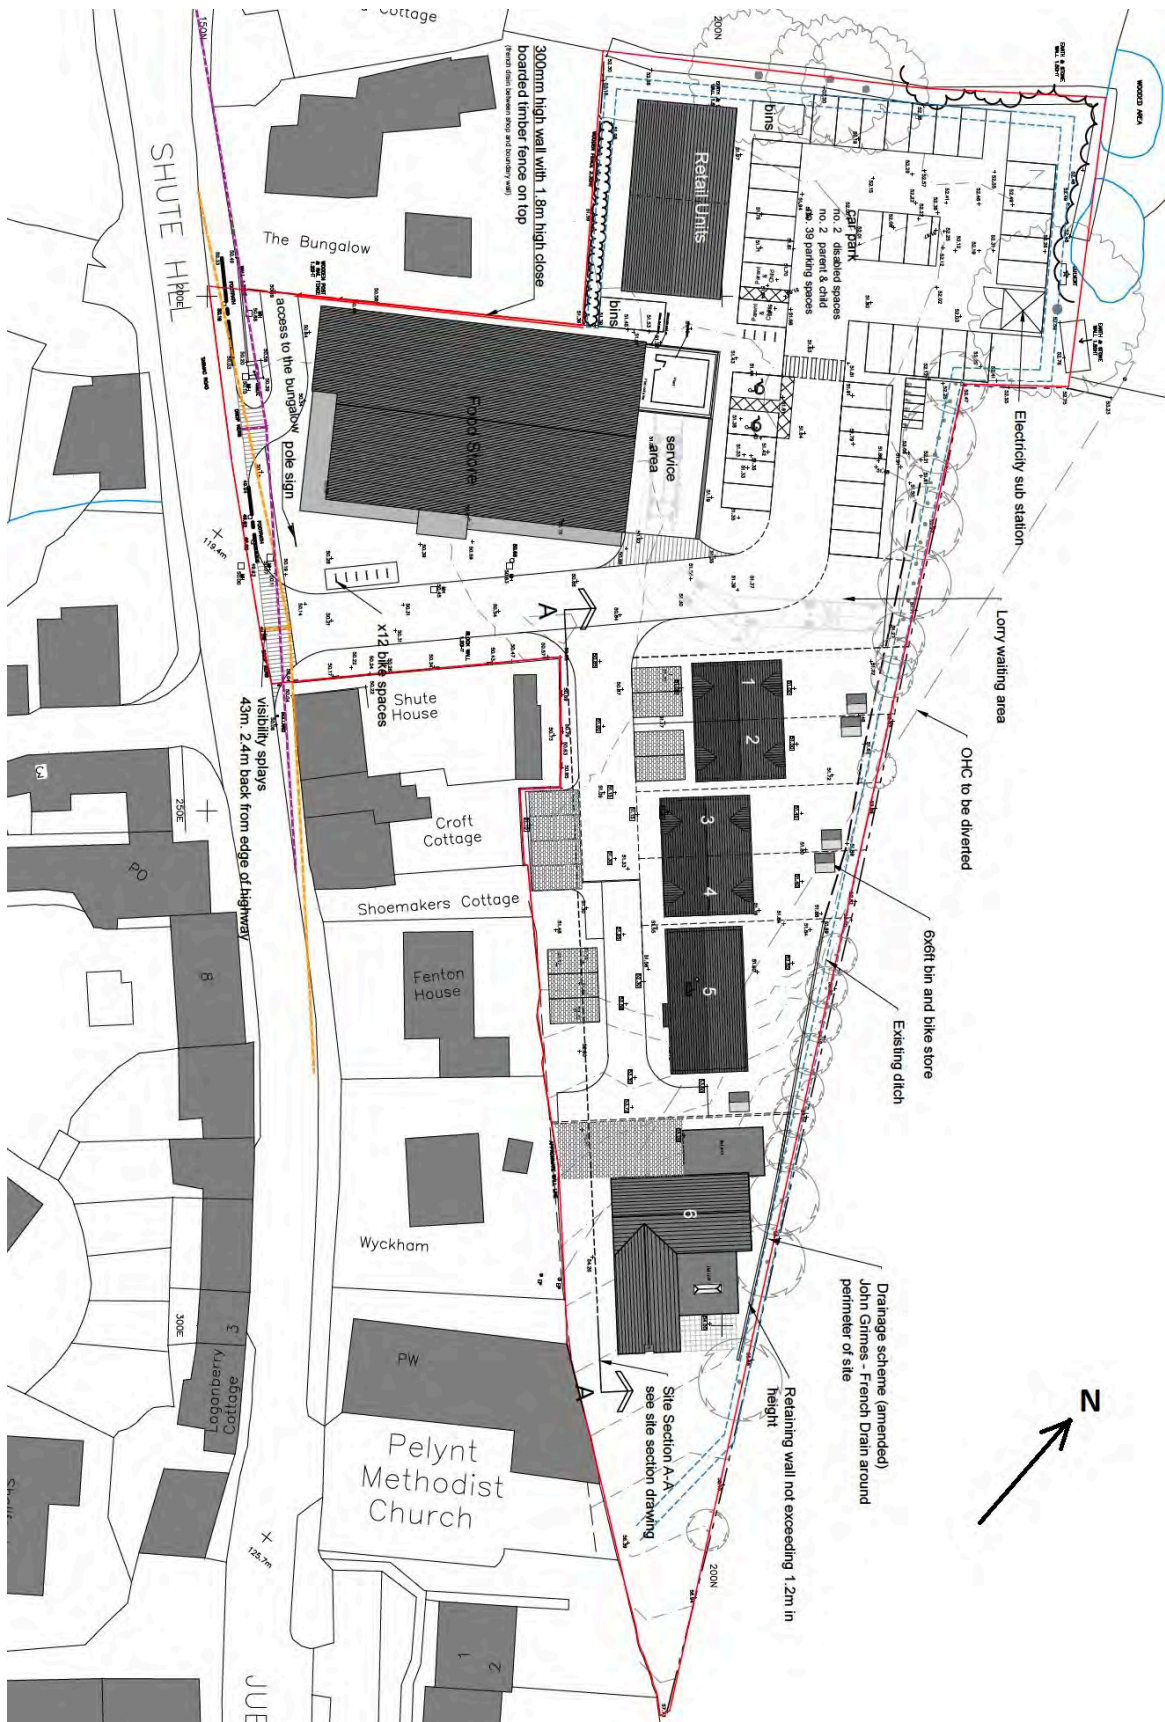
Figure 6: Proposed Development Layout

The proposed development is understood to comprise a mixed-use commercial/retail and residential development consisting of six houses with gardens and three commercial units together with access, parking and landscaping provision. Figure 6 provides the proposed layout.
