Milltown House, Yeolmbridge, Launceston, Cornwall, PL15 8TL

Statement of Significance

SH Ref MILT0921

NHLE1142820 MILLTOWN HOUSE AND GARDEN WALLS TO FRONT. GII*

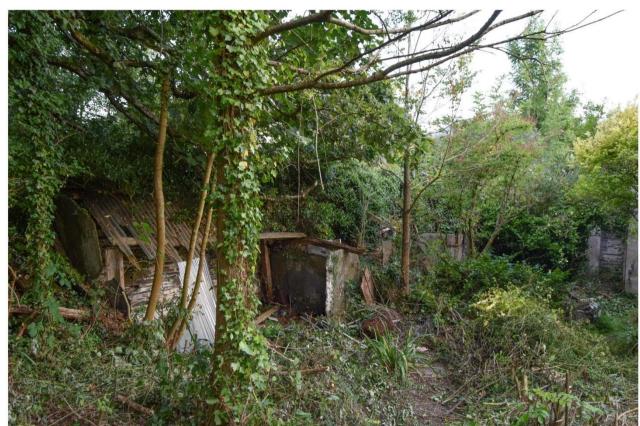
i) Outbuilding to the east of the house

- 3.1.6 In its most recent form the **eastern outbuilding (figure 6i)**, now mostly very ruined and overgrown preventing close inspection, was probably a piggery. The building's current form may reflect rebuilding of the shippon recorded as destroyed by fire in 1891. The rear (eastern wall) of the building is a well-built stone wall of similar construction to the western building supporting the remains of a monopitch roof structure, with outer walls constructed of megalithic slates set vertically and connected with metal straps, a vernacular technique particularly locally distinctive of the areas within 10km of *Bodmin Moor*, and the north-east coast slate mine sources.

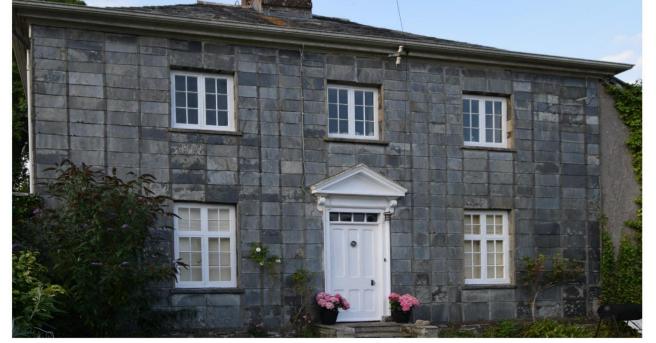
Figure 6: Milltown House, Principal elevation

iii) Principal elevation

- 3.1.11 The **Principal South Elevation** is shown at **figure (figure 6iii)**. The elevation is as described by the list description stating "Symmetrical 3-window front. Flight of dressed granite steps up to central entrance with C18 pedimented doorcase and circa late C19 door. Flanked by probably the original C18 mullion and transom windows. Three, possibly original 2-light casements on first floor".

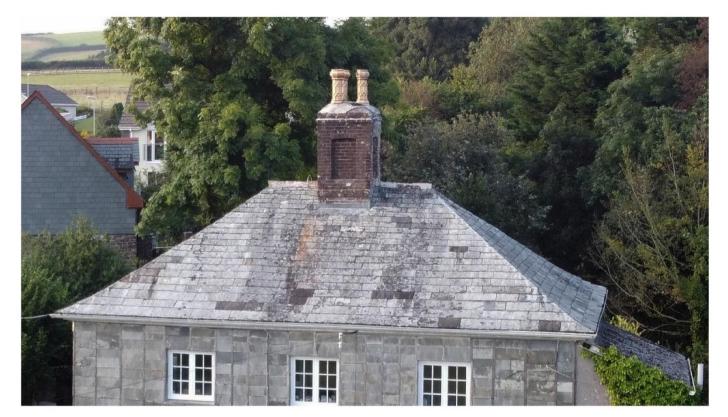
i) Rag slate roof and chimney, souther slope

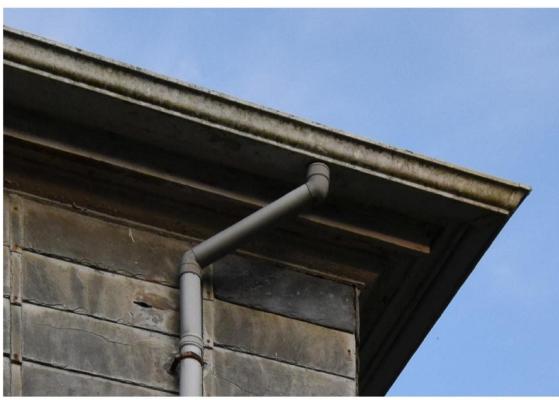
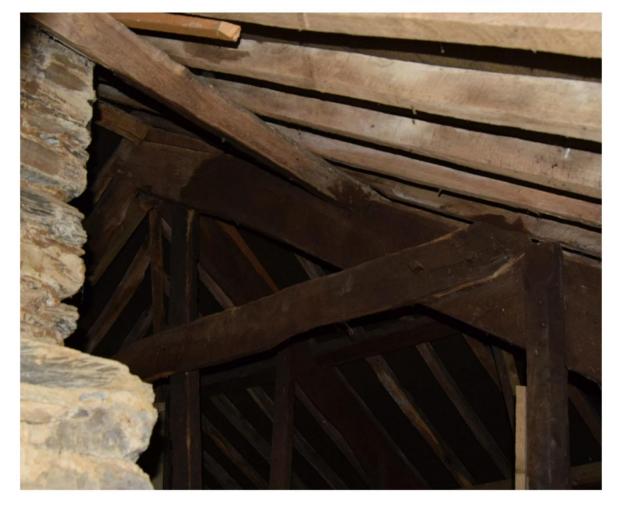
ii) Rainwater goods south corner of west elevation

iv) roof structure

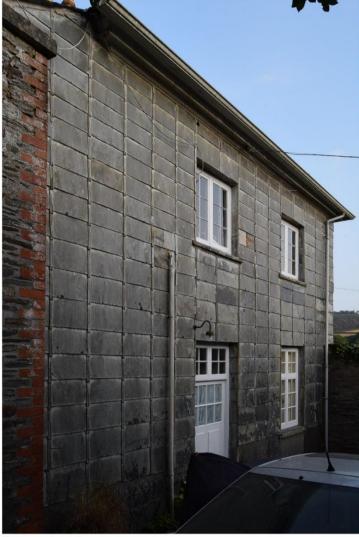
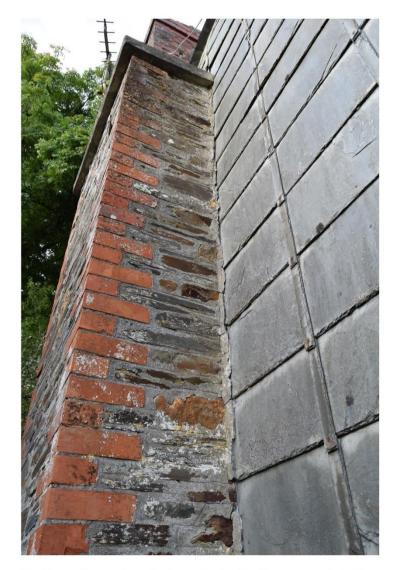
Figure 9: West elevation

i) West elevation, main range

ii) Above, the western stack as attached to the rear outshut. Stone rubble in cement mortar with brick detailing.

- The bracketed timber pediment on carved brackets above the door supports an early to mid 18th century date.
- 3.1.12 The **west (left-hand) elevation (figure 9)** has two pairs of symmetrically arranged openings on the main range with an external stone stack with brick and cement detailing (possibly late 19th or early 20th century) against the out-shut originally serving a range in the left-hand room of this part of the building.

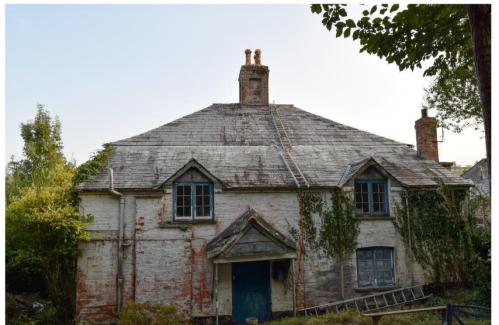
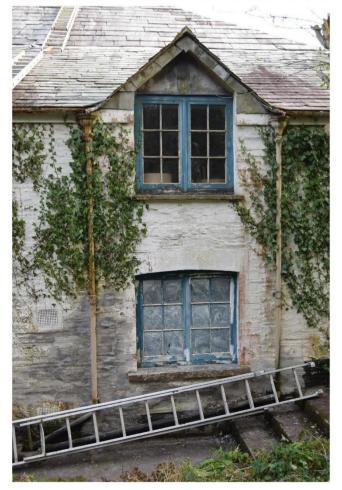
Figure 10: Rear elevation

i) North elevation, general

ii) Rear porch

ii) Detail showing rear dormer, and kitchen window

- 3.1.13 The **north (rear) elevation (figure 10)** is more vernacular in character of limewashed slate rubble. with an off-centre pitched porch.
- The porch, which has a rag slate roof, was originally supported by failing slanting timber brackets clad in wide timber planks, with further iron-bar stanchions probably added during the twentieth century as additional support, but now further supported by screw-props introduced as emergency safe-guarding works by our client). The porch urgently requires a more permanent solution if it is to be conserved, or replacement informed by this record (this would require listed building consent). We do not recommend like-for-like repair or replacement due to the inherent historic shortcomings of the current design, and would suggest that the advice of a structural engineer or architect is sought.

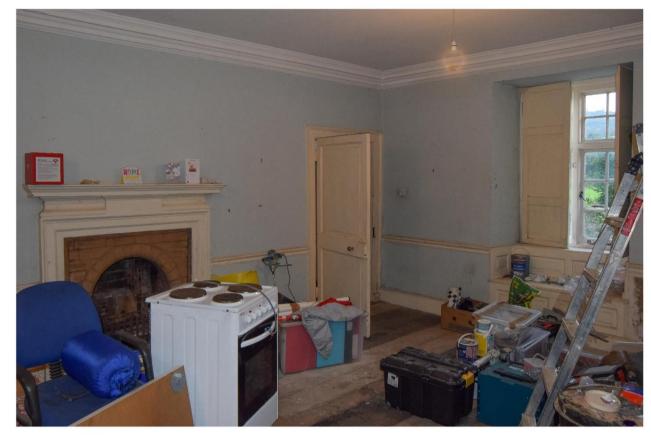
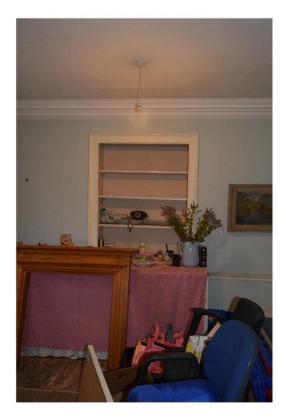
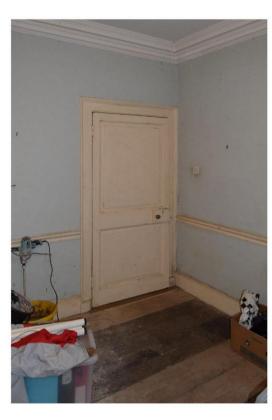
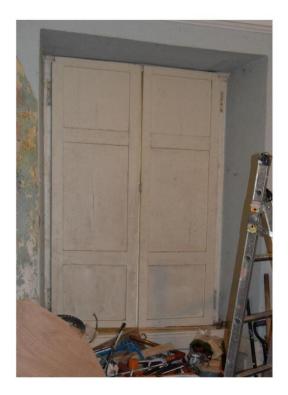
> Figure 12: West room (principal reception room)

i) Looking south west across the principal (western) reception room

ii) (left) china cupboard in north wall

iii) (right) door to baffle entry hall

iv) (left) shutters v) (right) moulded fireplace

- 3.1.15 The **interiors and fixtures of the building** are remarkably complete.
- The better preserved of the two main downstairs rooms is that to the **left (west) of the principle elevation (figure 12)**. This room retains moulded plaster cornices, moulded chair rails, an original early-mid 18th century 2 panel doors with raised and fielded panels (on 20th century rising hinges); a very good bolection moulded plaster fire surround around a (possibly later) arched brick fireback; and a simply framed china cupboard in the back wall. Raised and fielded panels are around and below simple window seats and the windows retain 18th century panelled shutters. The floor retains timber boards of varying widths, with some damage from a previous occupant's leaking freezer currently temporarily covered in hardboard panels.
