**Victoria's, Ashford Road, Harrietsham,
Maidstone, Kent**

Road Safety Audit Stage 1

on behalf of Swift Roofing Contracts

TMS reference no: 15875

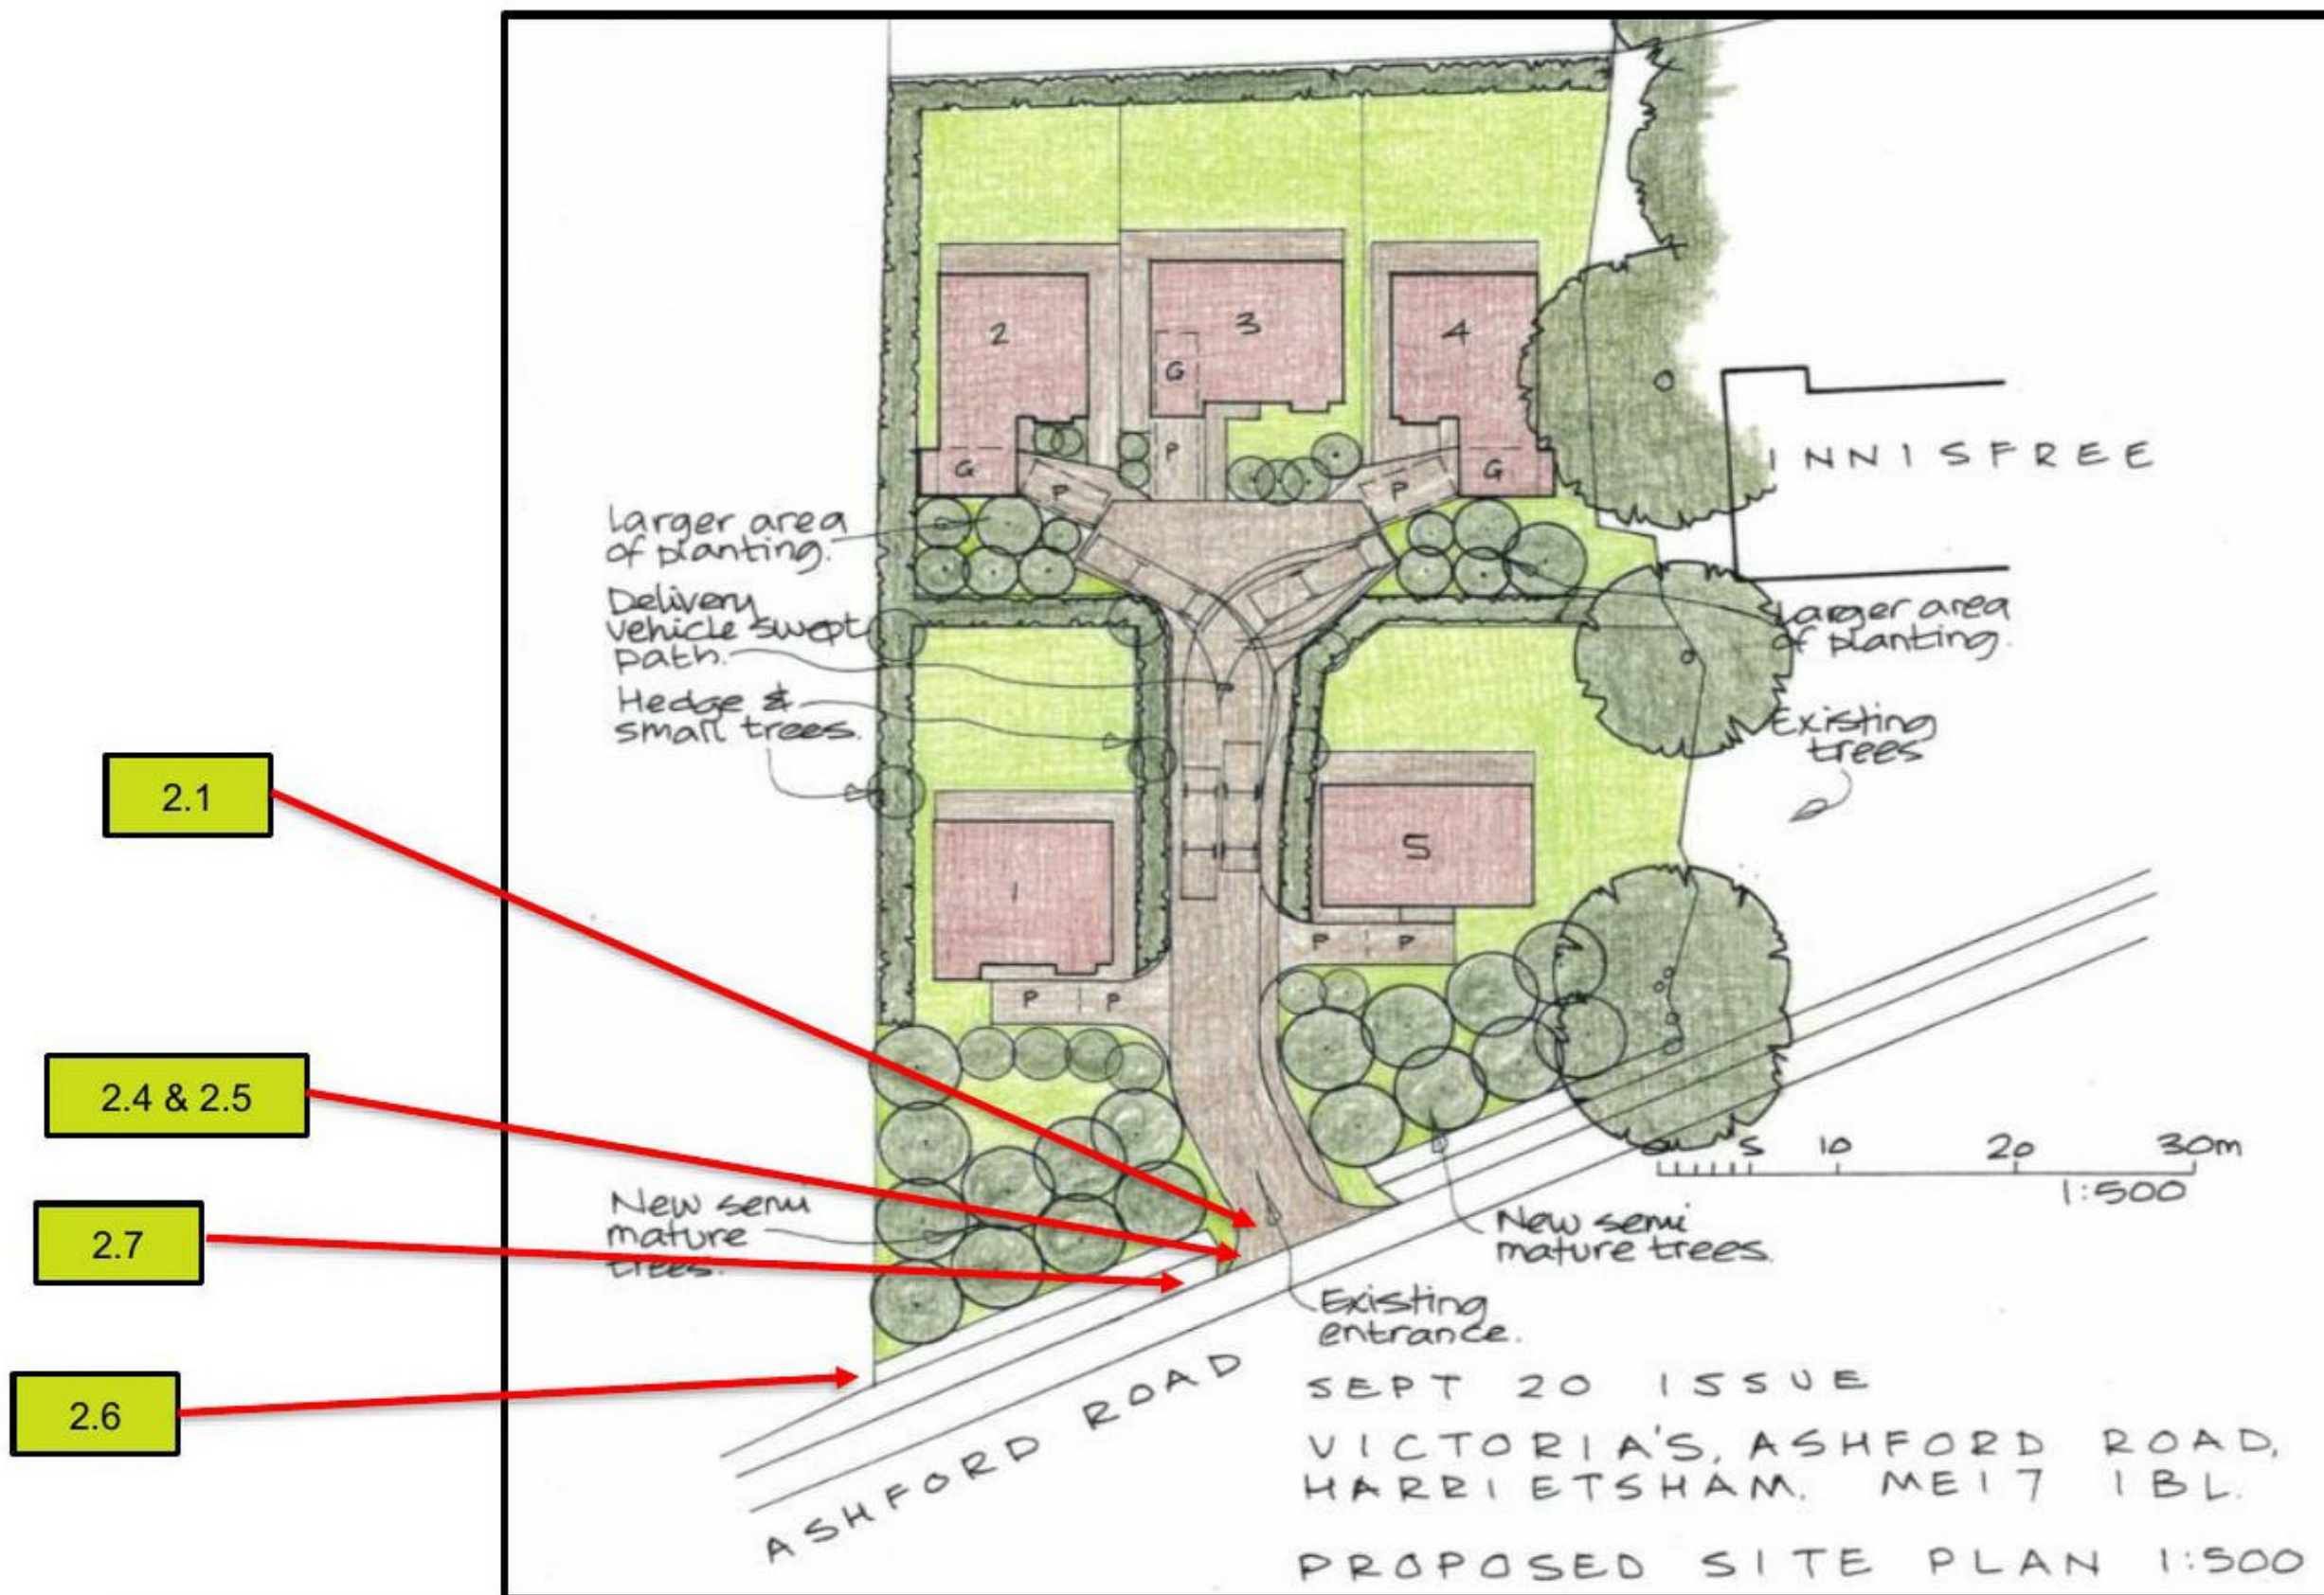
Summary: Risk of tripping or injury for pedestrians

A lighting diagram has not been provided to cover the proposed development. This could cause trip / slip / trip type injuries to pedestrians together with vehicle related collisions during the hours of darkness.

The footway is currently uneven on Ashford Road near the vicinity of the development, with evidence of patching and uneven surfaces. These could potentially cause trip / slip / fall type injuries to pedestrians, particularly to those with mobility and visual impairments.

Details have not been provided for new locations of utility and service covers. Existing service / utility covers located in junction turning areas may present skid hazards to turning vehicles, particularly to two wheeled vehicles. In addition, metal service covers, and drainage gullies may present a slip hazard to pedestrians. Both issues will be exacerbated during wet or icy conditions.

The right-hand visibility splay at the junction for drivers waiting at the give-way line is likely to be obstructed by existing vegetation, this could result in pull-out type collisions if drivers fail to see approaching vehicles in time.

There are currently several old metal verge markers on the northern footway which could be a hazard to any errant vehicle attempting to turn too early into the development. This could increase the risk of injury to vehicle occupants.

The posts should be removed and replaced with a sufficient kerbed edge to the footway to safeguard users.
