Barn at Gibbons Farm, Battisford, Suffolk

(Suffolk HER BAT 051)

Historic Building Record

October 2022

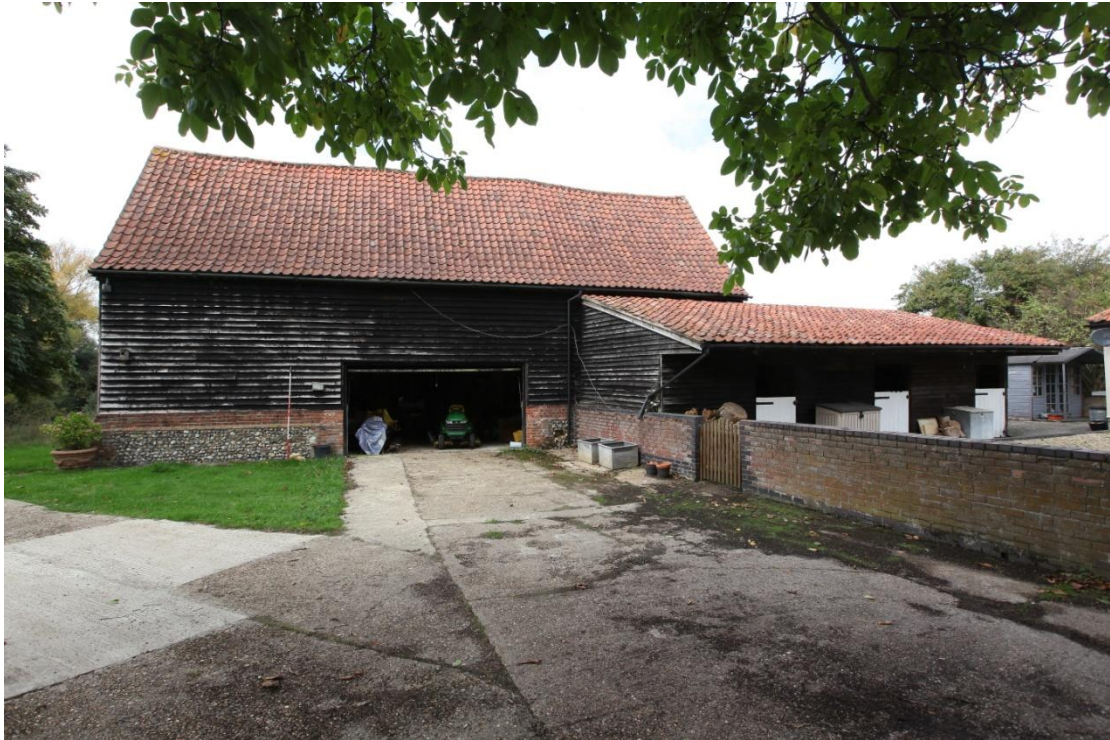
Illus. 5. The barn (1) from the east showing the pantiles that are likely to have replaced thatch and the tarred weatherboarding on a plinth of flint-rubble and brick. The present ‘up-and-over’ garage-type door occupies the position of the original full-height central entrance but extends further to the left. The lean-to former stable (2) on the right consists of modern softwood and dates only from the late-20th century, having replaced a smaller open-fronted shelter-shed shown on 19th century maps.

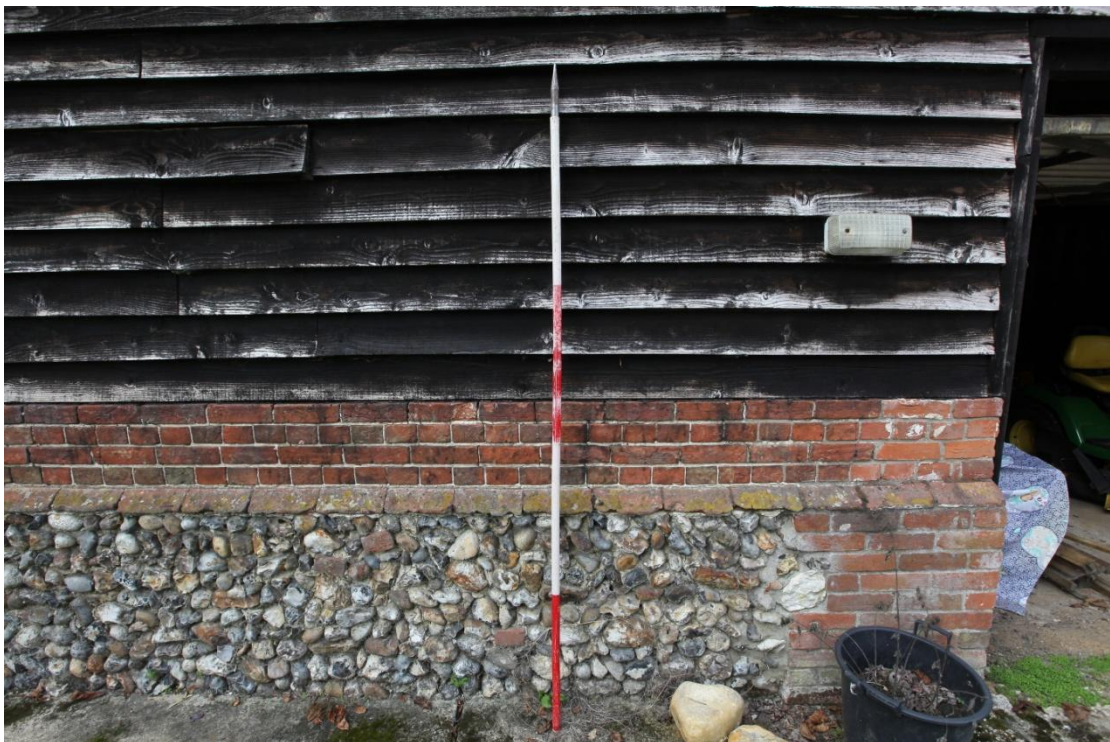
Illus. 6. A detail of the tarred 20th century softwood weatherboarding to the barn’s eastern exterior (1) showing its original brick and flint-rubble plinth with modern brickwork to the jamb of the enlarged entrance on the right.

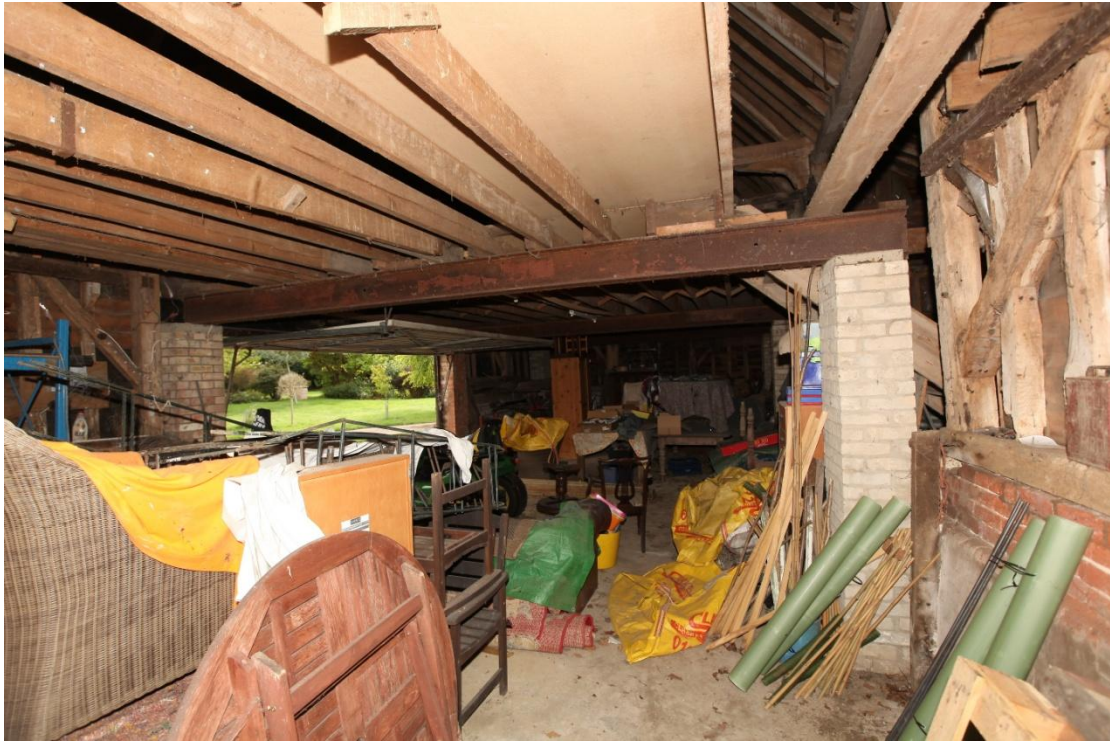
Illus. 11. A general view of the barn's interior (1) as seen from the north, with the 20th century garage door in the eastern wall to the left. The barn contains a late-20th century loft of narrow-sectioned softwood joists supported by RSJs on brick piers which conceals the roof structure from ground level.

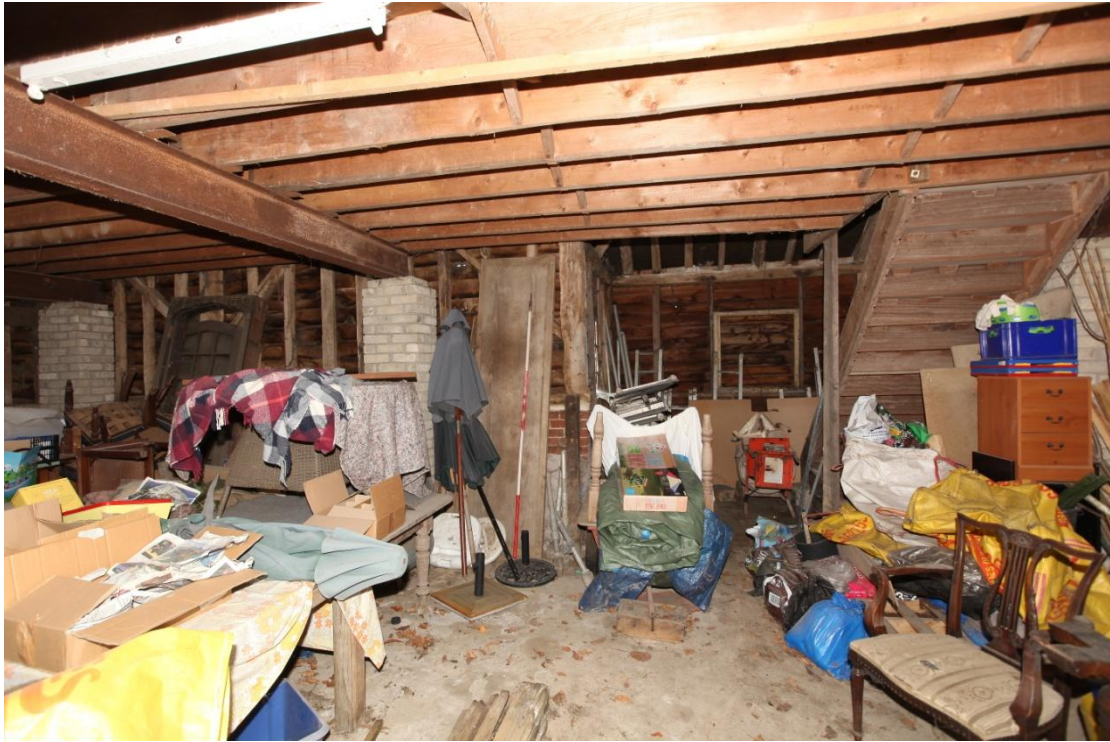
Illus. 13. The western interior of the barn (1) showing the modern loft stair in the central rear porch to the right and the brick piers supporting its RSJs in the southern bays to the left. The floor consists of 20th century concrete with no trace of the boarded or brick threshing floor that would have occupied the central bay.

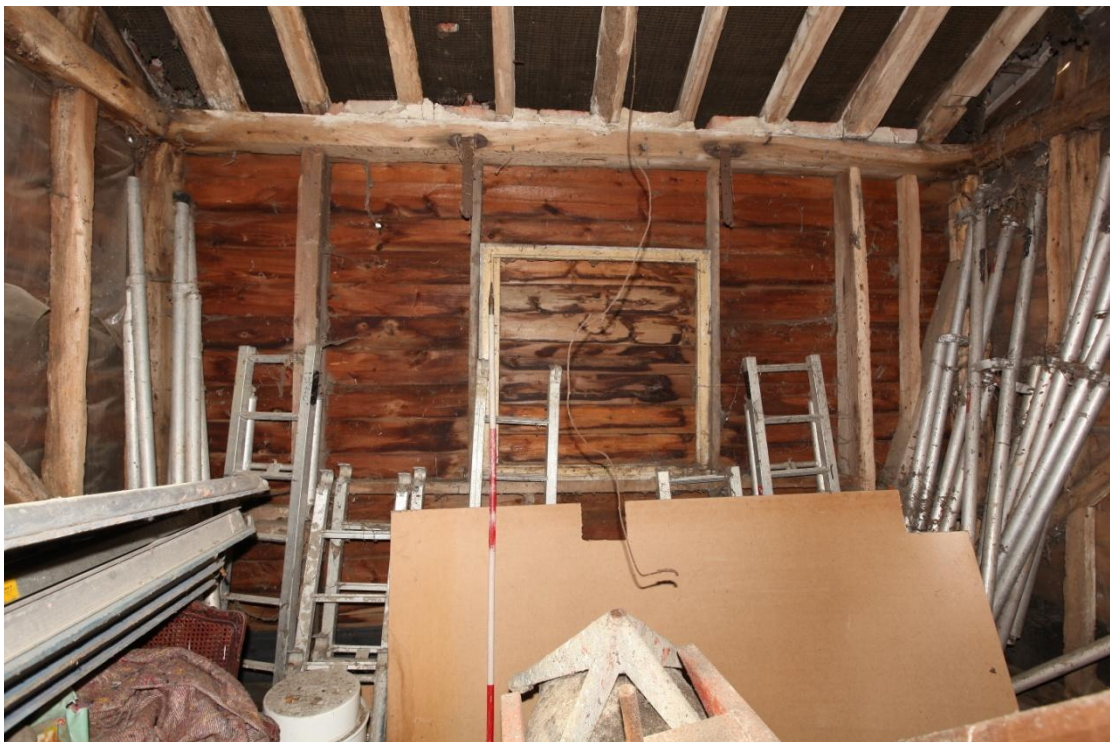
Illus. 18. The western interior of the rear lean-to porch (1) showing the original jamb of its doors pegged to the roof-plate on the right and a renewed softwood jamb in the original pegged mortice to the left. A mortice in the centre of the plate held the locking post of the doors and the iron hinges on each side evidently held a secondary vertically hinged hatch or shutter. The stud and diagonal brace to the right are also original.

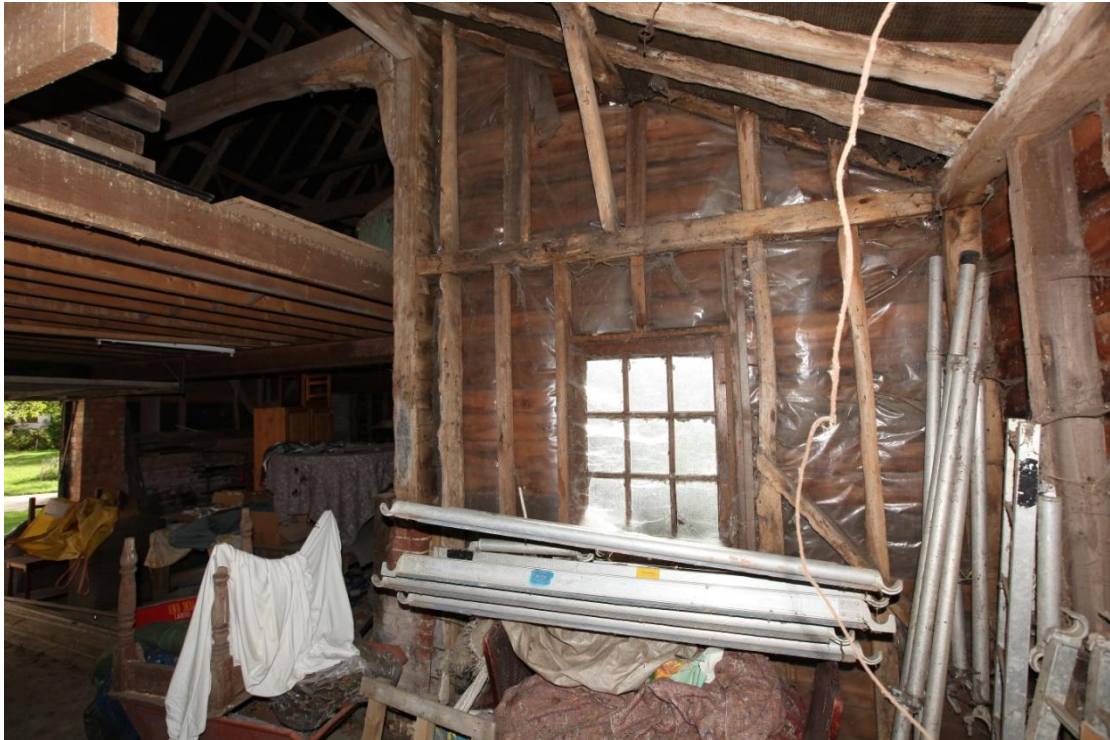
Illus. 21. The southern internal wall of the western lean-to porch (1), showing the narrow studs and diagonal primary brace of its original framing, partly cut by a later window. The tie-beam is pegged and tenoned to the western roof-plate on the right and to the storey post of the main span on the left.

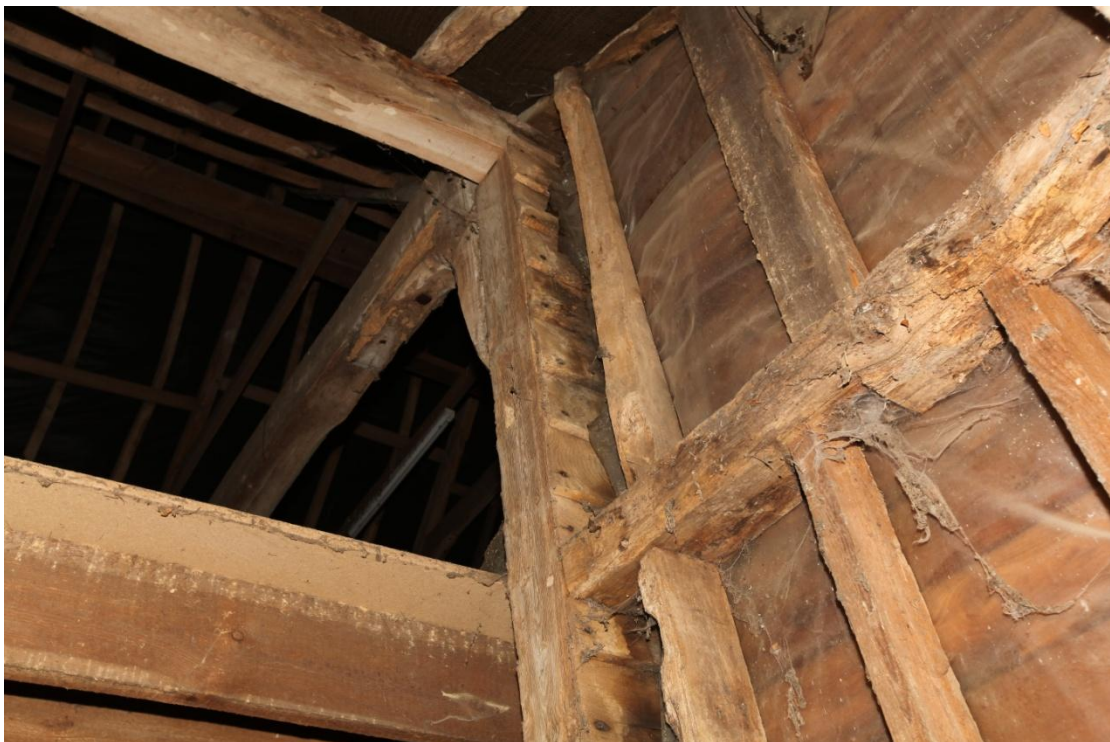
Illus. 22. A detail of the southern internal wall of the porch in illustration 21 showing its junction with the storey post of the main span (1). The horizontal tie-beam is pegged to the post and respected by the ends of the original elm weatherboards which continue externally but were protected by the porch from the application of tar. The adjoining roof-plate of the main structure at top left is devoid of mortices for studs or doors.

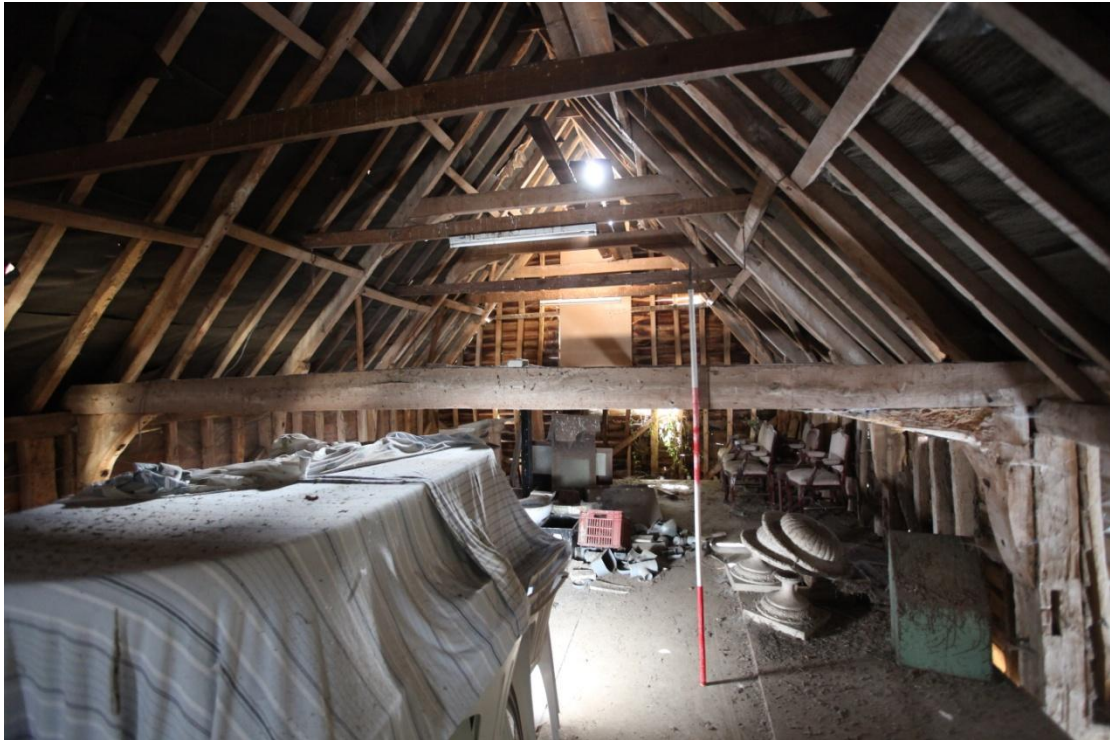
Illus. 27. The southern bays of the barn (1) seen from the central threshing bay with the latter's original knee-braced tie-beam in the foreground.

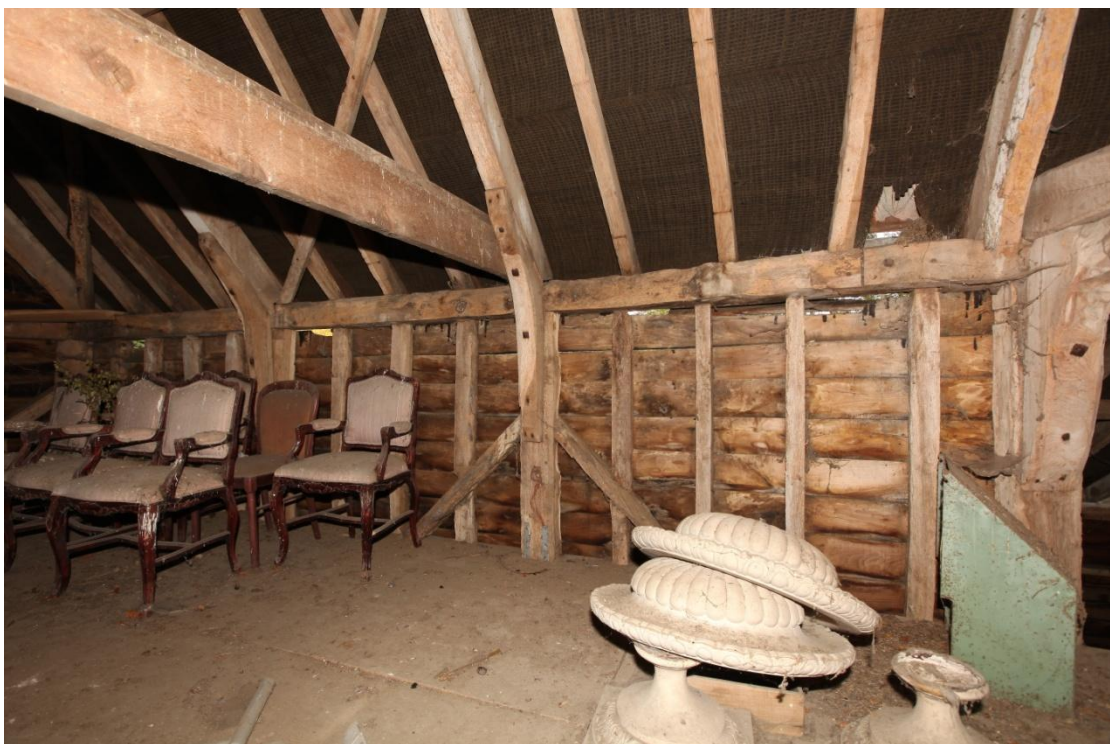
Illus. 30. The western interior of the barn's southern bays (1) showing their intact original framing and rafter knee-braces with the original elm weatherboarding. A face-halved and bladed scarf joint of typical post-medieval form is visible to the right.

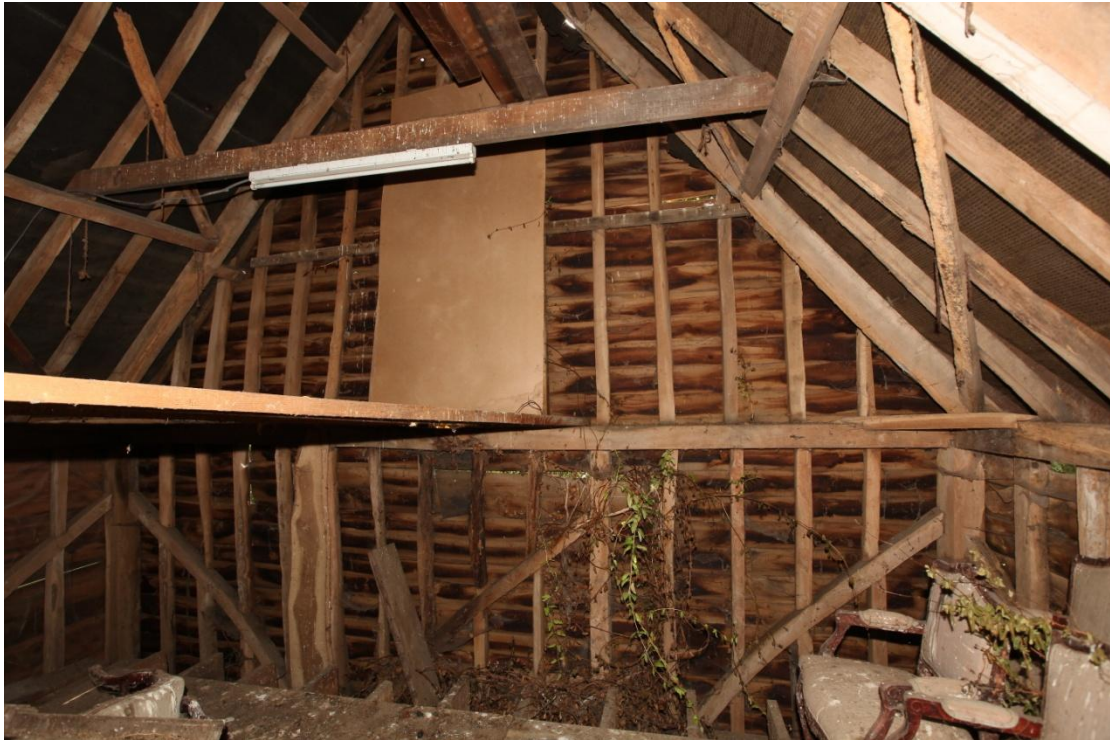
Illus. 31. The southern internal gable of the barn above the loft showing its intact asymmetrical framing with two curved braced descending from the right and one to the left. Unlike the tie-beams of the threshing bay which are dovetailed to the roof-plates those of both gables are tenoned at the same level with their junctions strengthened by diagonal tie-beams as shown in illustration 32. The boarding above the gable tie-beam blocks a 20th century inserted window and there is no obvious evidence of original vents.

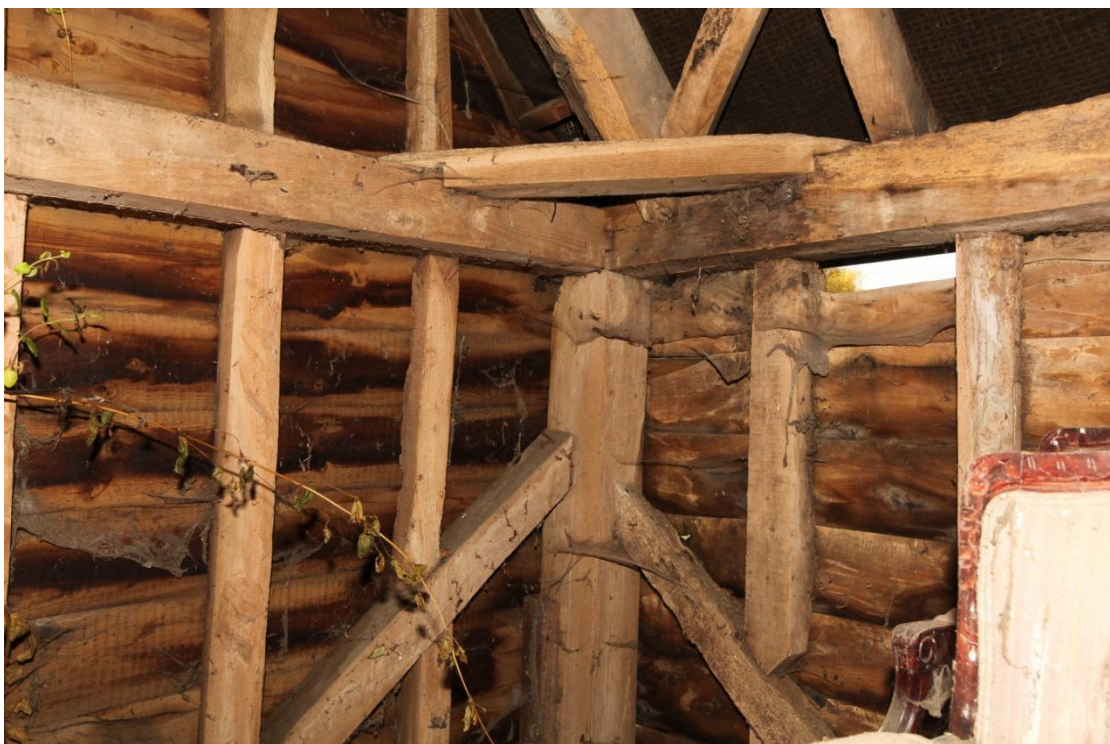
Illus. 32. A detail of the barn's south-western corner to the right in illustration 31 (1) showing the lack of jowl (swollen top) to the post and the tenoned and pegged junction of the gable tie on the left and the roof-plate to the right. The diagonal tie is original.

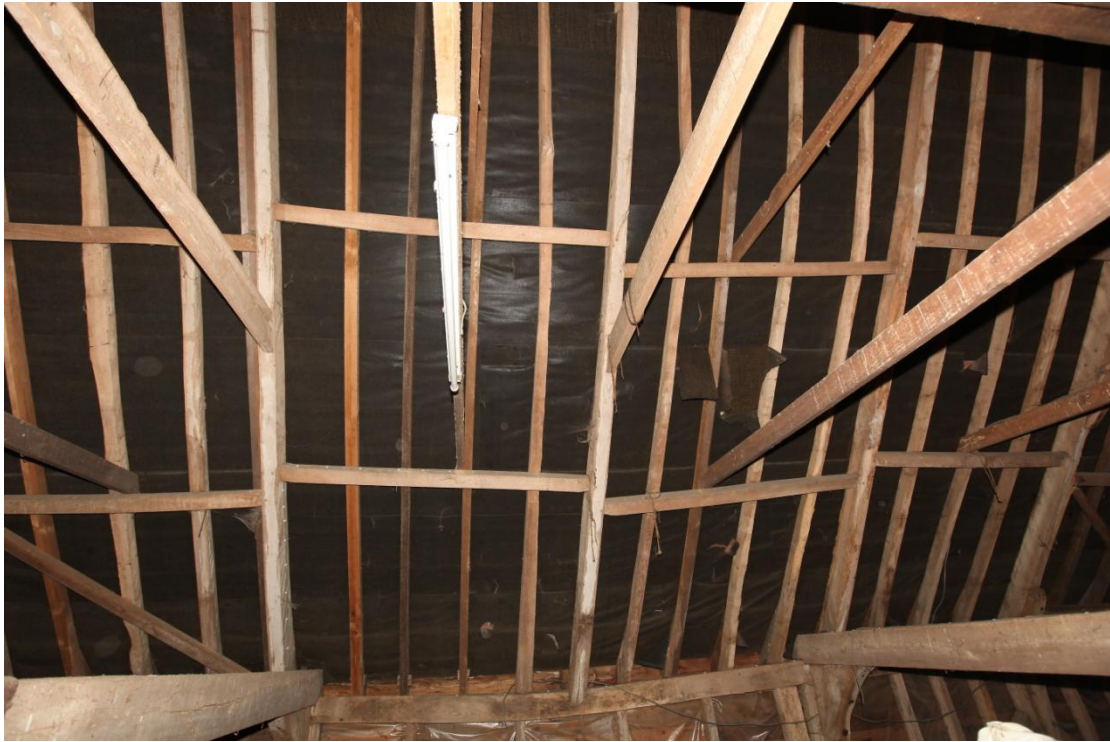
Illus. 33. The largely intact eastern roof structure above the central threshing bay (1) showing a small number of renewed softwood rafters and inserted nailed collars. The original timber consists of elm and oak. The upper collars of the three central principal trusses are pegged but not braced.

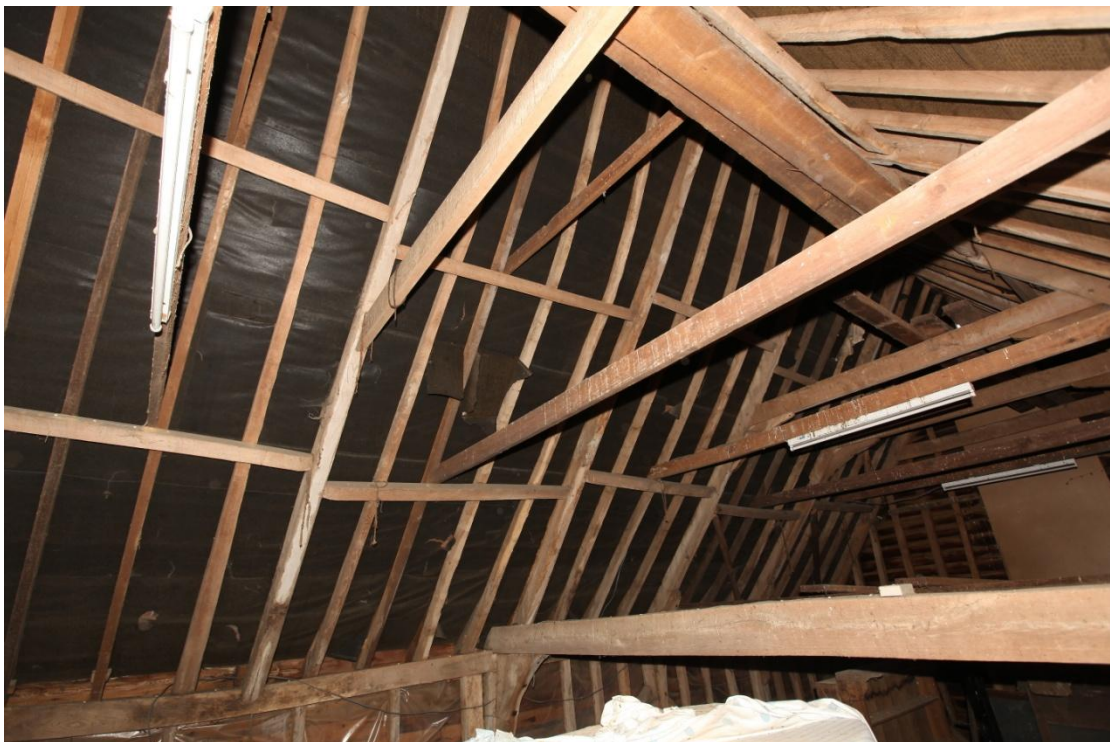
Illus. 34. The eastern roof structure of the southern bays of the barn as seen from the central threshing bay (1).

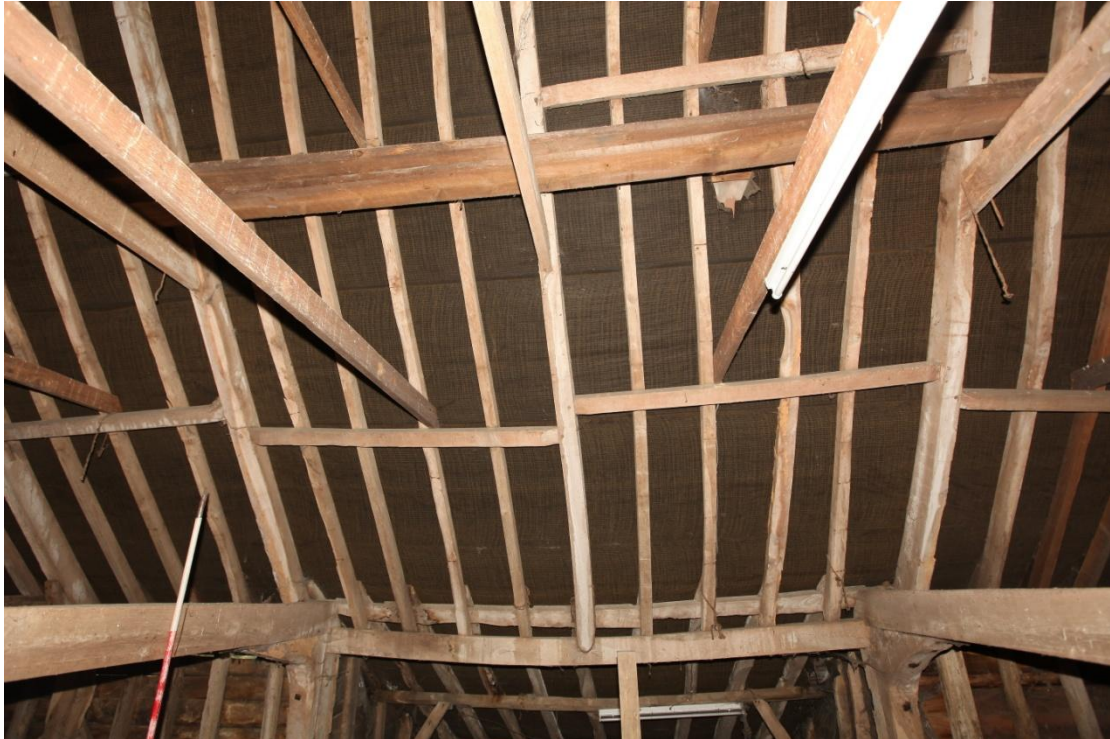
Illus. 35. The intact western roof structure above the rear lean-to porch showing the two arch-braced tie-beams flanking the central bay.

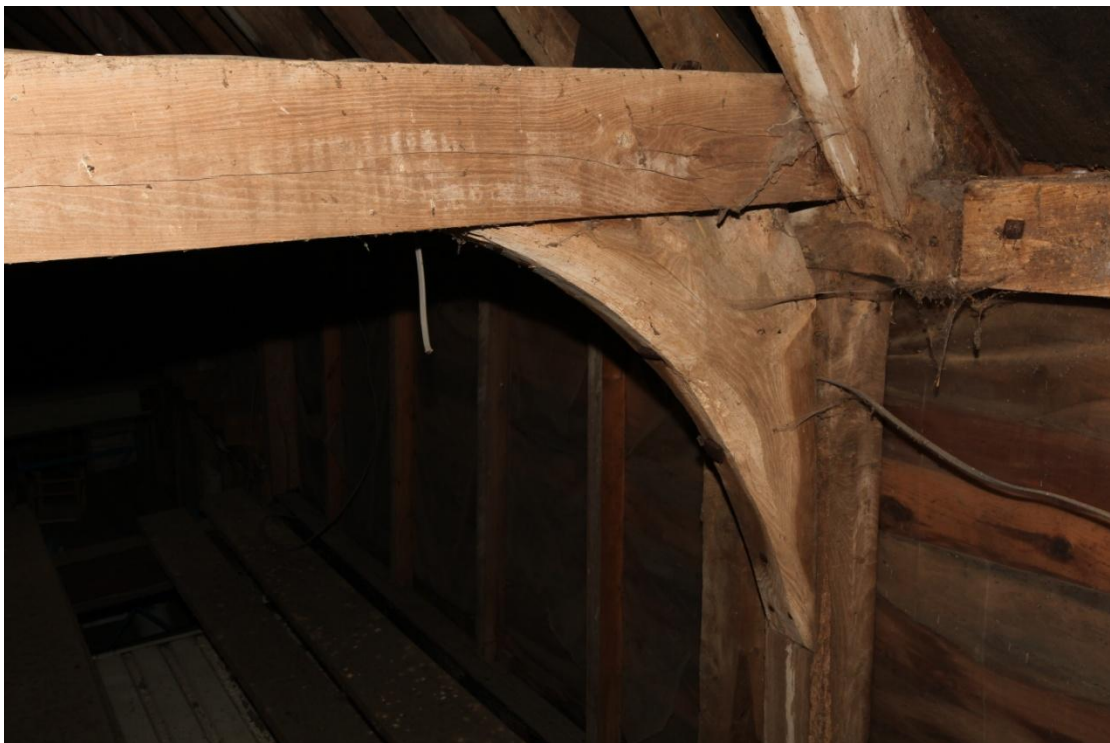
Illus. 36. A detail of the original bolted knee-brace to the south-eastern storey post of the threshing bay showing the distinctive colour and grain of the elm tie-beam with a face-halved and bladed scarf joint in the roof-plate to the right.
