223012.100

STRUCTURAL ASSESSMENT

CONVERSION OF EXISTING OUTBUILDINGS

**THE WILLOWS
EYNHAM ROAD
CASSINGTON
OX29 4DF**

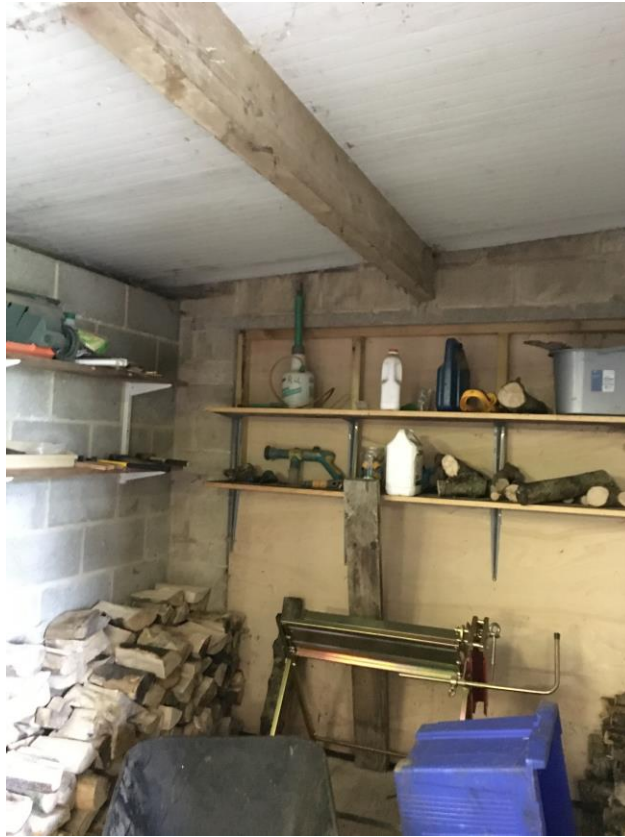
- 4.2.2** The corrugated sheet roof is supported on six rectangular 50x150mm deep timber purlins, which are in turn held in place by the walls and a front to back spanning steel beam in the middle of the building, splitting the span into two equal lengths. The steel beam is 280mm deep. There was no evidence of structural shortcomings observed in the roof.

Photograph 10 Stables – Steel beam supporting timber roof joists

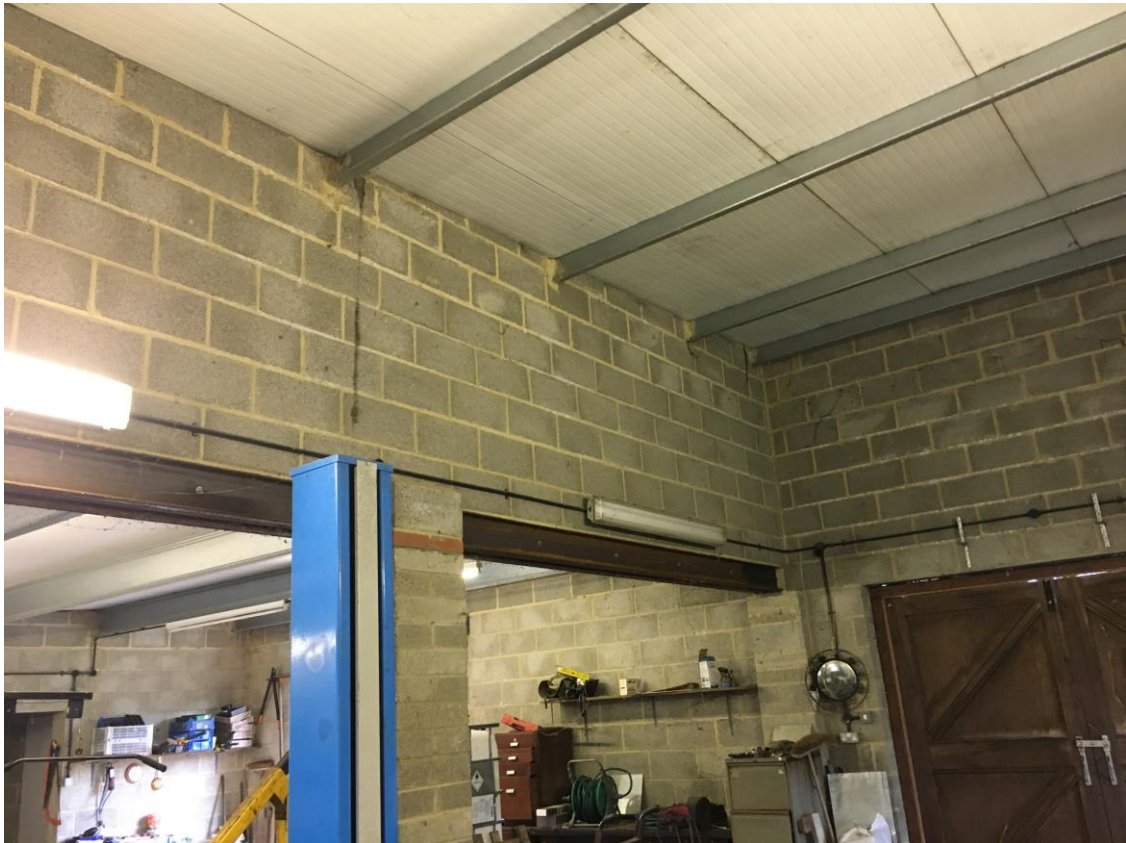
Photograph 13

Workshop – Z purlins and steel beams supported on block pier
