# The Morton Partnership

### STRUCTURAL ASSESSMENT REPORT OF CHURCH LANE COTTAGE, CHURCH LANE ALDHAM, IPSWICH SUFFOLK, IP7 6NP

**Date:** January 2023

**Reference:** SA/BBR/21268~srep

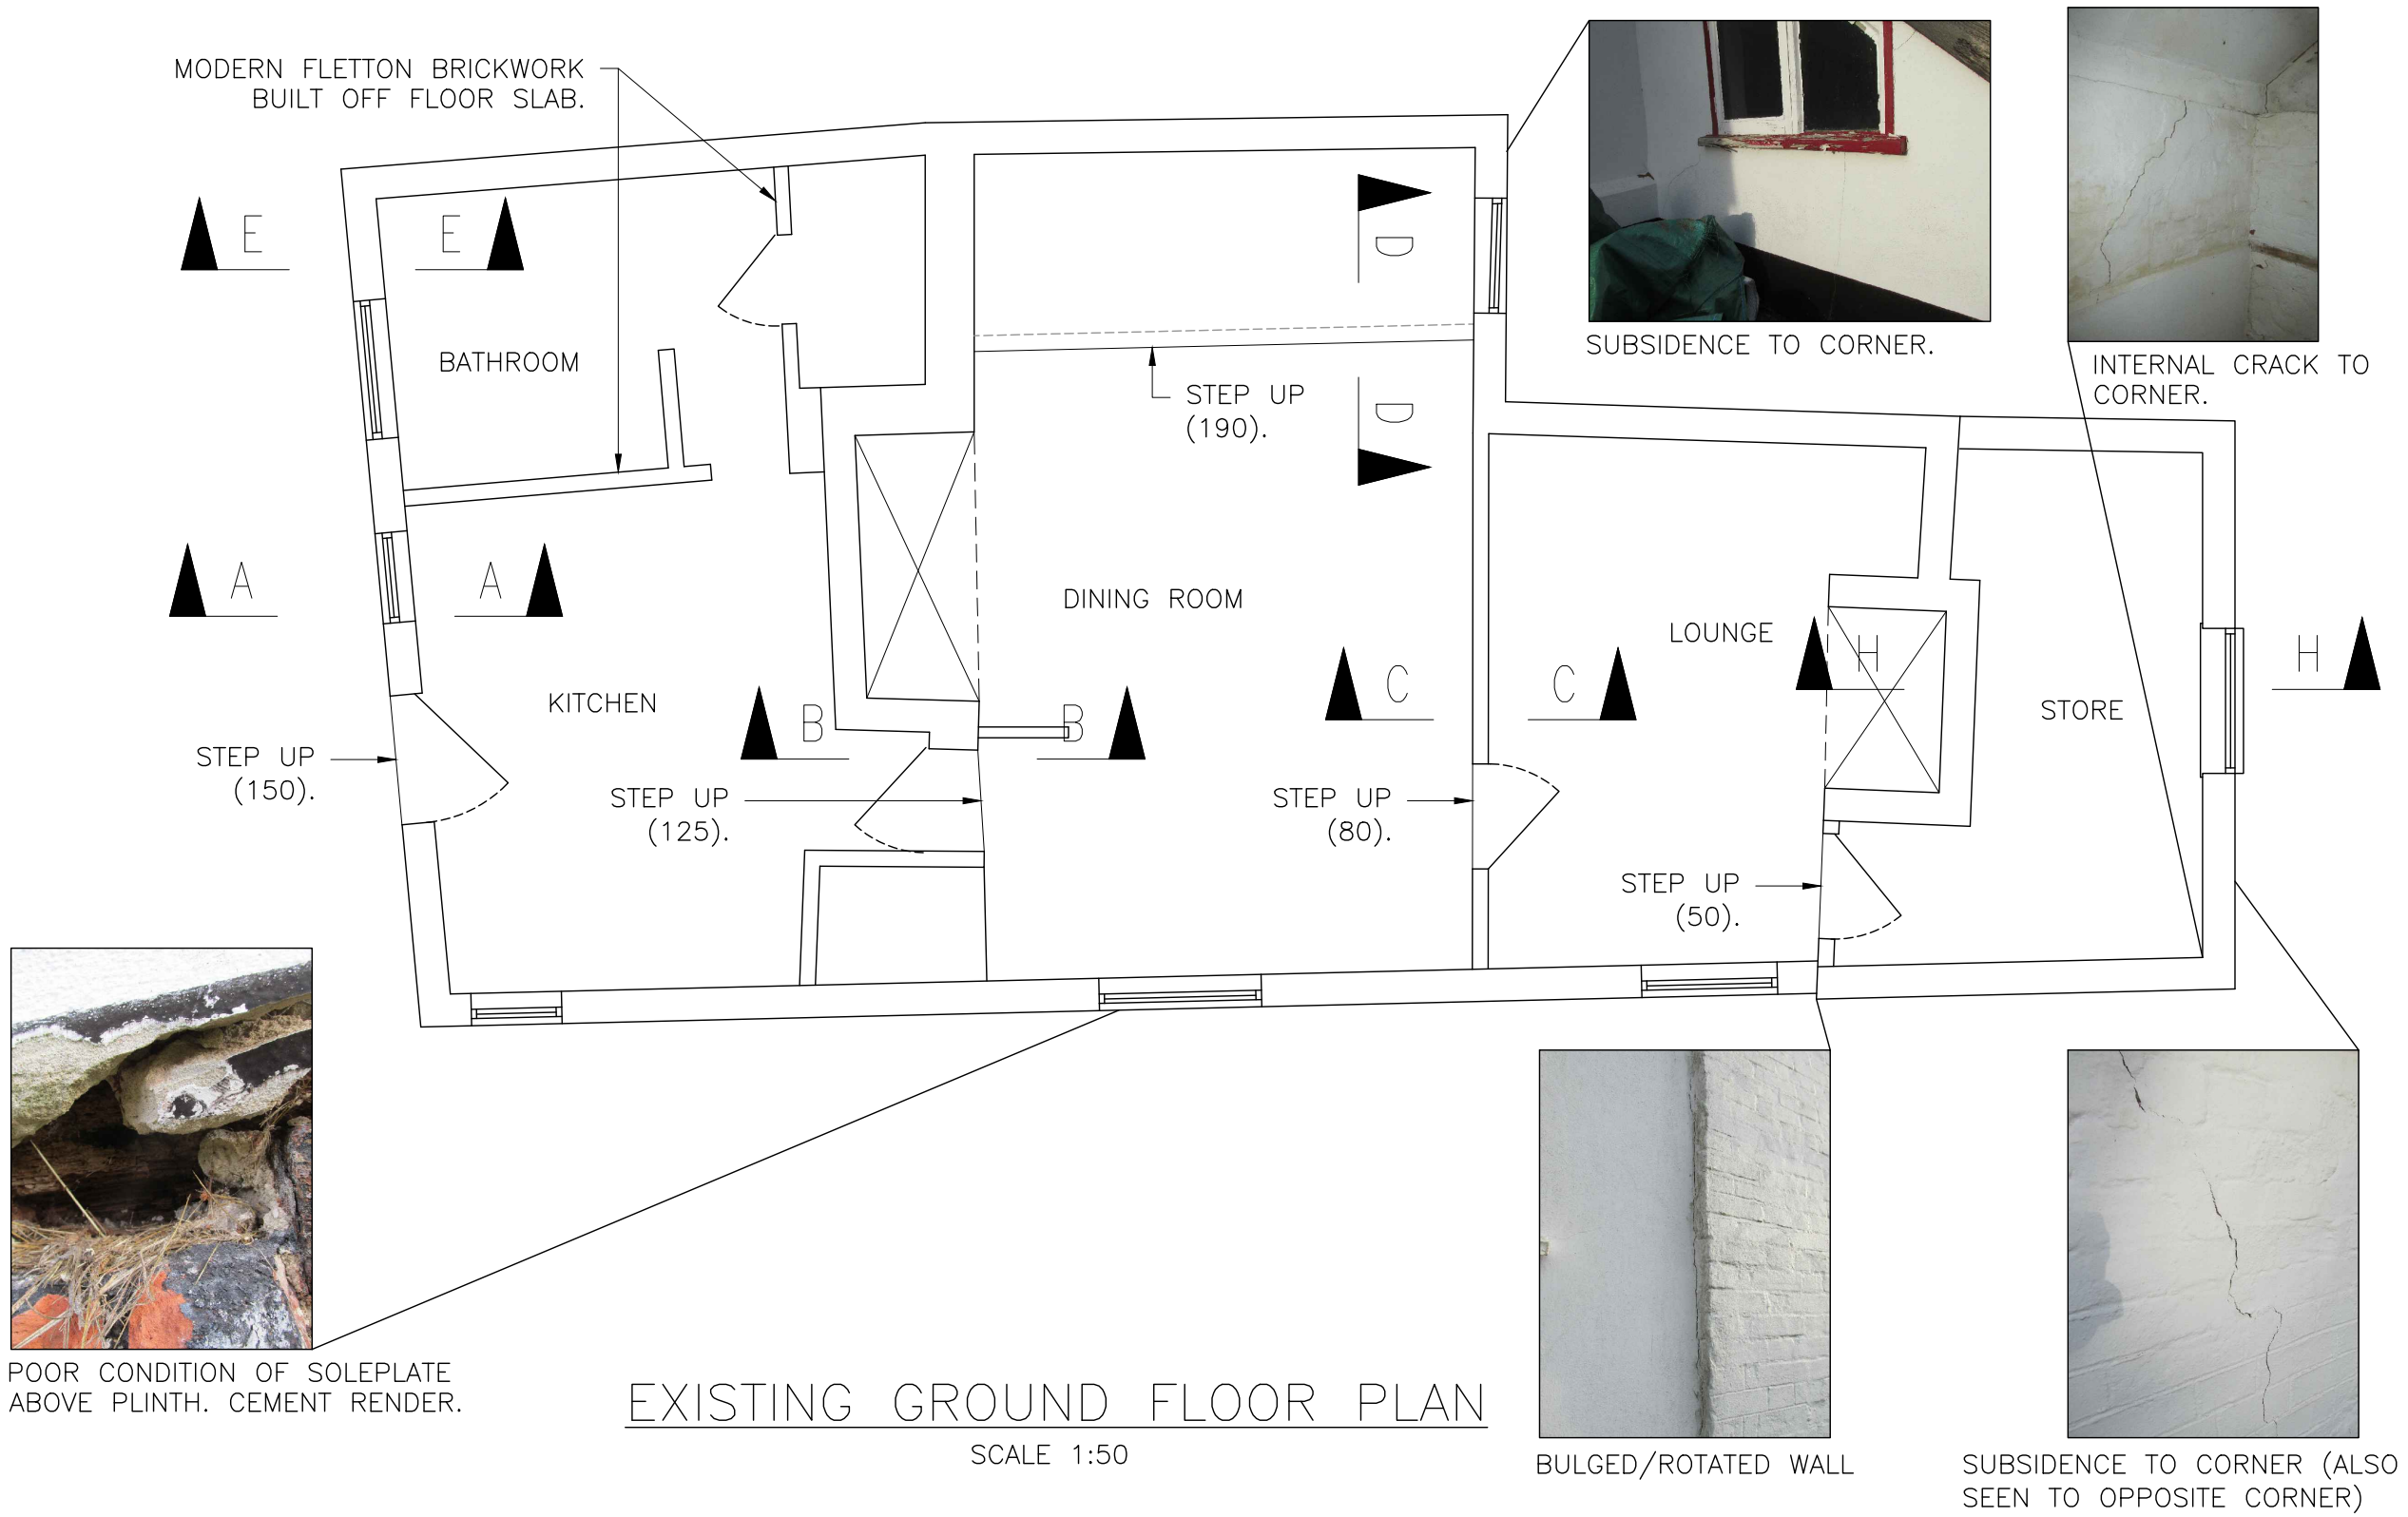
SCALE: 1:50 (A3) DRAWN BY: CJS  
DATE: FEBRUARY 2022 CHECKED BY: SJA  
DRG No. 21268/01 (REV C)

EXISTING GROUND FLOOR PLAN

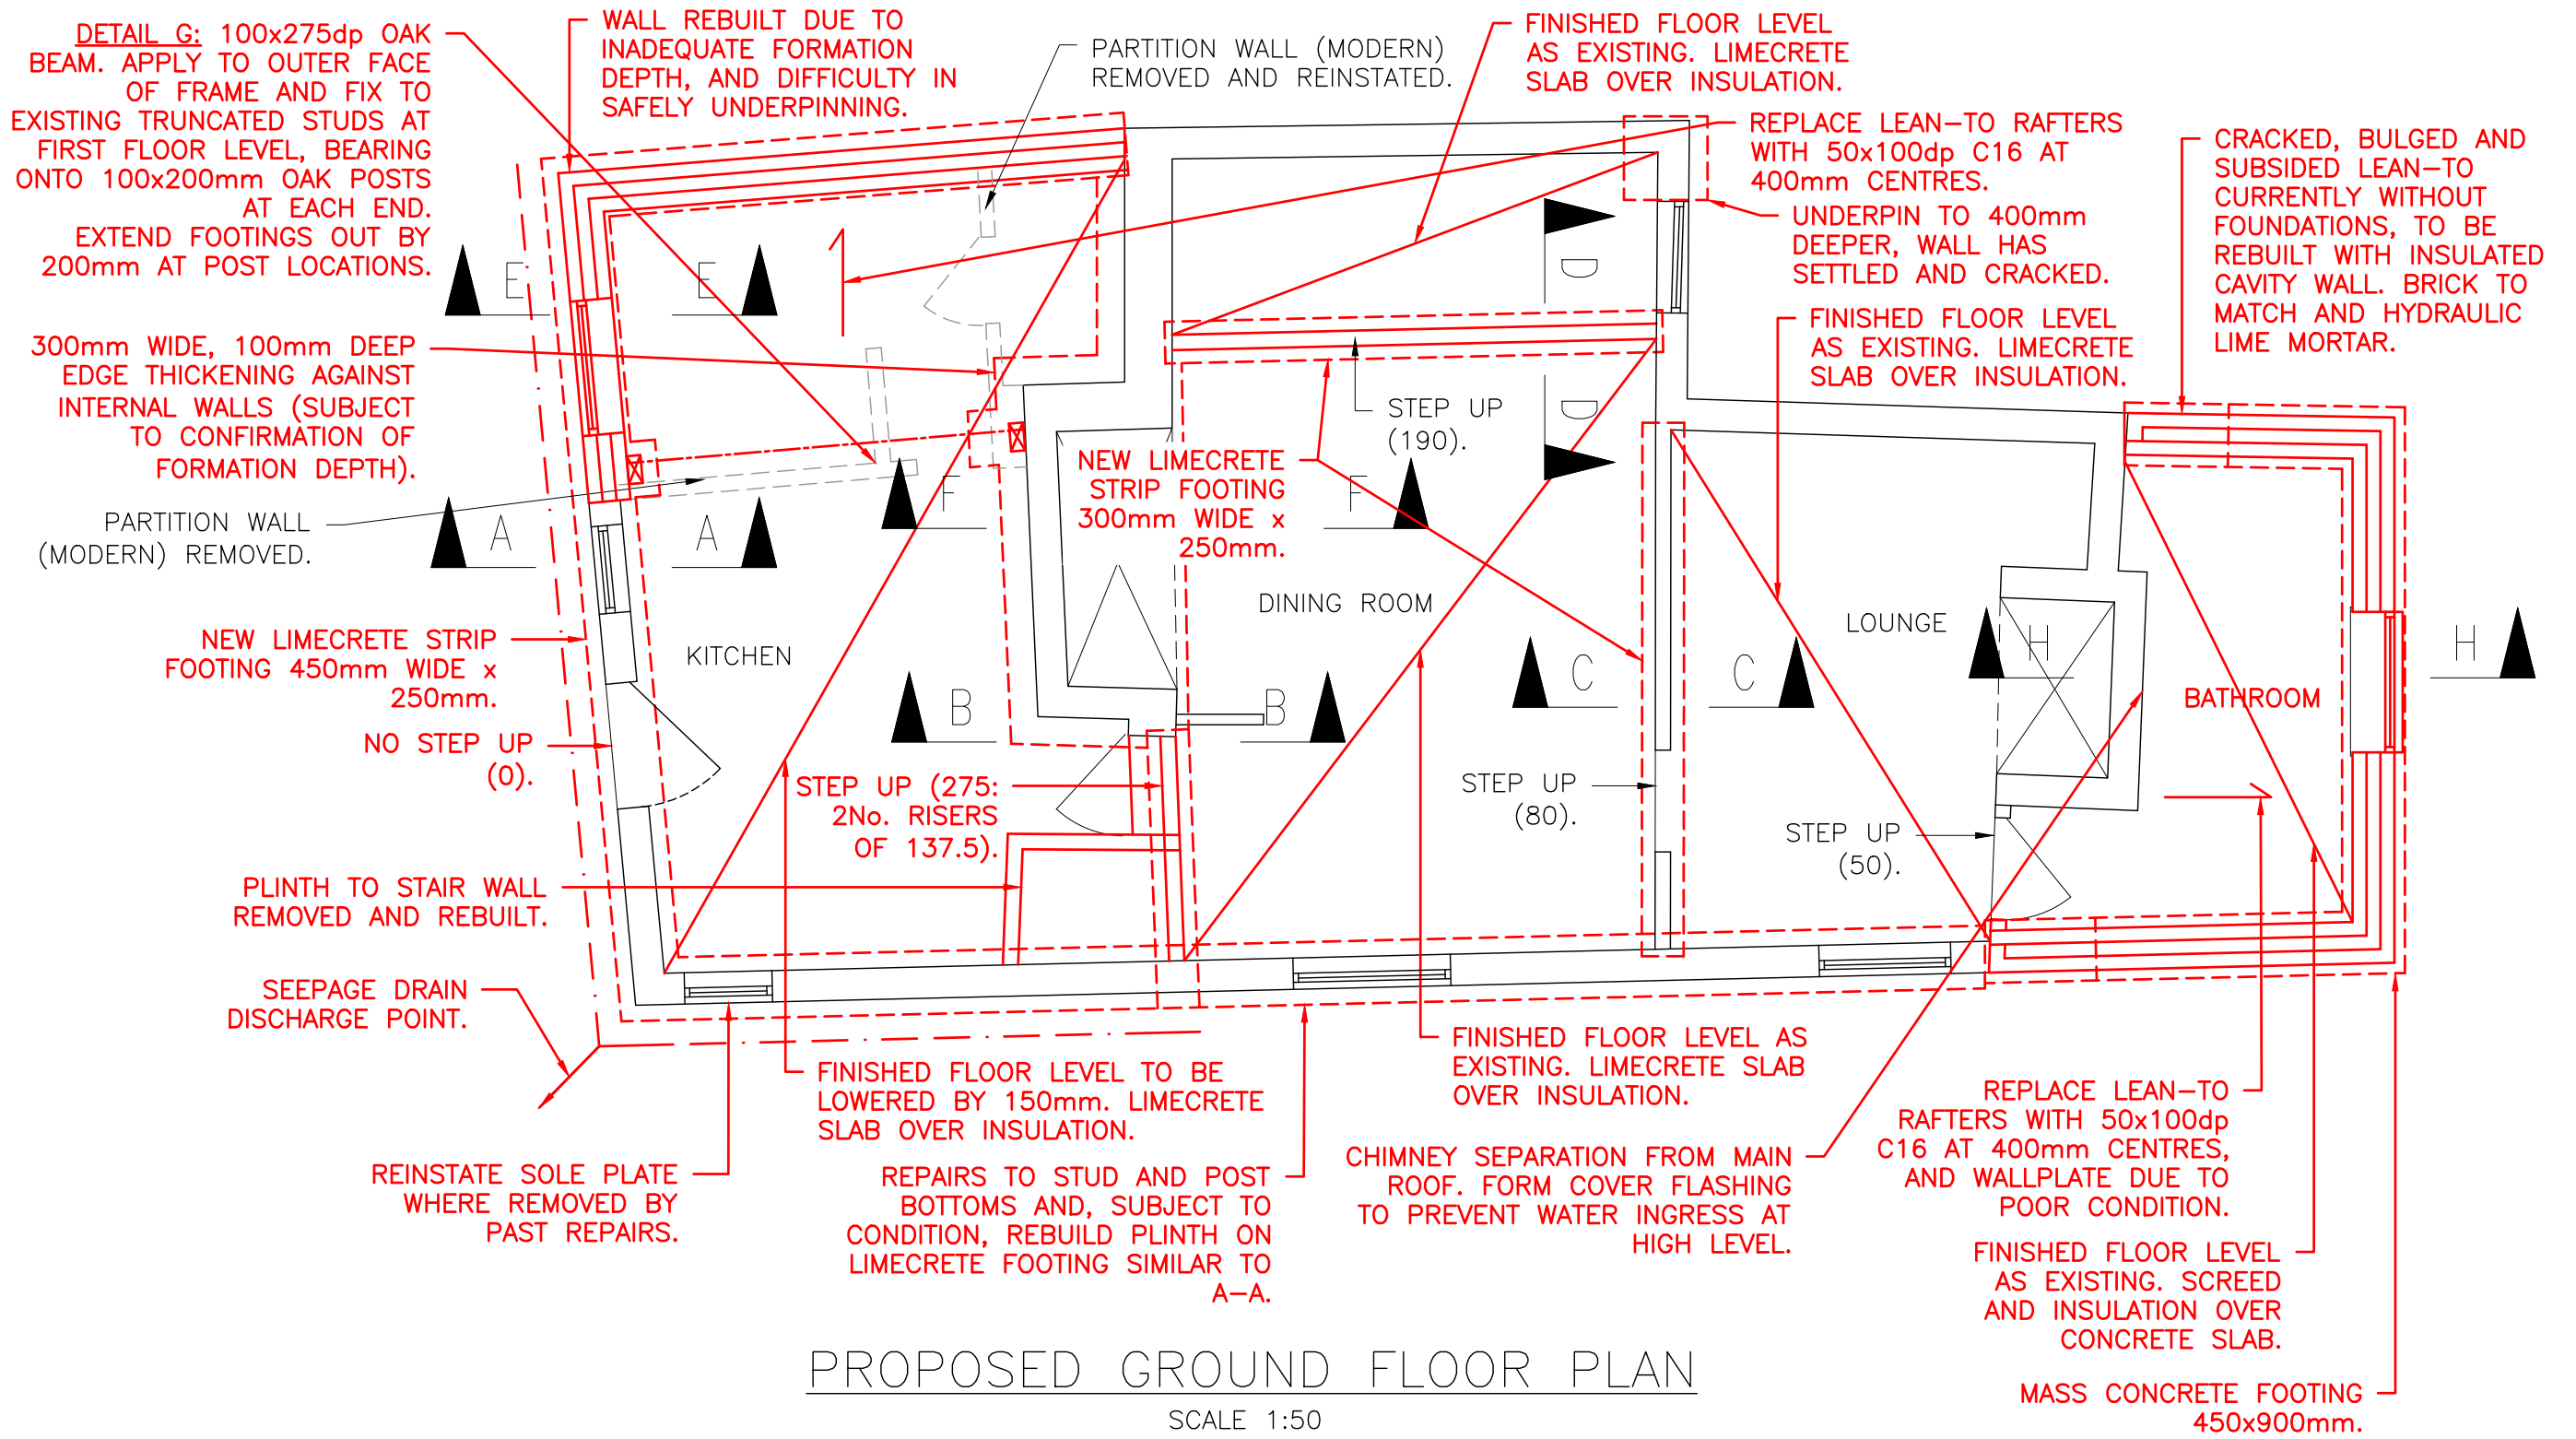
SCALE: 1:50 (A3) DRAWN BY: CJS  
DATE: FEBRUARY 2022 CHECKED BY: SJA  
DRG No. 21268/02 (REV C)

**PROPOSED GROUND FLOOR PLAN**  
SCALE 1:50

- 3.8 At the far end of the property and to part of the rear lean-to to the existing bathroom where there has been movement, and the walls are of relatively short height (being single storey or less), it is proposed to rebuild these brick walls on new footings. The extent of rebuilding is shown on the proposed drawings. The condition of these existing low level walls is relatively poor, with aspects of rotation and settlement, as well as to the end lean-to, a foundation very close to ground surface level. There are a series of cracks to the walls of the end lean to, as well as a bellying out of the front wall. Whilst complex and costly works could perhaps be undertaken to underpin these walls and repair the cracks and restrict the rotation seen, given their more modern and modest nature and height, as well as the practical difficulty of safely carrying out the work, as stated, it is advised that reconstruction offers a more pragmatic approach.

- 3.10 It is proposed that these walls will be rebuilt to modern Building Control requirements (as will be required) as insulated wall on concrete footings. The lean-to roofs will be replaced as part
