Heritage Statement

Home Farm House

Penton Mewsey

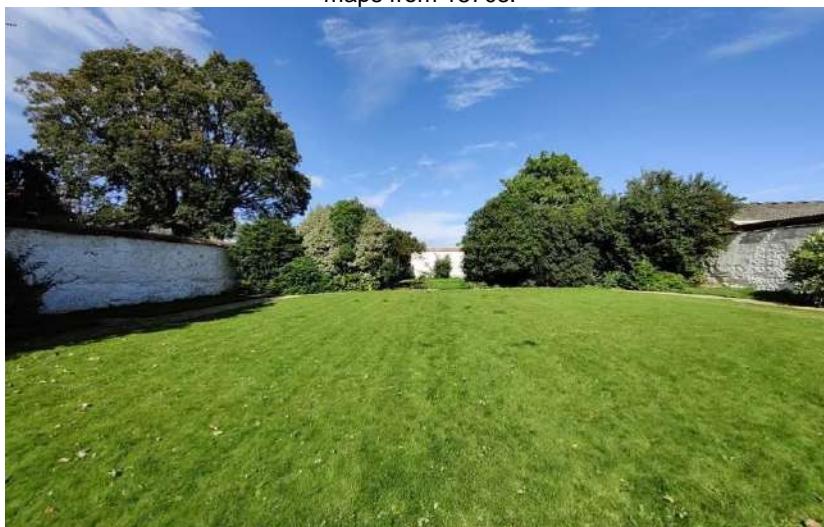
Figure 8 View towards back of garden showing historic boundary wall

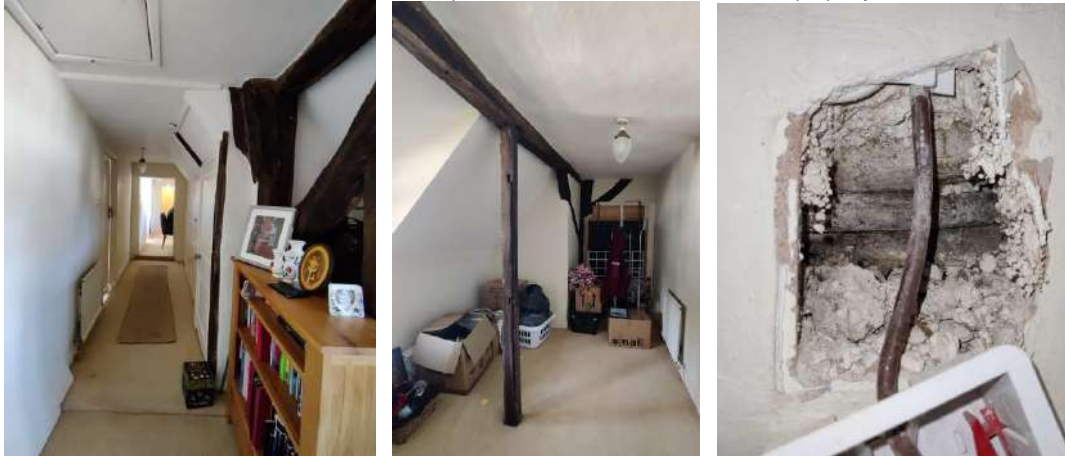
Figure 34 First Floor 18th century timber framing in historic core
 Figure 35 First Floor 18th century timber framing in historic core
 Figure 36 First floor wall opening up showing horizontal branches in situ in historic core

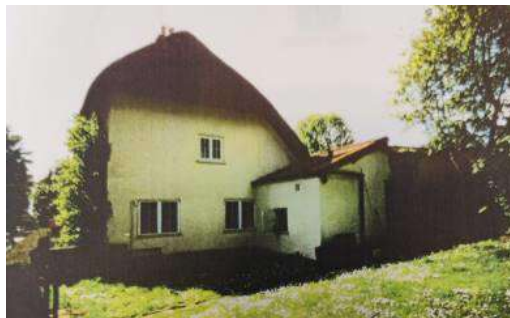
Figure 39 Image prior to 1997 extension showing east elevation of property.

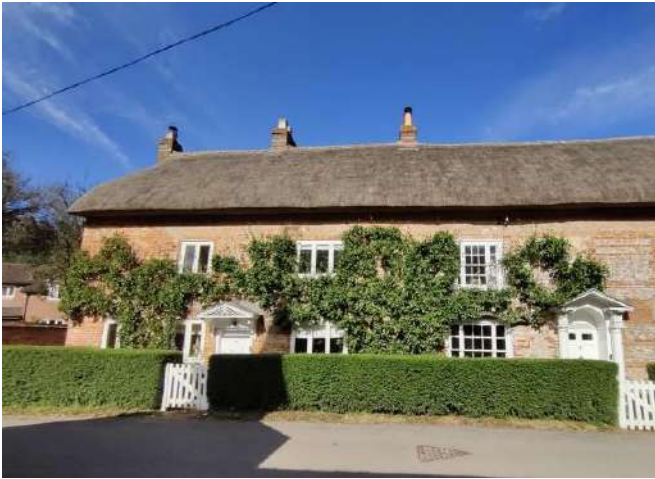
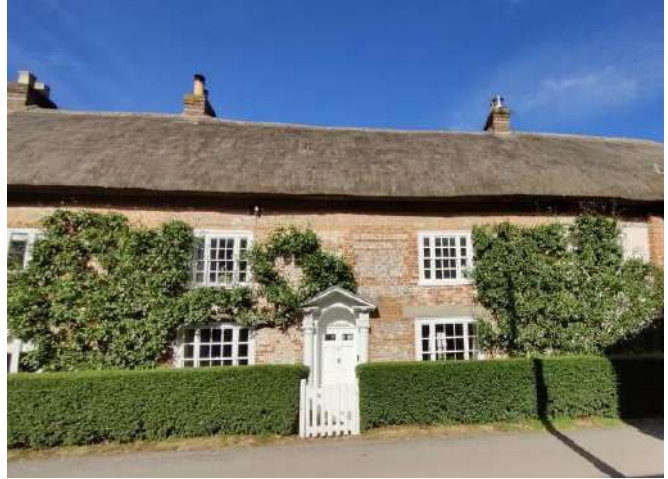
On the principle elevation, the external finish is predominantly alternating knapped flint bands with handmade brick bands in a mixture of Flemish and English bonds. There are lots of areas of modern repair/replacement and sections of alternative brickwork and decoration where the elevation has been altered including when the property was divided into properties. The left-hand side of the south elevation and the north elevation of the property have been refaced in late 19th-century brickwork matching the listed Stable Block (listing 1230053) adjacent which was constructed in 1865.

Figures 40 & 41 Front (south) elevation showing brick and knapped flint bands.

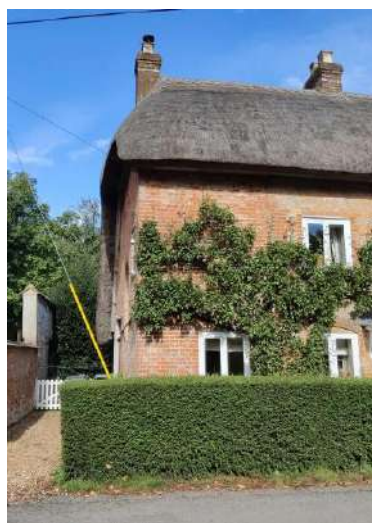
The furthest 'bay' of the south elevation appears to have been constructed in the early 19th century (before 1938) but was refaced in brickwork in approximately 1865 when the road was diverted and the extension to the south of the property was removed. There is evidence that this section of the property was previously whitewashed. The brickwork in this area is in sound condition with some areas of modern repairs. The window in this section of the building appears to be early 20th century and there is no brick arch or decorative features around the window indicating it is a later addition.

Figure 67 Mid 19th century (approx. 1865) brick refacing – far left of south elevation

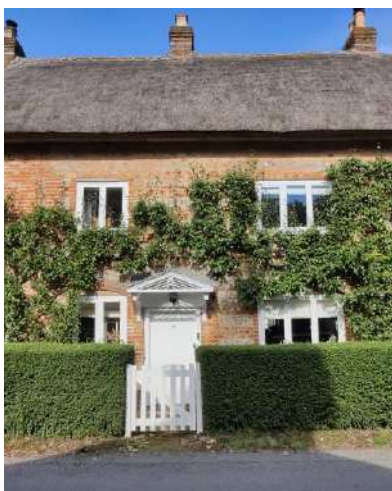
The brickwork and flint work are in fair condition with areas of deterioration due to inappropriate modern repairs. There are examples of large areas of later replacements/repairs with examples of standardised machine-cut brickwork and replacement flints amongst the historic brickwork. There are also large areas of cement mortar repairs that have led to the deterioration of the older areas of brickwork including blown faces.

Figure 68 early 19th century brick and flintwork bands with brick quoins.

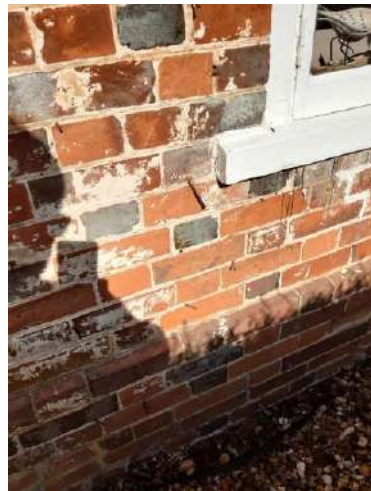
Figure 69 Evidence of whitewashes.

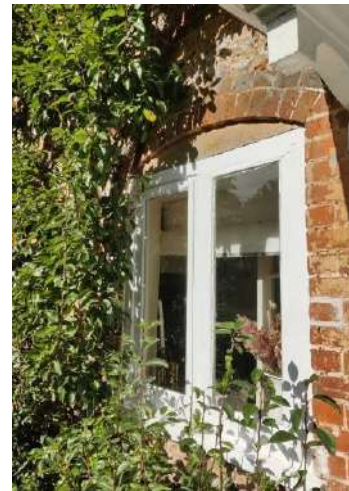
There is some evidence of whitewashing remaining in small areas. The windows in this section appear to be early 20th-century replacements but the brick arch details would indicate they have been fitted into pre-existing openings. The six-panel door which was mentioned in the listed in the 1960s has been replaced with a plain modern alternative.

Figure 70 Cambered arches above windows. 20th century replace timber casement windows.

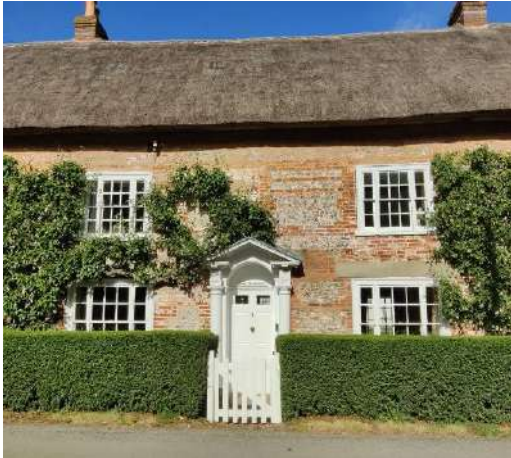
Figure 71 early 18th century flinwork walls with brick quoins with sash windows and six panel door with pediment surround.

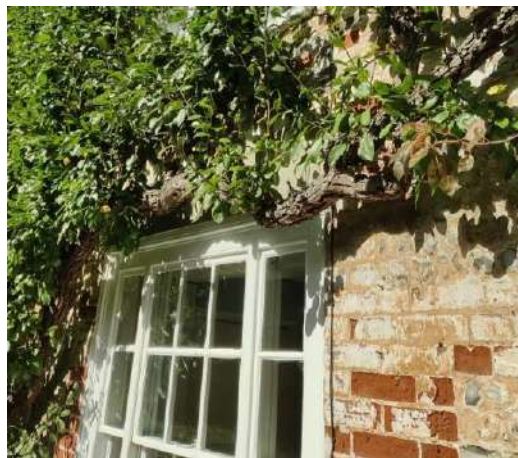
Figure 72 Evidence of whitewashes.

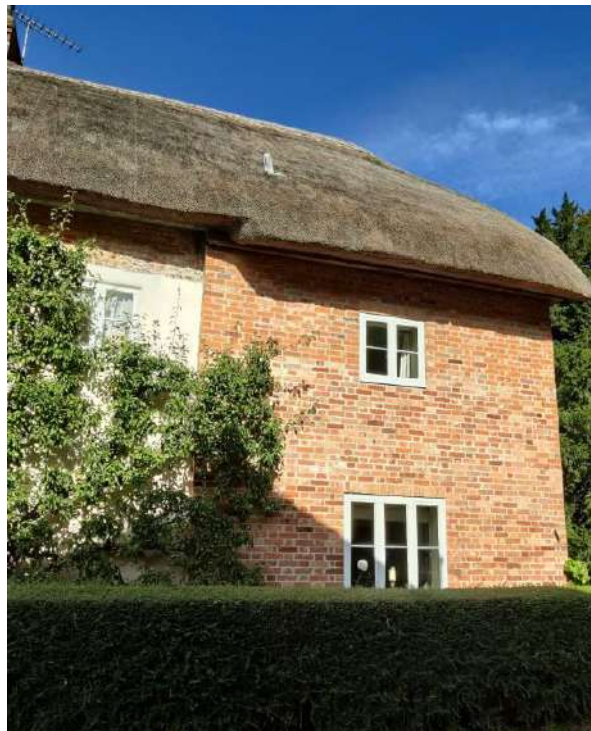
The next bay is rendered with concrete render but opening up works indicate the wall behind is brick and flint assumed early 19th century based on the roof construction. There is one window in this wall at the first-floor level which was added during the 1997 extension. It is not possible to gauge the condition of the wall behind the render finish but the render itself is in sound condition with some areas of cracking. A timber window has been installed on this wall during the 1997 extension.

The final (RHS) bay was constructed in 1997 and the brickwork and timber framed windows are in good condition. The windows in this section are timber framed casements in a style referred to as Hampshire Casement in the Penton's Conservation Area Assessment.

Figure 74 Early 19th century rendered bay and 1997 brick extension.

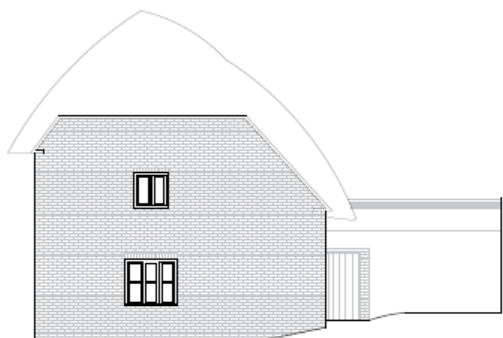
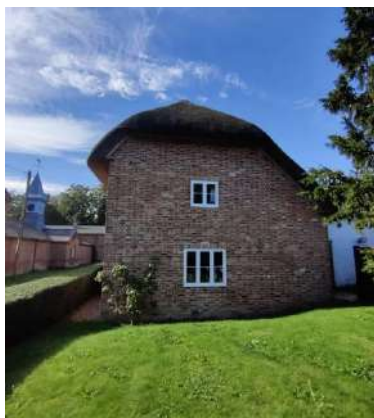
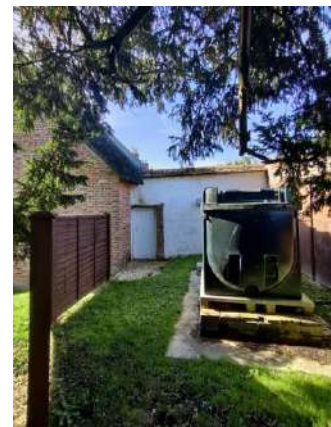
This elevation was constructed in 1997 and the brickwork and Hampshire Casement timber framed windows are in good condition. There is also a 20th century oil tank located within a fenced enclosure (1994 works) to the east of the property which currently detracts from the setting and partially obstructs views of the historic garden wall.

Figures 80 & 81 East Elevation
Figure 82 20th century oil tank and fence enclosure

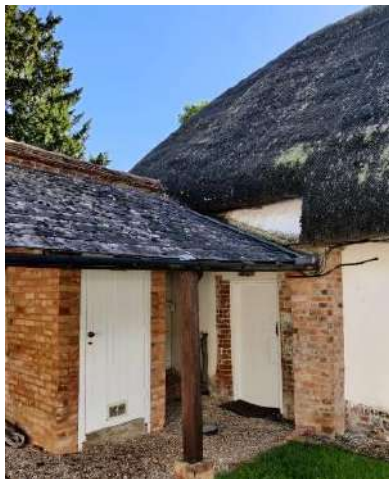
Figure 84 Furthest bay – 1997 extension incorporated 1890s single storey extension with thatch roof. 20th century slate roof lean-to with 1997 boiler cupboard.

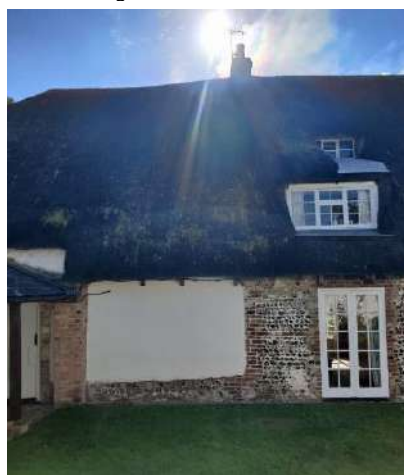
The next bay is the east early 19th-century extension with cement rendered finish. Material evidence and evidence from the scoping survey that this section of wall has been repaired/rebuilt in sections and re-rendered with cement render. Some areas of remaining 19th-century historic flint and brick. The fabric behind the render is in very poor condition and causing damp internally. This wall has undergone significant areas of replacement and rebuilding before being rendered.

Figure 85 Early 19th century extension with cement rendered finish.

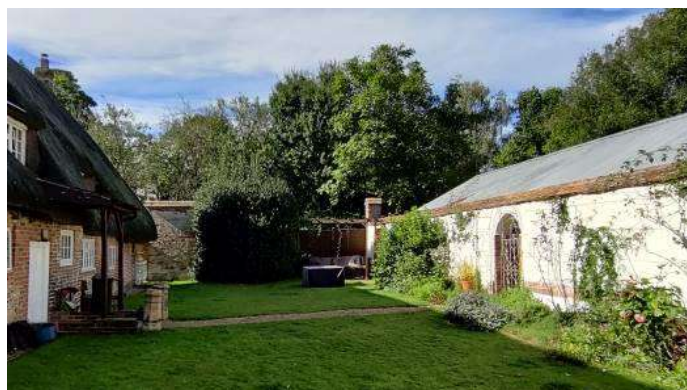
The garden directly to the north of the property is bounded on the north, east, and west by 19th garden walls constructed of brick, flint, and cob and rendered with tile cappings. The garden has been retained as grass with small areas of gravel. The size and layout of the garden remain as per historic maps. The historic walls are in fair condition and repair work is proposed as part of the proposals. Areas of historic wall incorporated within the new extension will be repaired and remain exposed as feature walls rather than obscuring the historic fabric.

Figure 91 View of rear garden including north historic wall
