Our Ref: 6870/2

### ***Structural assessment for conversion of a barn***

Further to your instruction to undertake an inspection of the former agricultural building at Elm Farm, I include the following notes below regarding its' structure, condition, and suitability for conversion.

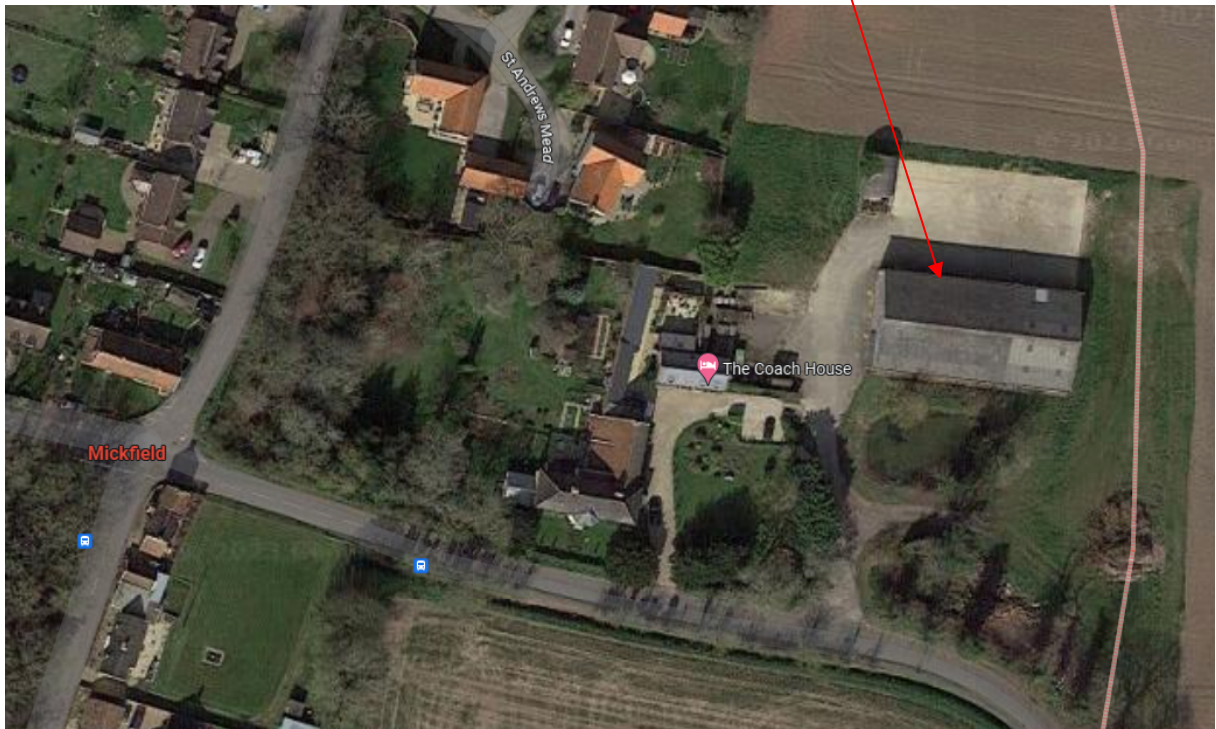
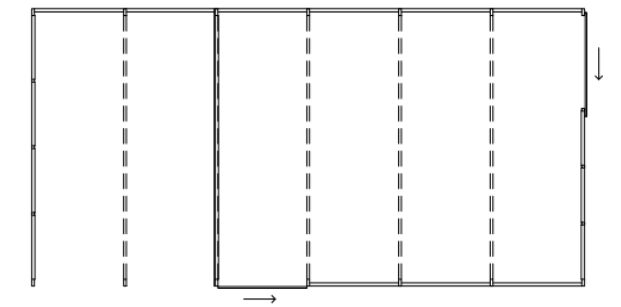
Client: Mr J Forster  
 Job No: Elm Farm, Mickfield  
 Drawing Title: Existing Plan and Elevations  
 Date: 14/05/2024  
 Scale: 1:100  
 Drawing No: 1/24/01  
 Author: J. Forster  
 Checker: J. Forster  
 Date: 14/05/2024

This is a large agricultural barn constructed from concrete portal frame and concrete purlin and providing the support to external cladding materials to both roof and walls with brickwork concrete blockwork to the walls at low level and a bare concrete floor slab. The barn is in a rectangular format with double pitched roof and a few open bays to the west end of the north side as well as some large sliding doors on the north and east sides.
