Site Westcroft Somerton Rd Hartest
 Date of survey 11/08/2022
 Surveyor J Choat

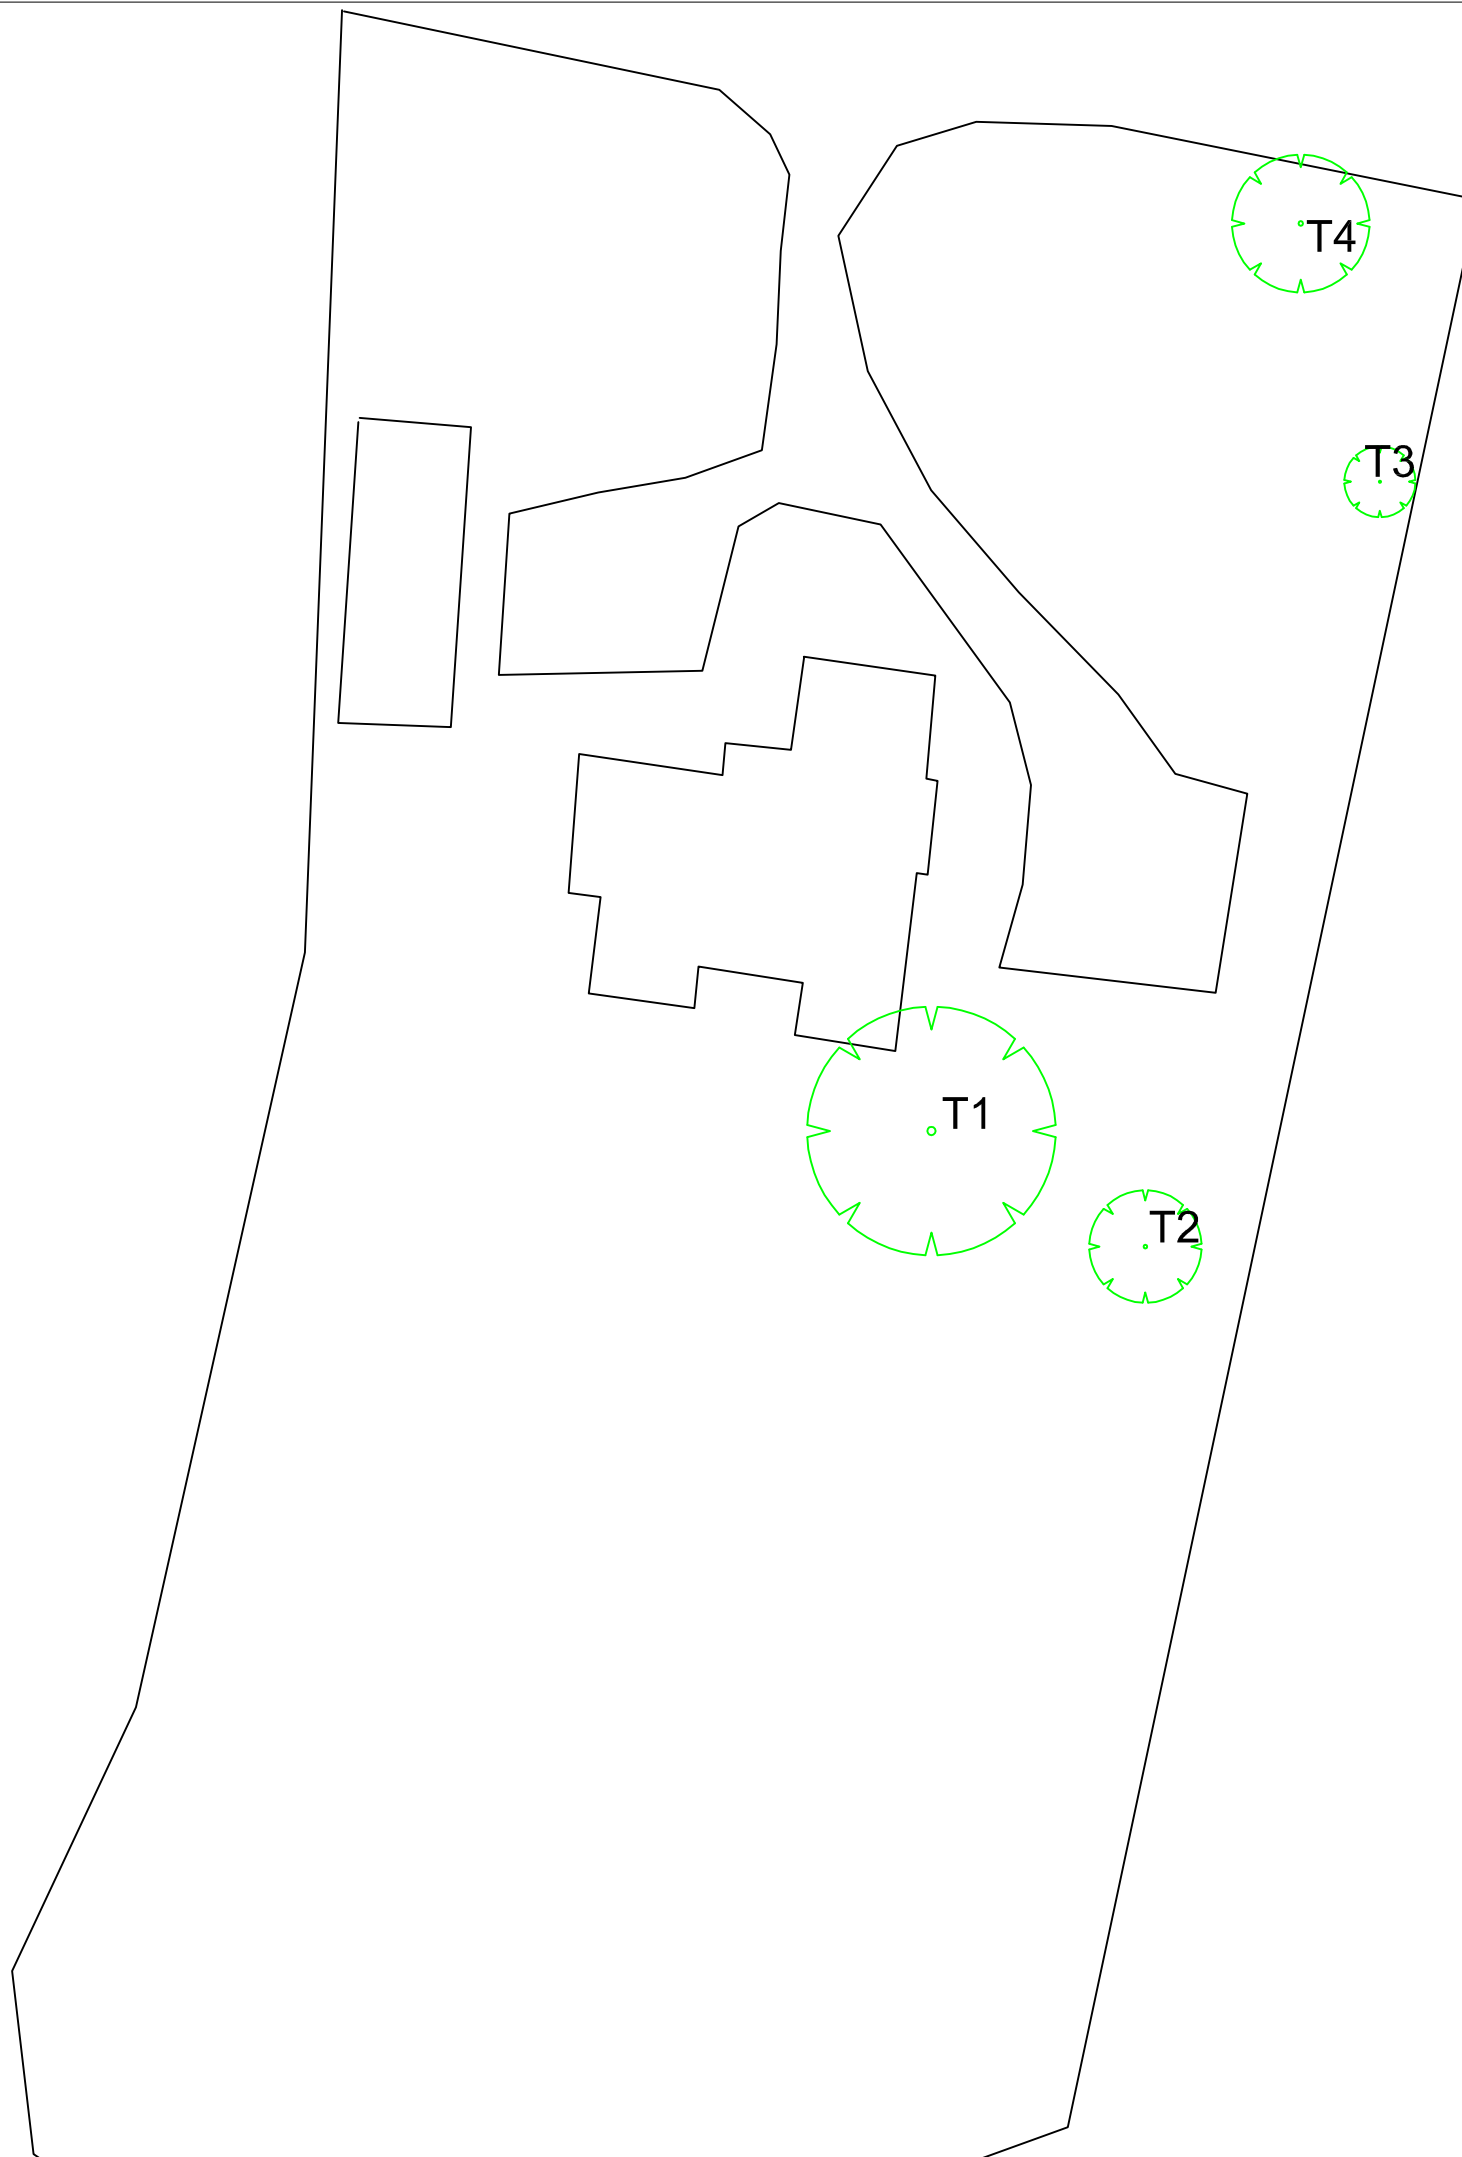
Photo 1 T1

Plan Number	Tree Number	Species	Age	Height in m	Condition	Recommendations	Informed by risk	
							Work Priority	Inspection
1	T1	Common Lime <i>Tilia x europaea</i>	M	19	Stem forks at 0.3m to form 2 co-dominant stems, compression fork formed with included basal union. Stem welding at 1m. Occasional deadwood within crown approx. 10cm dia mostly on the south / western aspect. Leaves appear to be good size, shape and colour for time of year. Tree causing shading in summer months limiting use of patio and conservatory during morning / midday.	Reduce crown height by 3m. Reduce lateral spread by 2m. Raise crown to 6-7m removing 6 lowest primary laterals around the circumference of the stem (approx. 10-25cm dia). Remove remaining sub-laterals to achieve crown clearance of 6-7m.	3	3
1	T2	Lawsons cypress (Blue) <i>Chamaecyparis lawsoniana</i>	M	12	Twin stem. Slightly sparse higher crown. Tree causing shading in summer months limiting use of patio and conservatory during morning / midday.	Fell and grind stump following below ground service check.	3	0
