# Preliminary Ecological Appraisal and Preliminary Roost Assessment

# Lowdham Cars, Lowdham Road, Gunthorpe, Nottinghamshire, NG14 7ES Lowdham Cars

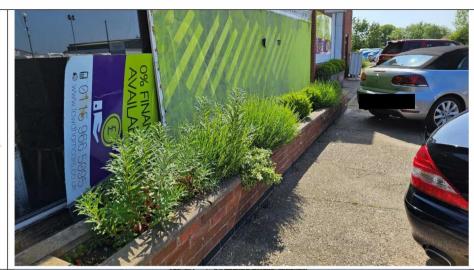
Introduced shrubs – u1b, 1160

There are three brick-built planters on site filled with introduced shrubs, two along the western elevation and one on the southern elevation. Species include evergreen spindle (O), English lavender (R), common box (O) and willowherb sp. (O).

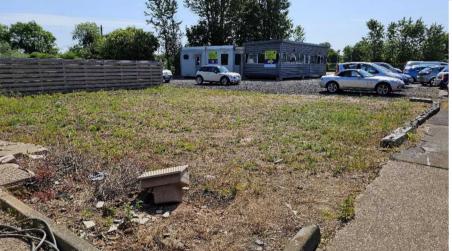
Vacant/derelict land with ruderal vegetation, – u1b, 351, 17 A residential dwelling was previously on this land which had to be demolished due to an arson attack. The land is now vacant with a number of ruderal forb and grass species emerging. These species include soft brome (F), bristly oxtongue (O), herb Robert (F), common poppy (O), doves foot cranesbill (F), bramble (O), common nipplewort (O), common dandelion (O) and prickly lettuce (R).

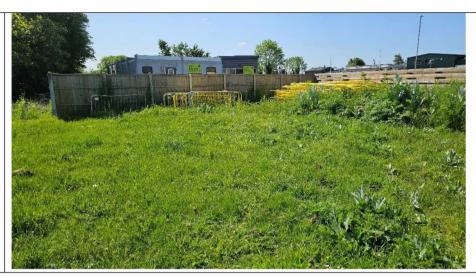
Other neutral grassland – g3c

A small area of neutral grassland is located to the east of where the residential dwelling previously existed, separated by a wooden panel fence. Grass species include great brome (A) and meadow grass sp. (A). Forb species include scotch thistle (F), creeping thistle (O), hemlock sp. (O), pink-sorrel (O), garlic mustard (O), red campion (O), purple dead nettle (O), common nettle (O), bramble (O), white clover (F), doves foot cranesbill (F), ribwort plantain (F), common daisy (F) and common dandelion (F).

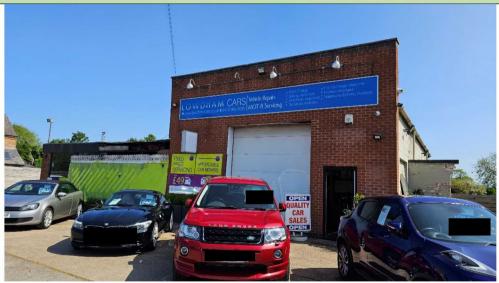
There is one gap above the large metal door on the western elevation where a wooden panel has come loose, possible through water damage. This gap could provide a roosting feature for crevice dwelling bats, however it is unlikely as this gap would be regularly disturbed by the metal door being accessed on a regular basis. There are lights above this doorway which would also deter bats from using this gap.

Close up of gap above doorway on the western elevation of B1 (pictured above)

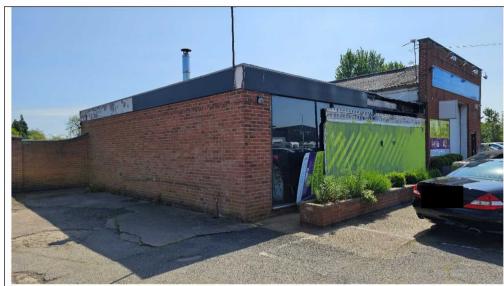
Northern and eastern elevations of B1 (pictured above).

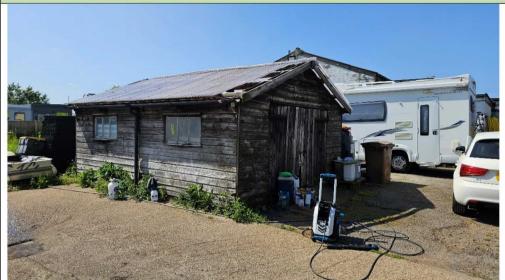
#### **B3 Exterior Photographs**

B3 is a single-storey detached wooden shed, with a pitched and gabled roof, all clad in clear corrugated uPVC sheeting. The roof appears to be in poor condition as there are several large holes in the roof near to the northern section of the building, in which bats or birds could access the internal space.

The door and window frames are constructed of wood and appear to be in fair condition as, for the most part, there are no gaps or cracks in which bats could roost. There is, however, a small gap above the door on the northern elevation in which bats could access the interior of B3.
