# Site Investigation Report

Auger Ref:  
146117.1USI

Client	Questgates
Client ref	QG1T 2 1472
Visit date	10/03/2023
Report date	06/06/2023

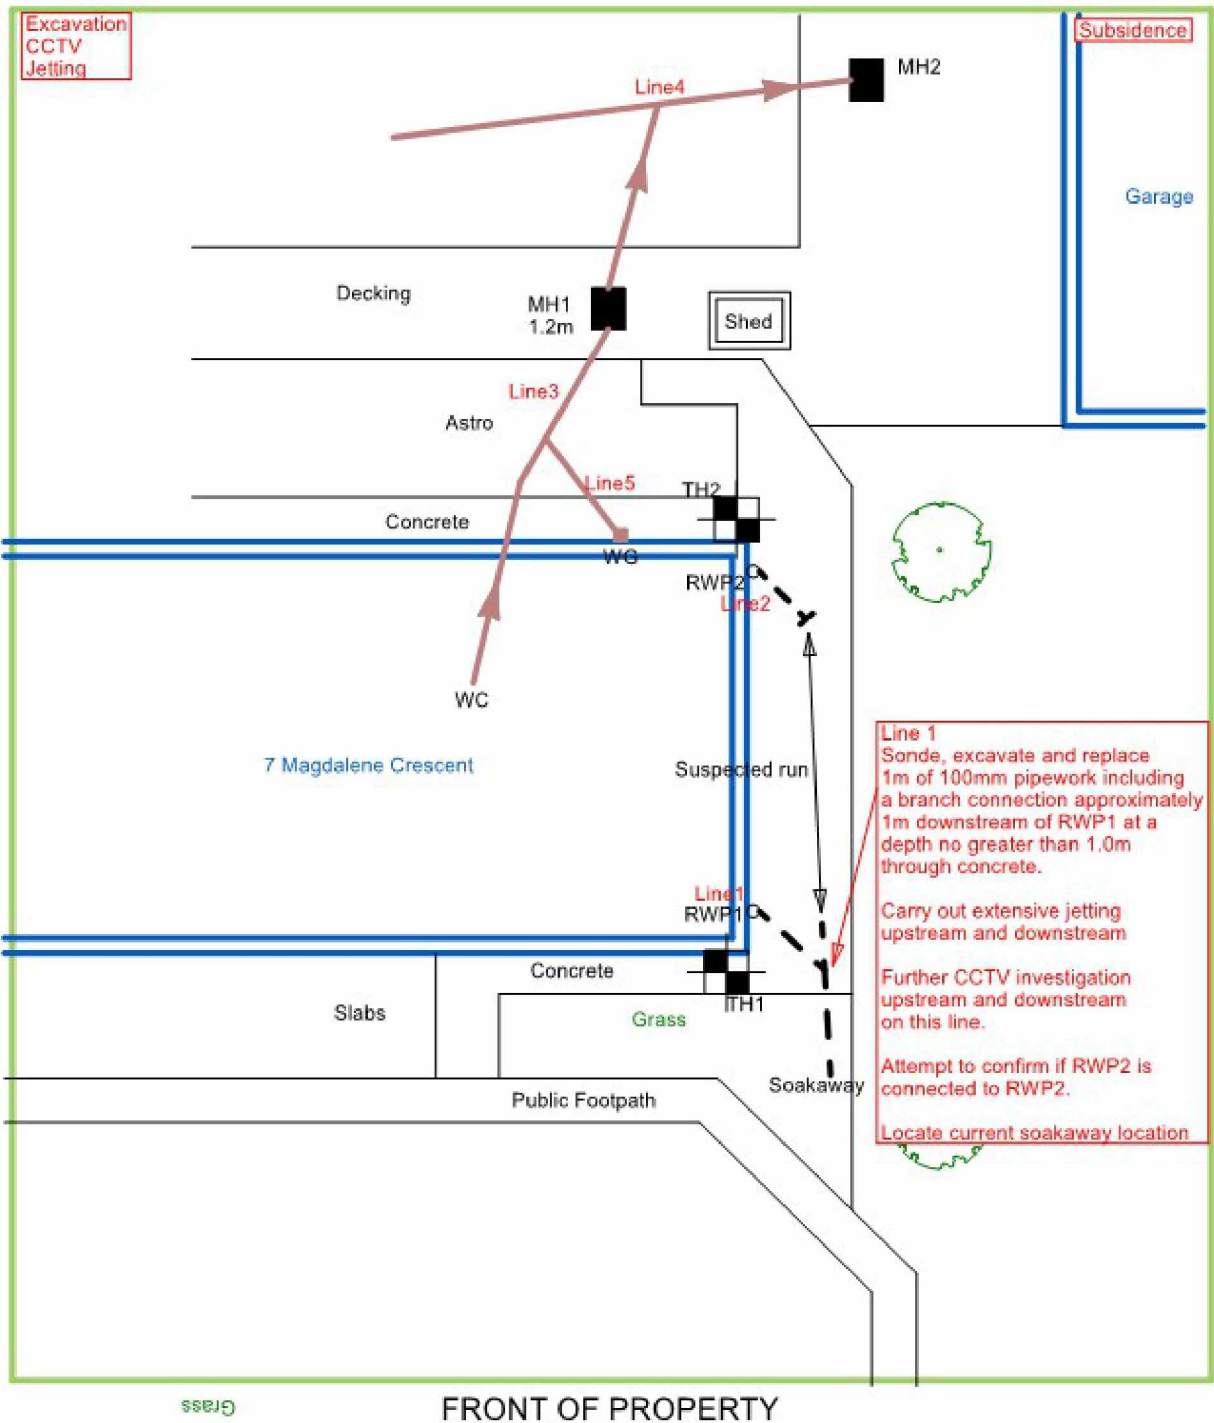
Our survey of line 2 revealed mass amounts of silt/debris that we were unable to clear of survey past. This line is suspected to lead to a soakaway however we are unable to confirm this.

Our survey of line 2: We were unable to pass a 90 degree bend approximately 1.5m downstream of RWP2 we were therefore unable to get a full visual of the pipework. This line is also filled with silt and debris.

Our survey of line 3 - 5 revealed no significant defects to the pipework on this line which could be allowing an escape of water.

<b>Refer Back to Client</b>	<p>It is recommended that the following repairs are carried out to prevent an escape of water from the system:</p> <p><b>Line 1</b> Sonde, excavate and replace 1m of 100mm pipework including a branch connection approximately 1m downstream of RWP1 at a depth no greater than 1.0m through concrete.</p> <p>carry out jetting to clear the line up and downstream of the excavation.</p> <p>We will then need to conduct a further CCTV investigation upstream and downstream on this line.</p> <p>Please note that the further CCTV investigation may reveal additional defects to the drainage system. This will be reported whilst on-site and could potentially cause an increase in repair costs and provide further inconvenience to the customer/occupants.</p> <p>During the clean-up/reinstatement process we will endeavour to leave the area we are working in clean and tidy and as close to how we found it as possible. There will always be an element of general debris/mud/waste that will build up in the area which cannot be prevented. There may however be elements of this process that are outside our remit i.e., Repainting or cleaning. If this is the case, then we will need to speak to the customer's insurers to help in this regard.</p> <p>We will now refer the claim back to the client in order to progress the claim.</p>

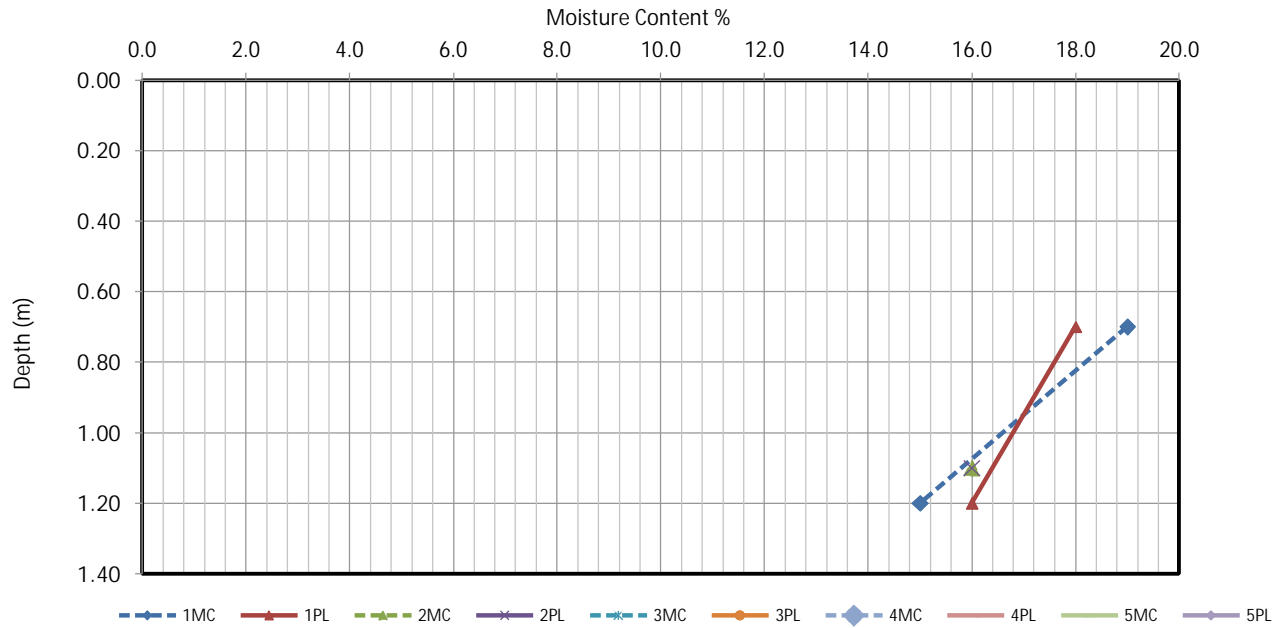
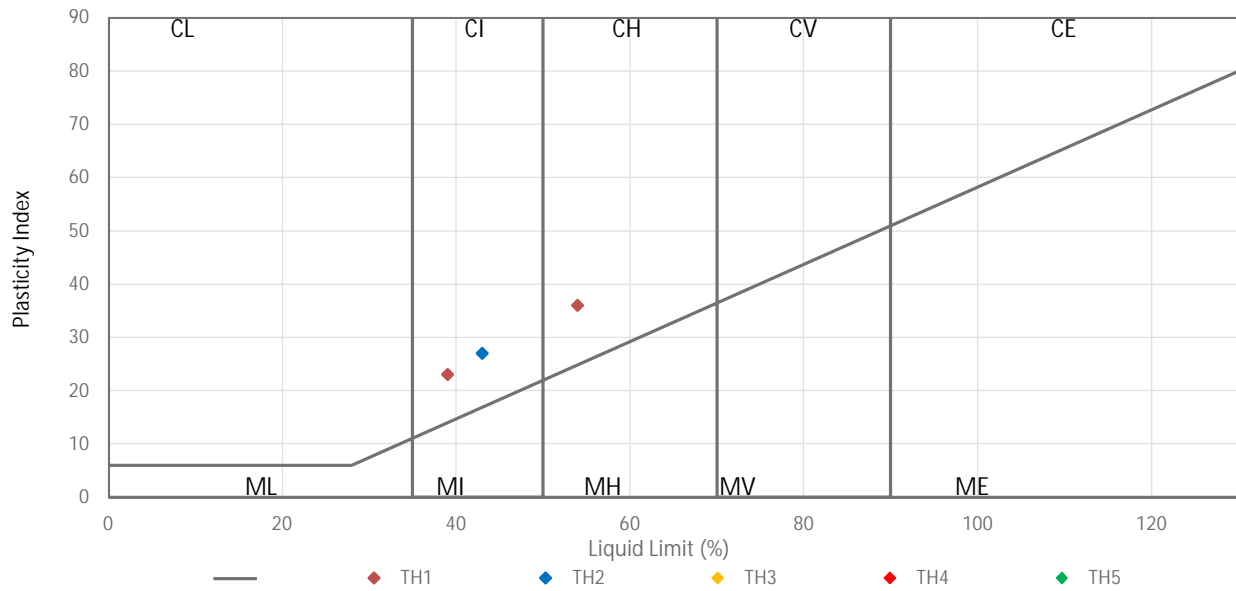
PLASTICITY CHART FOR CASAGRANDE CLASSIFICATION  
BS 5930:1999+A2:2010

TH Trial Hole	Sample Type	Depth (m)	Moisture Content %	Liquid Limit %	Plastic Limit %	Plasticity index %	Passing .425mm %	NHBC Chapter 4.2	Remarks
TH1	D	0.70	19	54	18	36	88	MEDIUM VCP	CH High Plasticity
TH1	D	1.20	15	39	16	23	86	MEDIUM VCP	CI Intermediate Plasticity
TH2	D	1.10	16	43	16	27	86	MEDIUM VCP	CI Intermediate Plasticity

Modified Plasticity Index (PI) <10 : Non Classified  
 Modified PI = 10 to <20 : Low volume change potential (LOW VCP)  
 Modified PI = 20 to <40 : Medium volume change potential (Med VCP)  
 Modified PI = 40 or greater : High volume change potential (HIGH VCP)
