Arboricultural Survey
Land off Main Street
Aunsby
Lincolnshire
NGR TF04871 38960

Survey by
Christopher Barker CEnv dipHort ACIEEM

Report prepared by: C Barker	Date Issued: 17 January 2023 Report Version: V1
Reviewed by: KLB	C B E Consulting Highbank, 5 Grantham Road, Navenby Lincoln. LN5 0JJ. Telephone (01522) 810086. www.cbeconsulting.co.uk
Report ref: P2697 /0123 /01

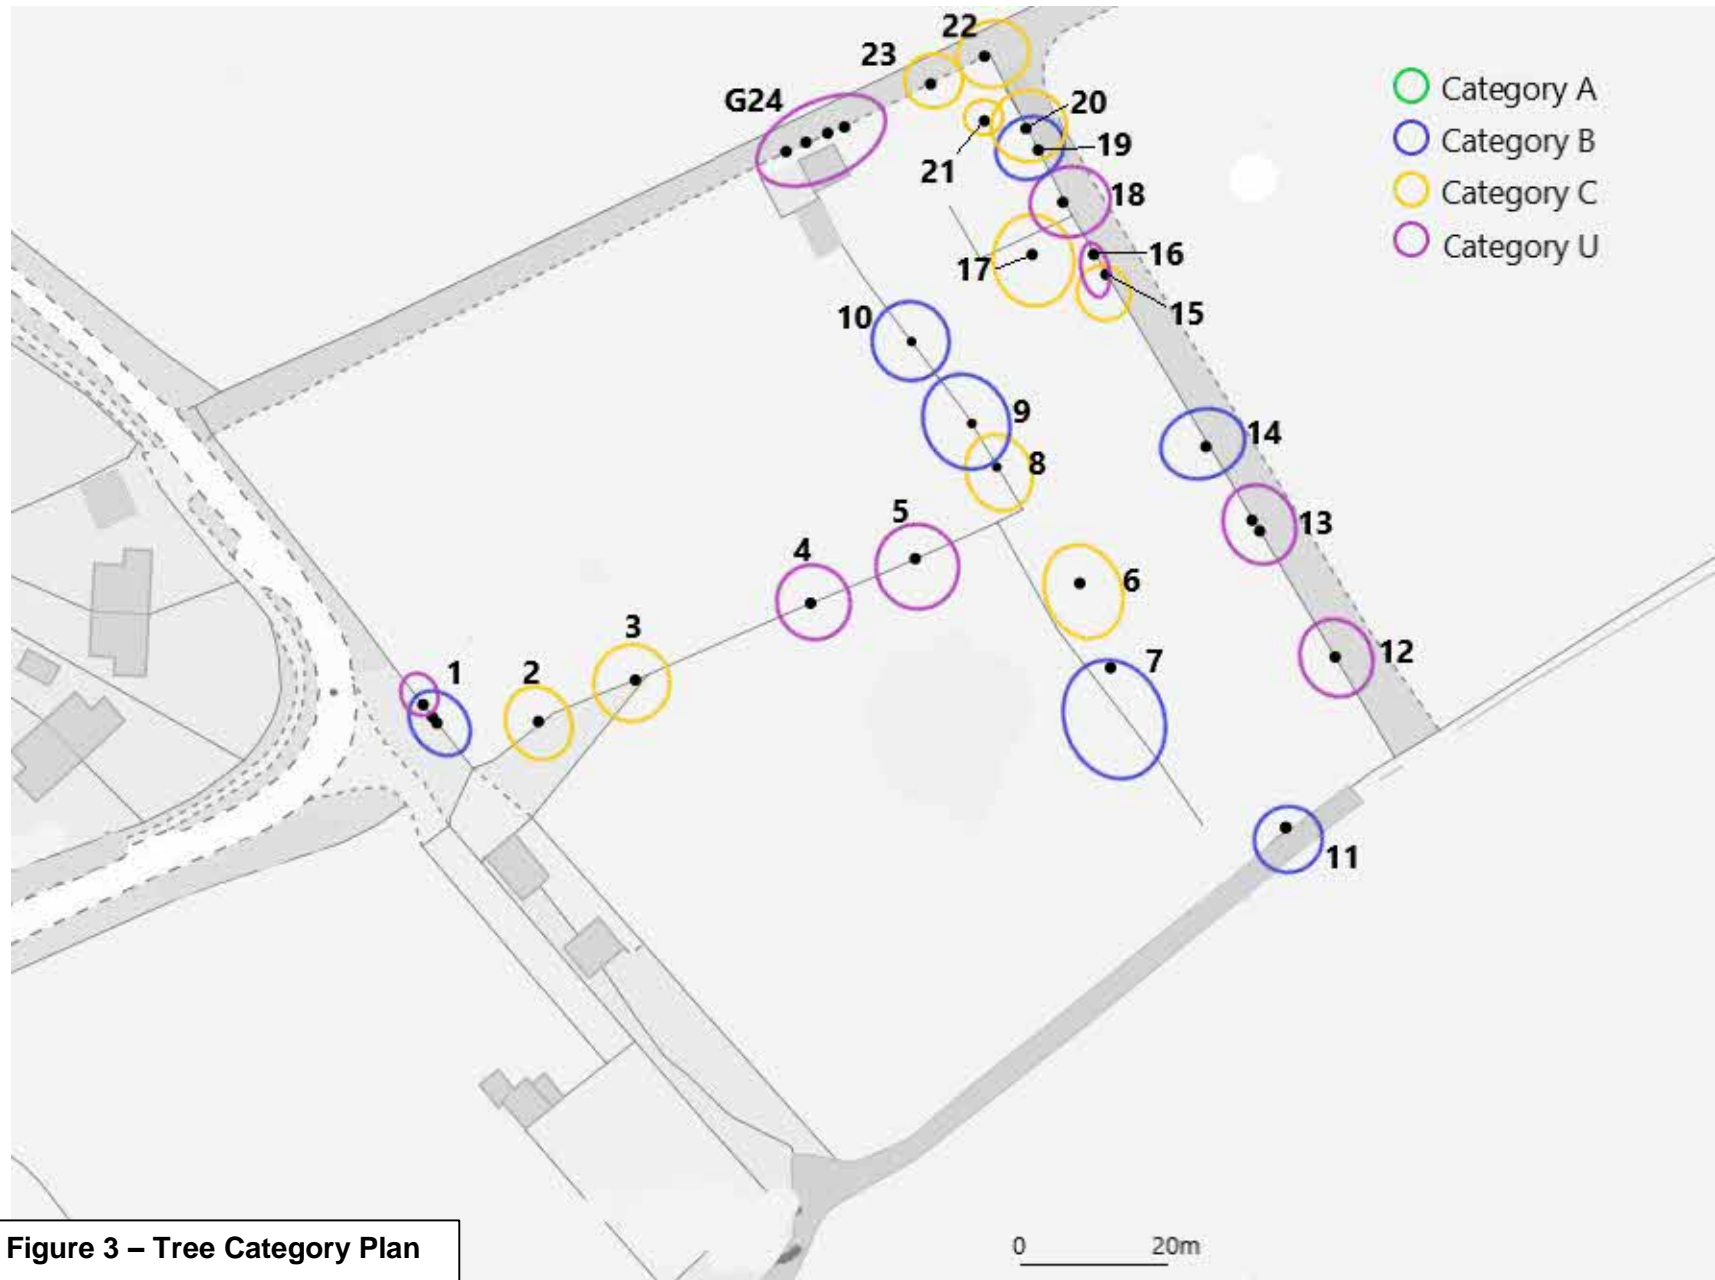
Figure 3 – Tree Category Plan

The position of significant individual trees or groups of trees measured out on the site is shown on the Tree Location Plan **Figure 3**. Within the summary table (**Appendix 1**) a calculated corresponding radius of the circle for each RPA has been calculated and if any works are proposed within the site area survey these RPAs should be protected from any harm.
