David Wattam BSc(Hons)For-HND-Arb RIDINGS FORESTRY UK LTD
BS5837 2012 TREE SURVEY

South Cave Sports Pavilion, Bull Field, South Cave, East Riding of Yorkshire.

Wednesday, March 1, 2023

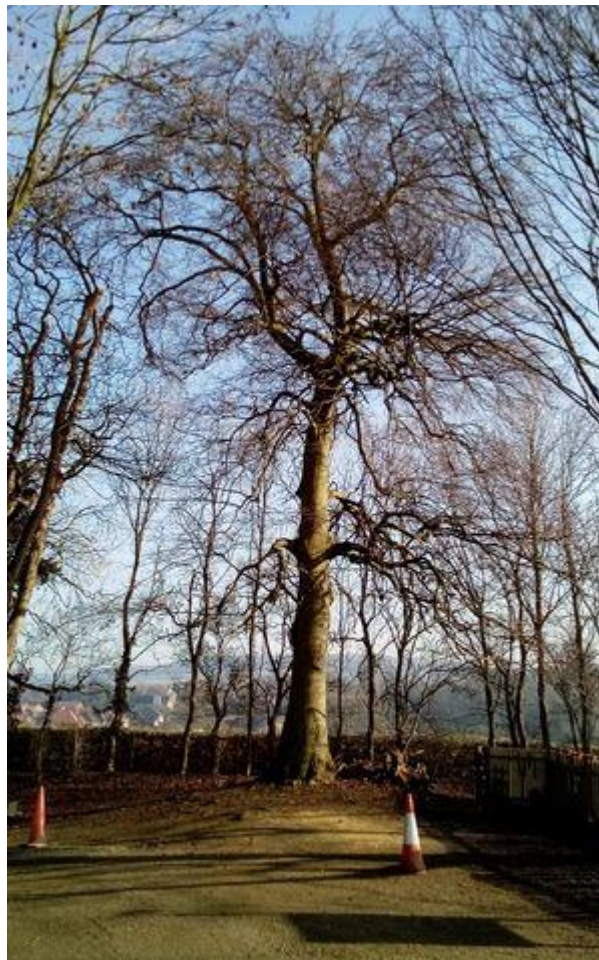
T030 Beech

The majority of trees within this area are of an even age and have been classed as mature. There are a number of specimen trees within this area. Some have been classed as Grade A trees, others have been classed as Grade B trees. The trees that have been classed as Grade B trees have been downgraded due to their impaired condition. Please see below for examples of Grade A trees.
