## **Structural Report**

**The Lodge  
Over Norton Park  
Chipping Norton**

May, 2023

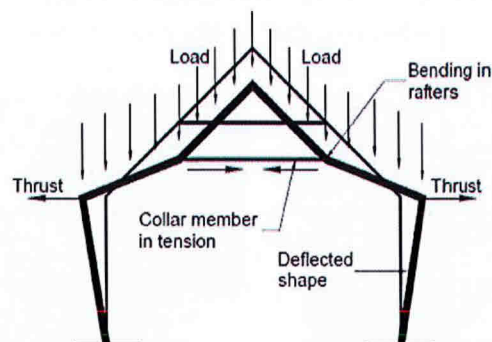
The truss has clearly failed and this will be due to the spreading of the principal rafters as there is a distinct lack of horizontal tie at floor level, therefore the rafter will bend about the collar due to the weight of the stone tiled roof. This has therefore caused a fracture at this position which has subsequently been propped.

An analysis shows that the principal rafter will fail under the current configuration but is satisfactory if a tie beam is inserted. Placing the new tie above the attic floor as currently found, means that the room is basically not useable. The proposal therefore is that a tie beam is inserted within the floor depth which will be jointed into the ends of the principal rafter and in this way, this will hold the feet in position, prevent further spread and ensure that the truss works satisfactorily.
