Healey Court Farm

Trial Pit Investigation and Structural
Feasibility Assessment

WBC Document Ref: 3230079-WBC-XX-XX-RP-S-20001
Revision: P01

Issue Date: 02 June 2023

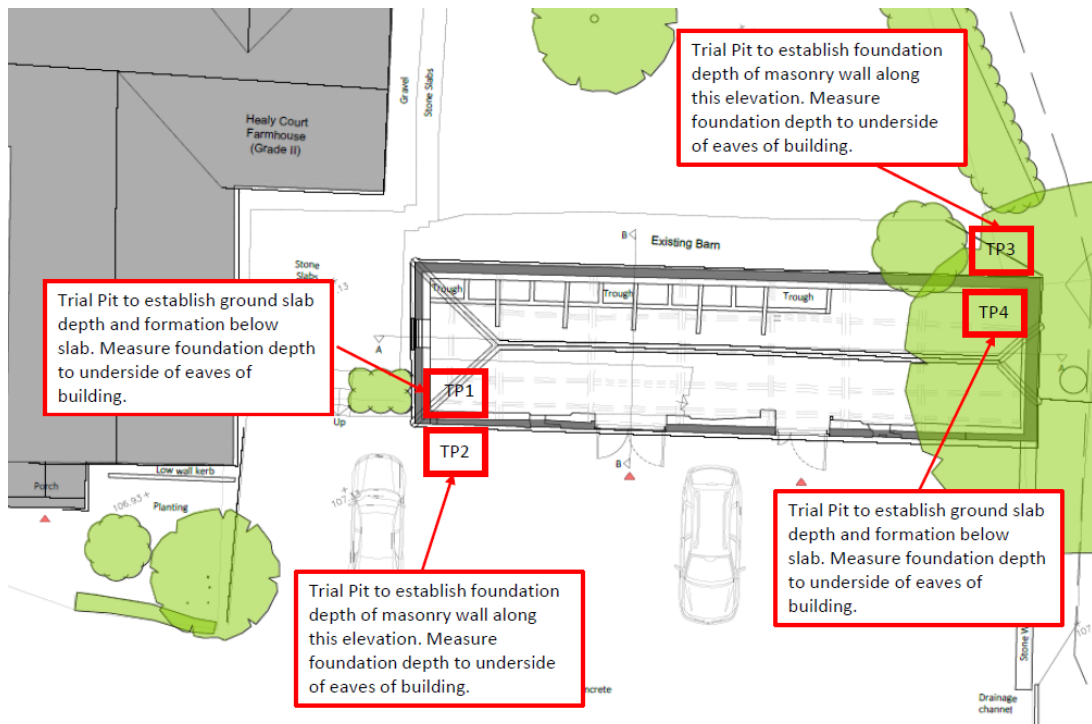
A shallow trial pit investigation was undertaken to establish the current foundation arrangement of the existing structure, the formation material and the thickness of the existing internal slab construction.

The location plan of the trial pit is noted on the following page

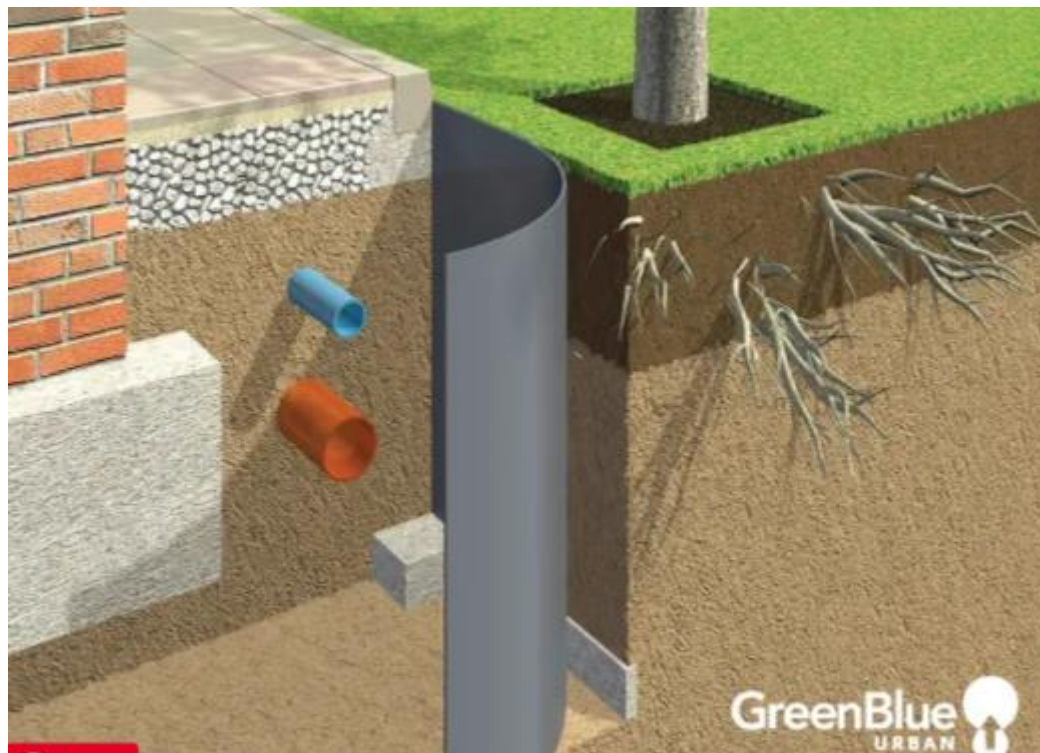
The presence of a large mature tree circa 500mm from the foundations should be addressed. The potential removal of the tree should be a last resort and other options should be explored fully before undertaking the removal of the tree.

On this basis, it would be essential to install a root protection system to the external face of the stone wall to reduce the impact of tree roots on the wall. The barrier ideally would be located below the footing level, circa 300mm below – reference to the manufacturers guidance would confirm this requirement.

Additionally, the new internal ground floor slab should be keyed into the existing footings via stainless steel dowels to prevent relative uplift from the roots.

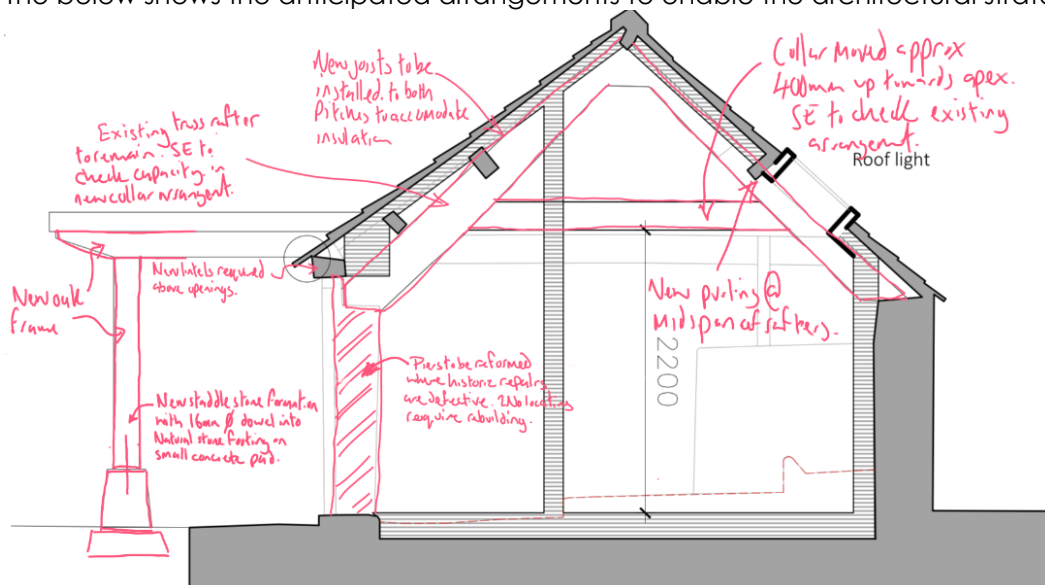
The existing timber rafter arrangement consists of damaged original members and replacement members of unsuitable sizing to accommodate modern habitable load arrangements. It is recommended that all rafters are removed and replaced with arrangements of suitable depth.

The below shows the anticipated arrangements to enable the architectural strategy.

The works will incorporate the removal of the existing roof tiles, setting aside for reuse where possible, the removal of the existing battens and felt and replacement with new suitable materials.

The existing purlin arrangement will be removed, with the originals assessed against the minimal size as determined by the structural assessment. If the condition and size of the member is suitable these will be reinstalled, if not, these will be re-purposed for other elements within the proposed works.

Surrounding masonry walls are to have suitable additional courses reformed to accommodate ventilation and modifications to surrounding lintels and wall plates.
