ARBORICULTURAL ASSESSMENT REPORT

The Limes, Queen Street, Waddesdon, Aylesbury, HP18 0JW

**PRI Ref:** 261898

**Survey Date:** 02/06/2023

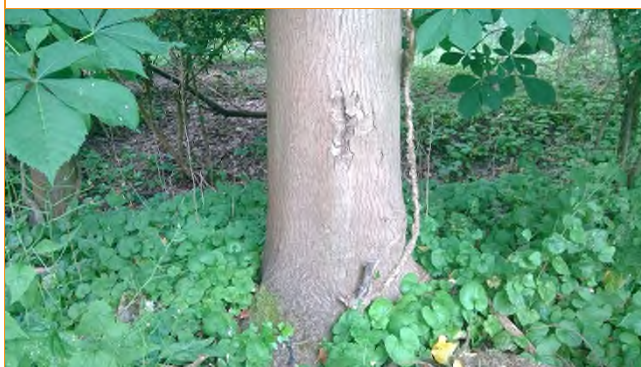
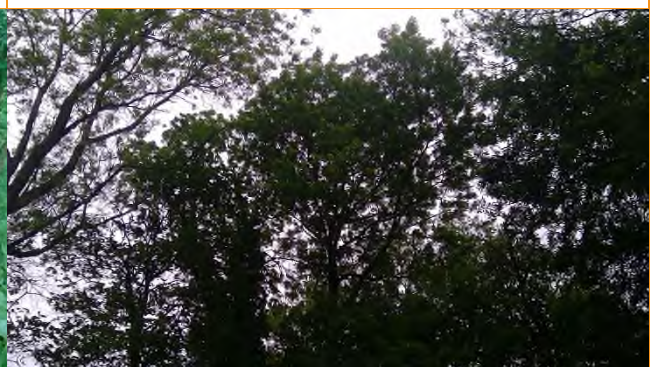
T3 - Ash (Common)

Tree No	Common Name	Age Class	Condition	Height (m)	Crown Spread (m)	Stem diam. (mm)	Dist to bldg. (m)	Roots Implicated	Pruning history	Recommendation	Tree work constraints	Notes	Owner address	Owner
T3	Ash (Common)	Mature	Fair	21.5	11.4	500	25.8	N	No significant past tree works.	No work required.			District Land Registry Search Required	UKN
T4	Ash (Common)	Mature	Fair	24.0	14.70	440*	24.66	N	No significant past tree works.	No work required.			District Land Registry Search Required	UKN
T5	Poplar	Mature	Fair	19.5	15.0*	480*	24.77	Y	No significant past tree works.	Fell and treat stump with eco plugs (broadleaved).	Restricted access.	Stem leaning to North.	District Land Registry Search Required	UKN
T6	Poplar	Mature	Fair	27.0	18.4	600*	21.17	Y	Subject to past management. No significant recent management.	Fell and treat stump with eco plugs (broadleaved).	Restricted access.		District Land Registry Search Required	UKN

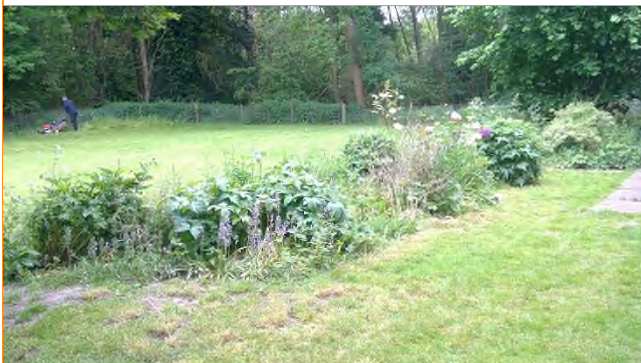
SG1 - Mixed species shrubs

Tree No	Common Name	Age Class	Condition	Height (m)	Crown Spread (m)	Stem diam. (mm)	Dist to bldg. (m)	Roots Implicated	Pruning history	Recommendation	Tree work constraints	Notes	Owner address	Owner
SG1	Mixed species shrubs	Mature	Fair	1.5	1.0	25*	2.3	N	Managed as a shrub group.	No work required.		Includes Peonies, Nettle, Rose, Sycamore, Geranium and Poppies.	The Limes Queen Street Waddesdon Aylesbury HP18 0JW	PH
SG2	Mixed species shrubs	Mature	Fair	1.5	1.0	25*	1.5	N	Managed as a shrub group.	No work required.		Includes Weigela, Ferns, Jasmine, Ash and Rhododendron.	The Limes Queen Street Waddesdon Aylesbury HP18 0JW	PH
T1	Yew	Mature	Fair	8.4	6.6	590	6.73	N	Subject to past management. No significant recent management.	No work required.			The Limes Queen Street Waddesdon Aylesbury HP18 0JW	PH
T2	Ash (Common)	Mature	Fair	22.5	13.6	500	24.66	N	No significant past tree works.	No work required.			The Limes Queen Street Waddesdon Aylesbury HP18 0JW	PH
