David Wattam BSc(Hons)For-HND-Arb RIDINGS FORESTRY UK LTD
BS5837 2012 TREE SURVEY

Robson Architecture

New Dwelling, North Back Lane, Kilham, East Riding of Yorkshire, YO254RU.

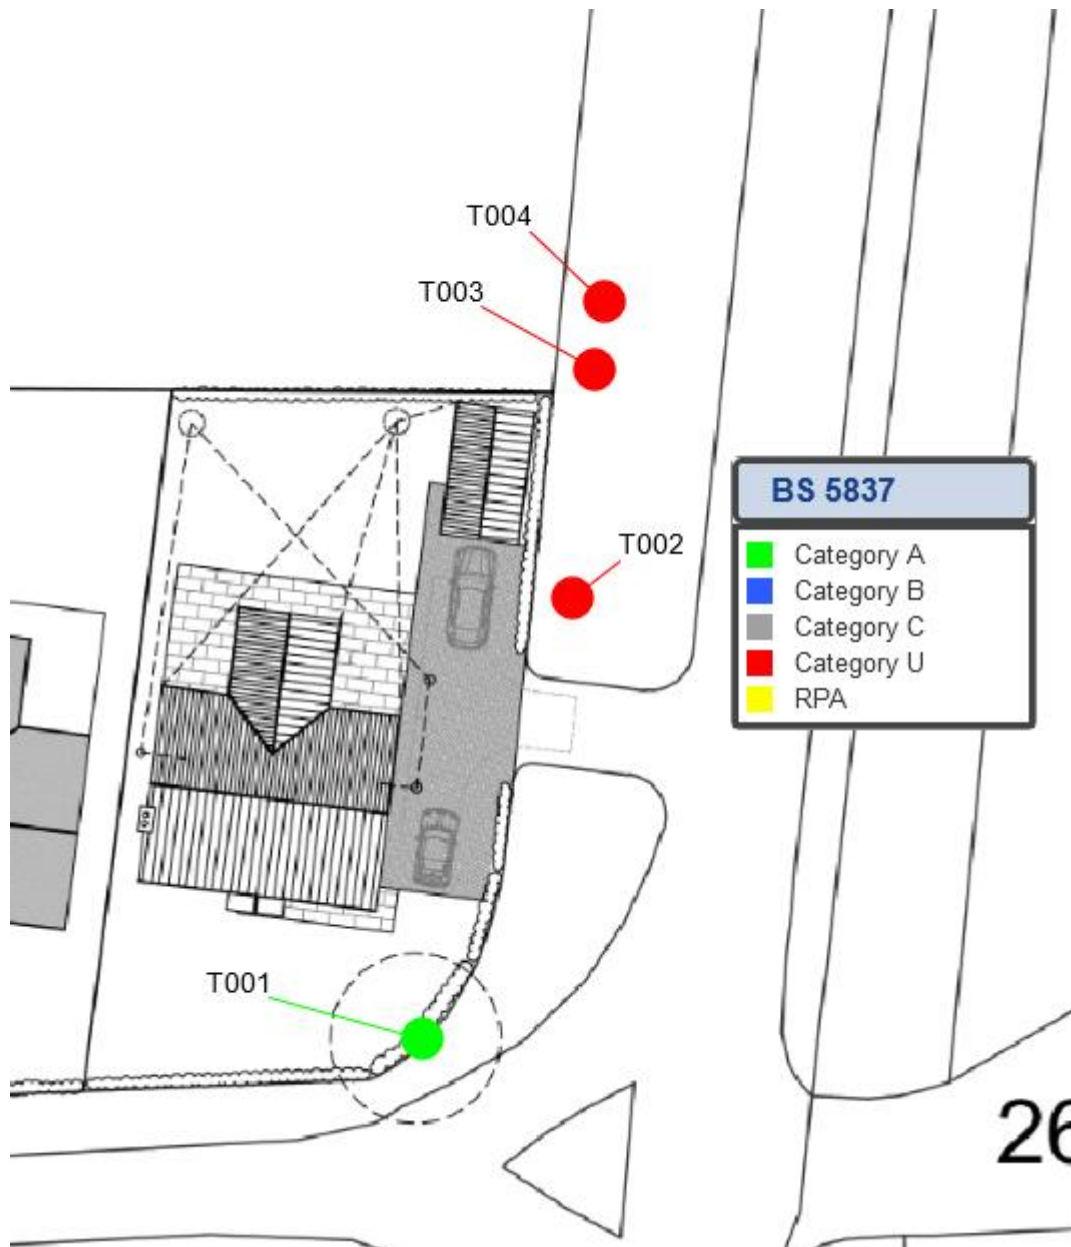
The locations of the trees and their grades in relation to BS 5837 2012 are shown on the plan below.

T001 is visible within the street scene of the Conservation Area and is an important feature of the landscape. This tree has been classed as Grade A. See picture below.

T002, T003 and T004 are hedgerow trees. All 3 trees are in a poor condition. T002 is an Ash Tree and has been heavily pruned on its eastern side. The tree is displaying signs of Ash Dieback 1-25%. These trees have been classed as Grade U. Please see picture below.

T003 is a dead Elm and T004 is an Ash. T004 is also infected by Ash dieback 25%. Please see picture below.

T002, T003 and T004 are in poor condition. I have recommended that these trees should be felled and replaced.

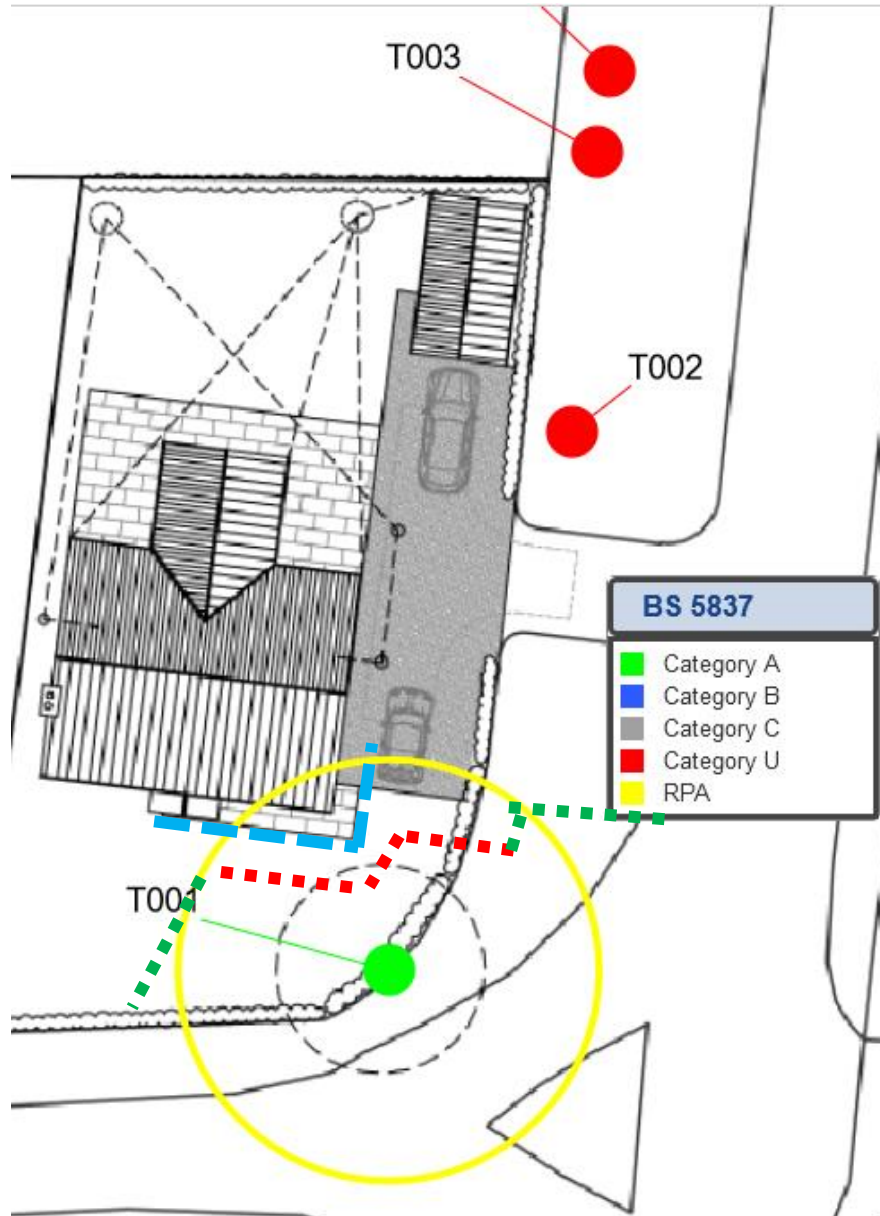
7.3) Tree Protection Plan

T001 has been classed as Grade A and is a significant feature of the street scene. The RPA is slightly compromised by the foundations of the proposed development. I have recommended Class 1 protective fencing for the compromised area. This should mitigate any compaction and damage to the root system of the tree during the construction phase. I have also recommended that any excavations within or around the RPA should be done by hand only, avoiding damage to the protective bark covering larger roots. Roots, whilst exposed, should be wrapped in dry, clean hessian sacking to prevent desiccation and to protect from rapid temperature changes. Roots smaller than 25 mm diameter may be pruned back, preferably to a side branch, using a proprietary cutting tool such as bypass secateurs or handsaws. Roots larger than 25 mm should only be severed following consultation with an arboriculturist, as they may be essential to the tree's health and stability. Prior to backfilling, any hessian wrapping should be removed and retained roots should be surrounded with sharp sand (builders' sand should not be used because of its high salt content which is toxic to tree roots), or other loose granular fill, before soil or other material is replaced. This material should be free of contaminants and other foreign objects potentially injurious to tree roots. Please see picture below.

Tree Protection Class 1 and Class 2 Fencing should be erected as detailed in the plan below. See Appendix A for fencing details. Fencing should remain in place for the duration of the build.
