Heritage Statement and Impact Assessment for Render Repair
Proposals at:

West Front Facade, Highclere Castle

Planning Issue - September 2023

Highclere Castle Estate

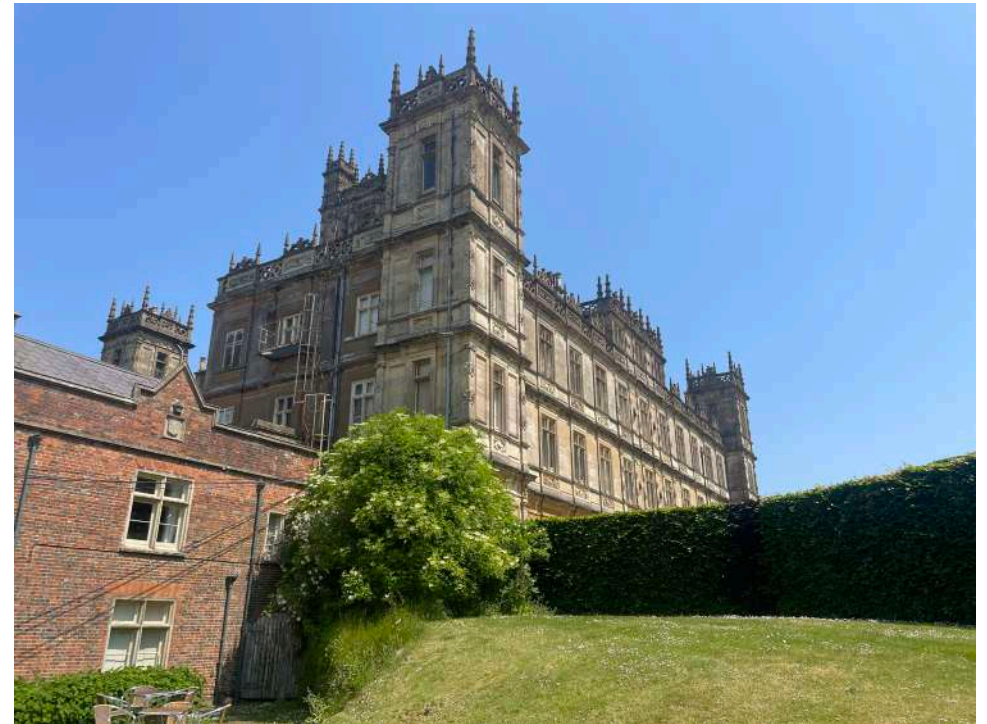
Fig. 3 (below) Highclere Castle's rendered West Front and stonework South Front and towers, viewed from the southwest (BHB Architects 2023)

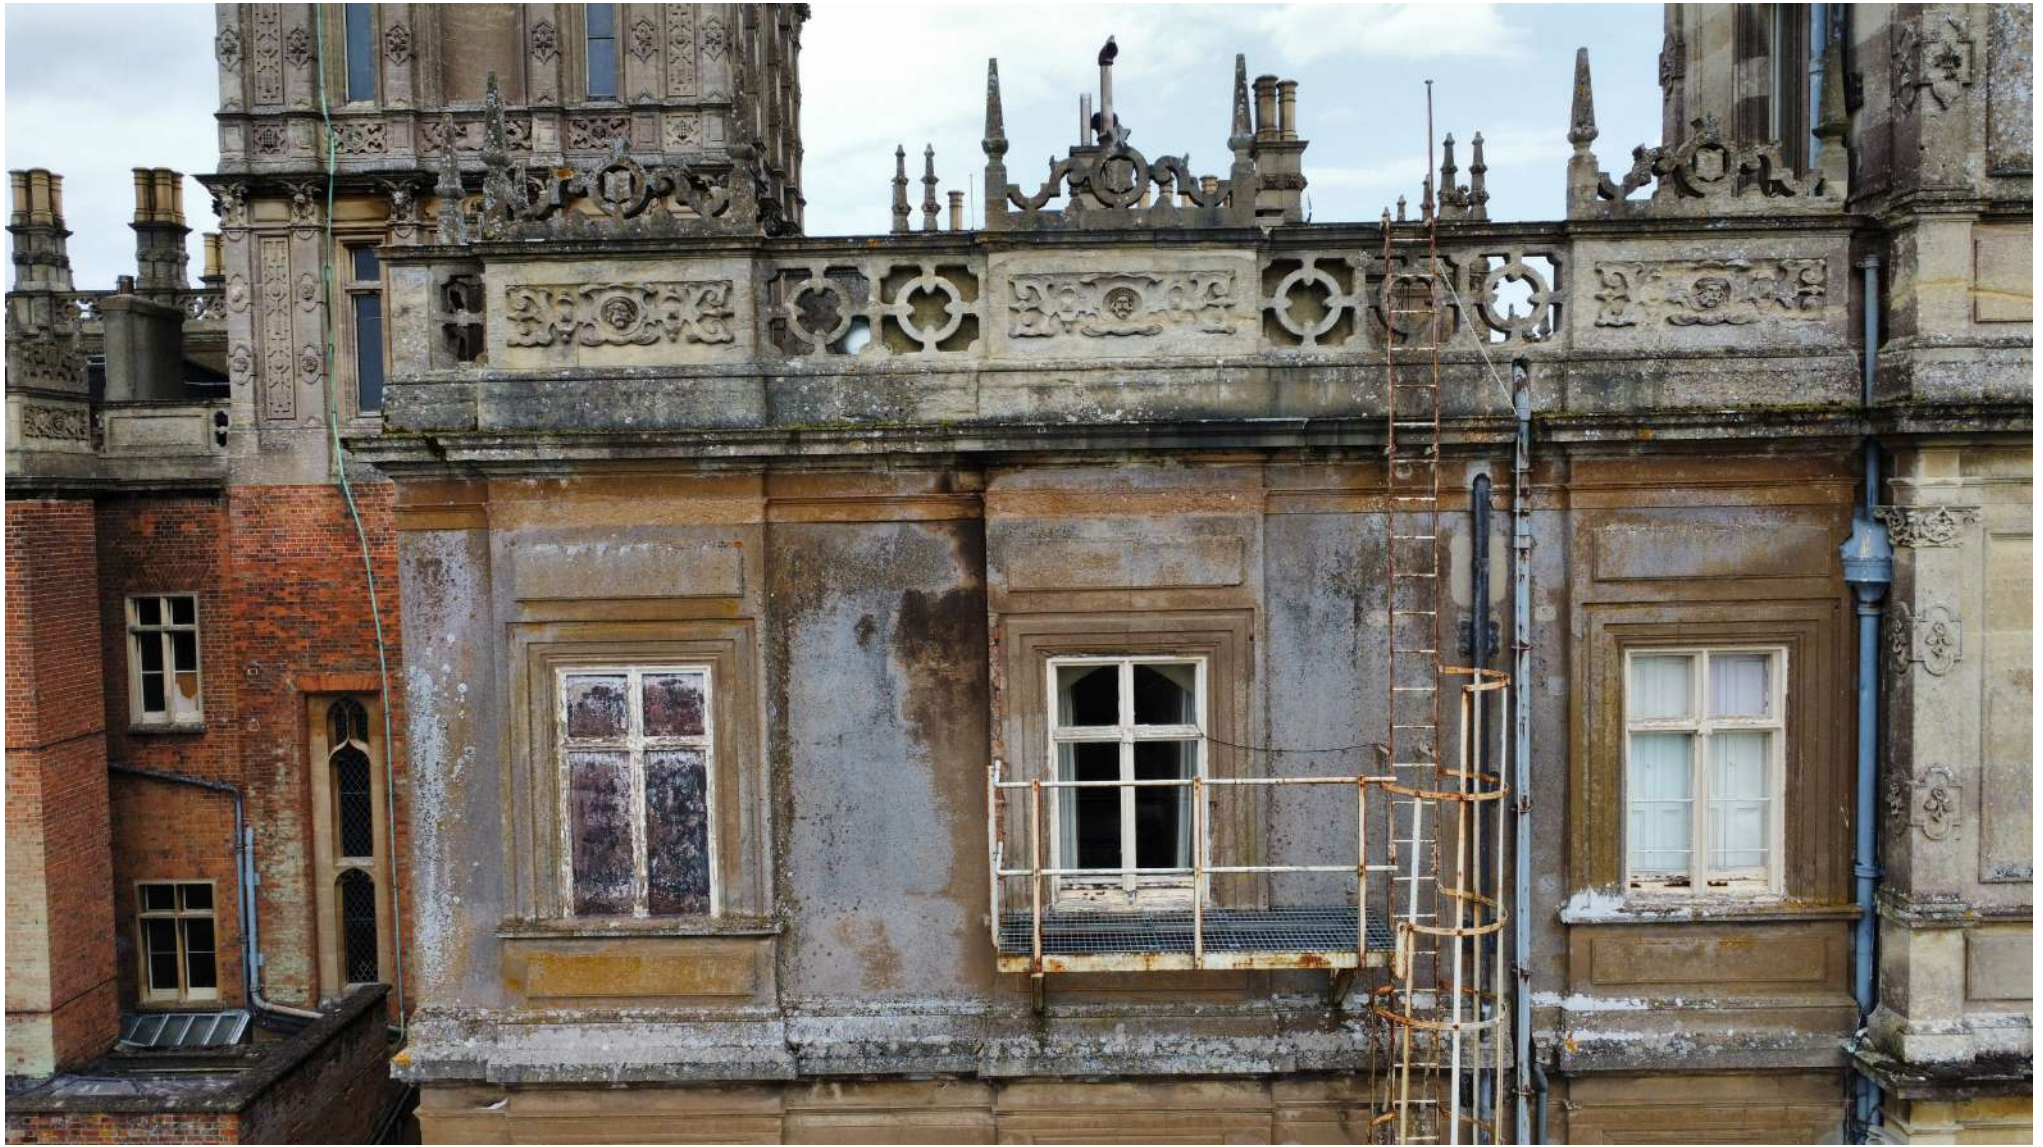
West Facade Elevation (Second Floor only):

Fig. 6 (below) A drone captured view of the site. Note the dummy window to the left hand side.

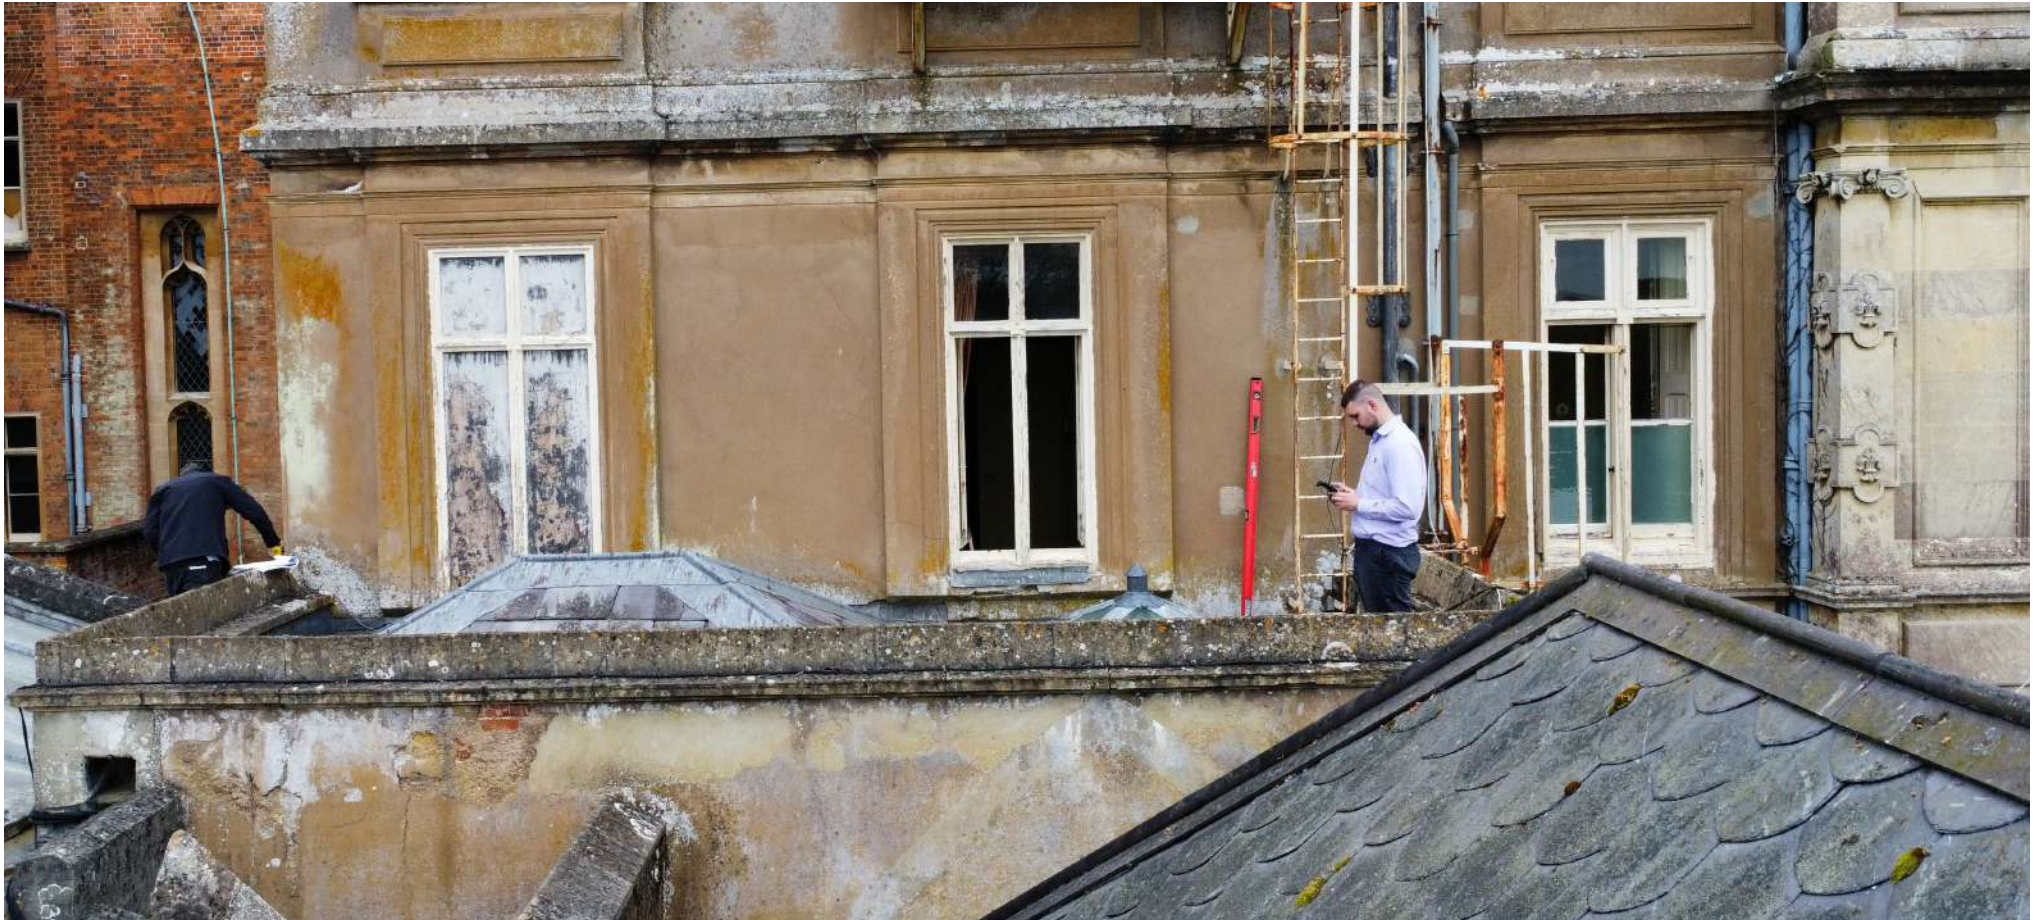
West Facade Elevation (First Floor only):

Fig. 7 (below) A drone captured view of the site. Note the dummy window to the left hand side.

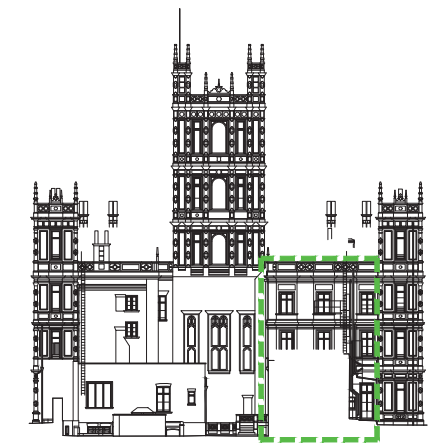
The condition of the render is very poor with numerous fissure cracks and areas of delamination. A large quantity of decorative render has fallen from the facade and there are areas of high discolouration and lichen growth. Following the archive research and the X-Ray diffraction test it is believed that the render is quite likely to be a Roman cement that has suffered from significant exposure to the elements which has affected the chemistry of the binder.

Fig.16. (Right) The facade viewed from the northwest. The warm tones of the Highclere Cement can be more easily seen in the lower levels that are more sheltered. The colourisation of the facade is not uniform and the mineral content is likely to vary across the facade.

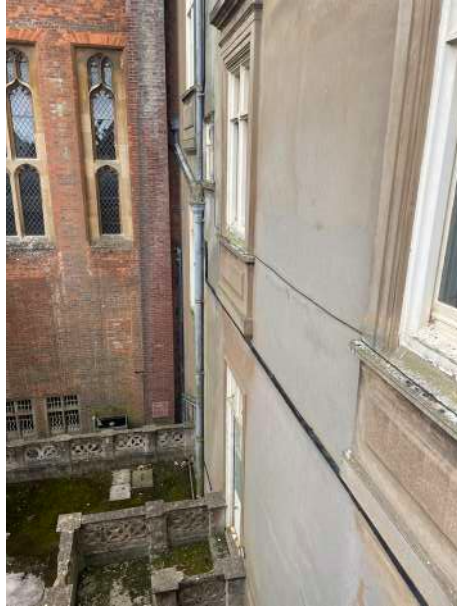
Fig. 25 The adjacent rendered wall that faces North to meet the central tower.

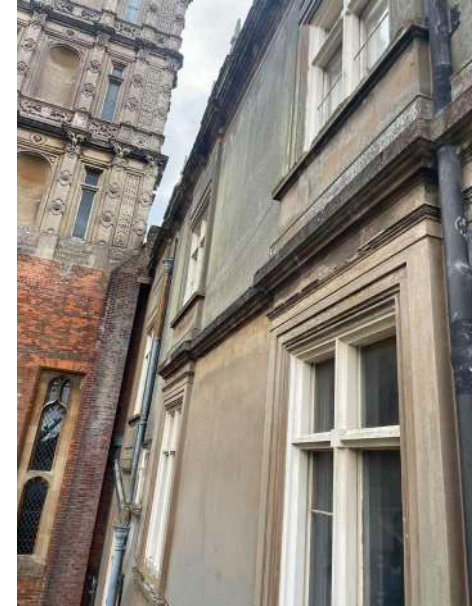
Fig. 26 The adjacent rendered wall that faces North to meet the central tower.

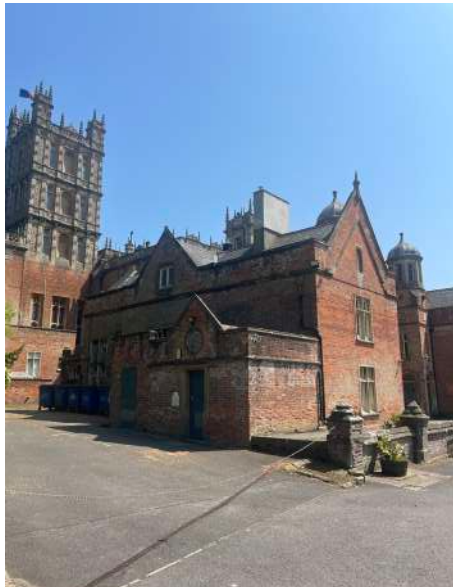
Fig. 27 The ground level view of rendered walls are frequently obscured by the West wing.

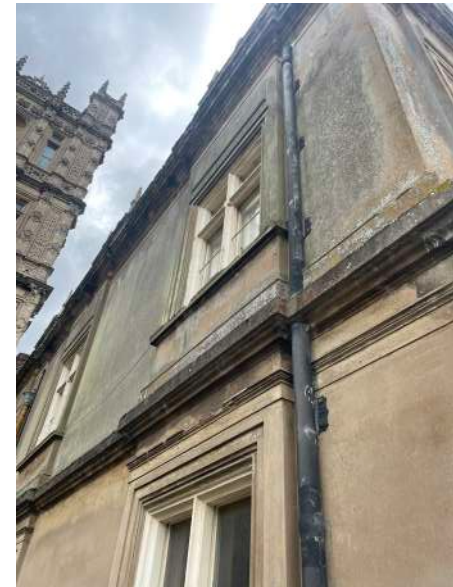
Fig. 28 The adjacent rendered wall that faces North to meet the central tower.
