BERKELEY HOUSE, LYNSTED

TREE SURVEY

DWG No: **FV04329-01**
 Scale: **1:200 (A1)**
 Date: **24 - 07 - 2023**
 By: **KCF**

TREE CONDITION SURVEY

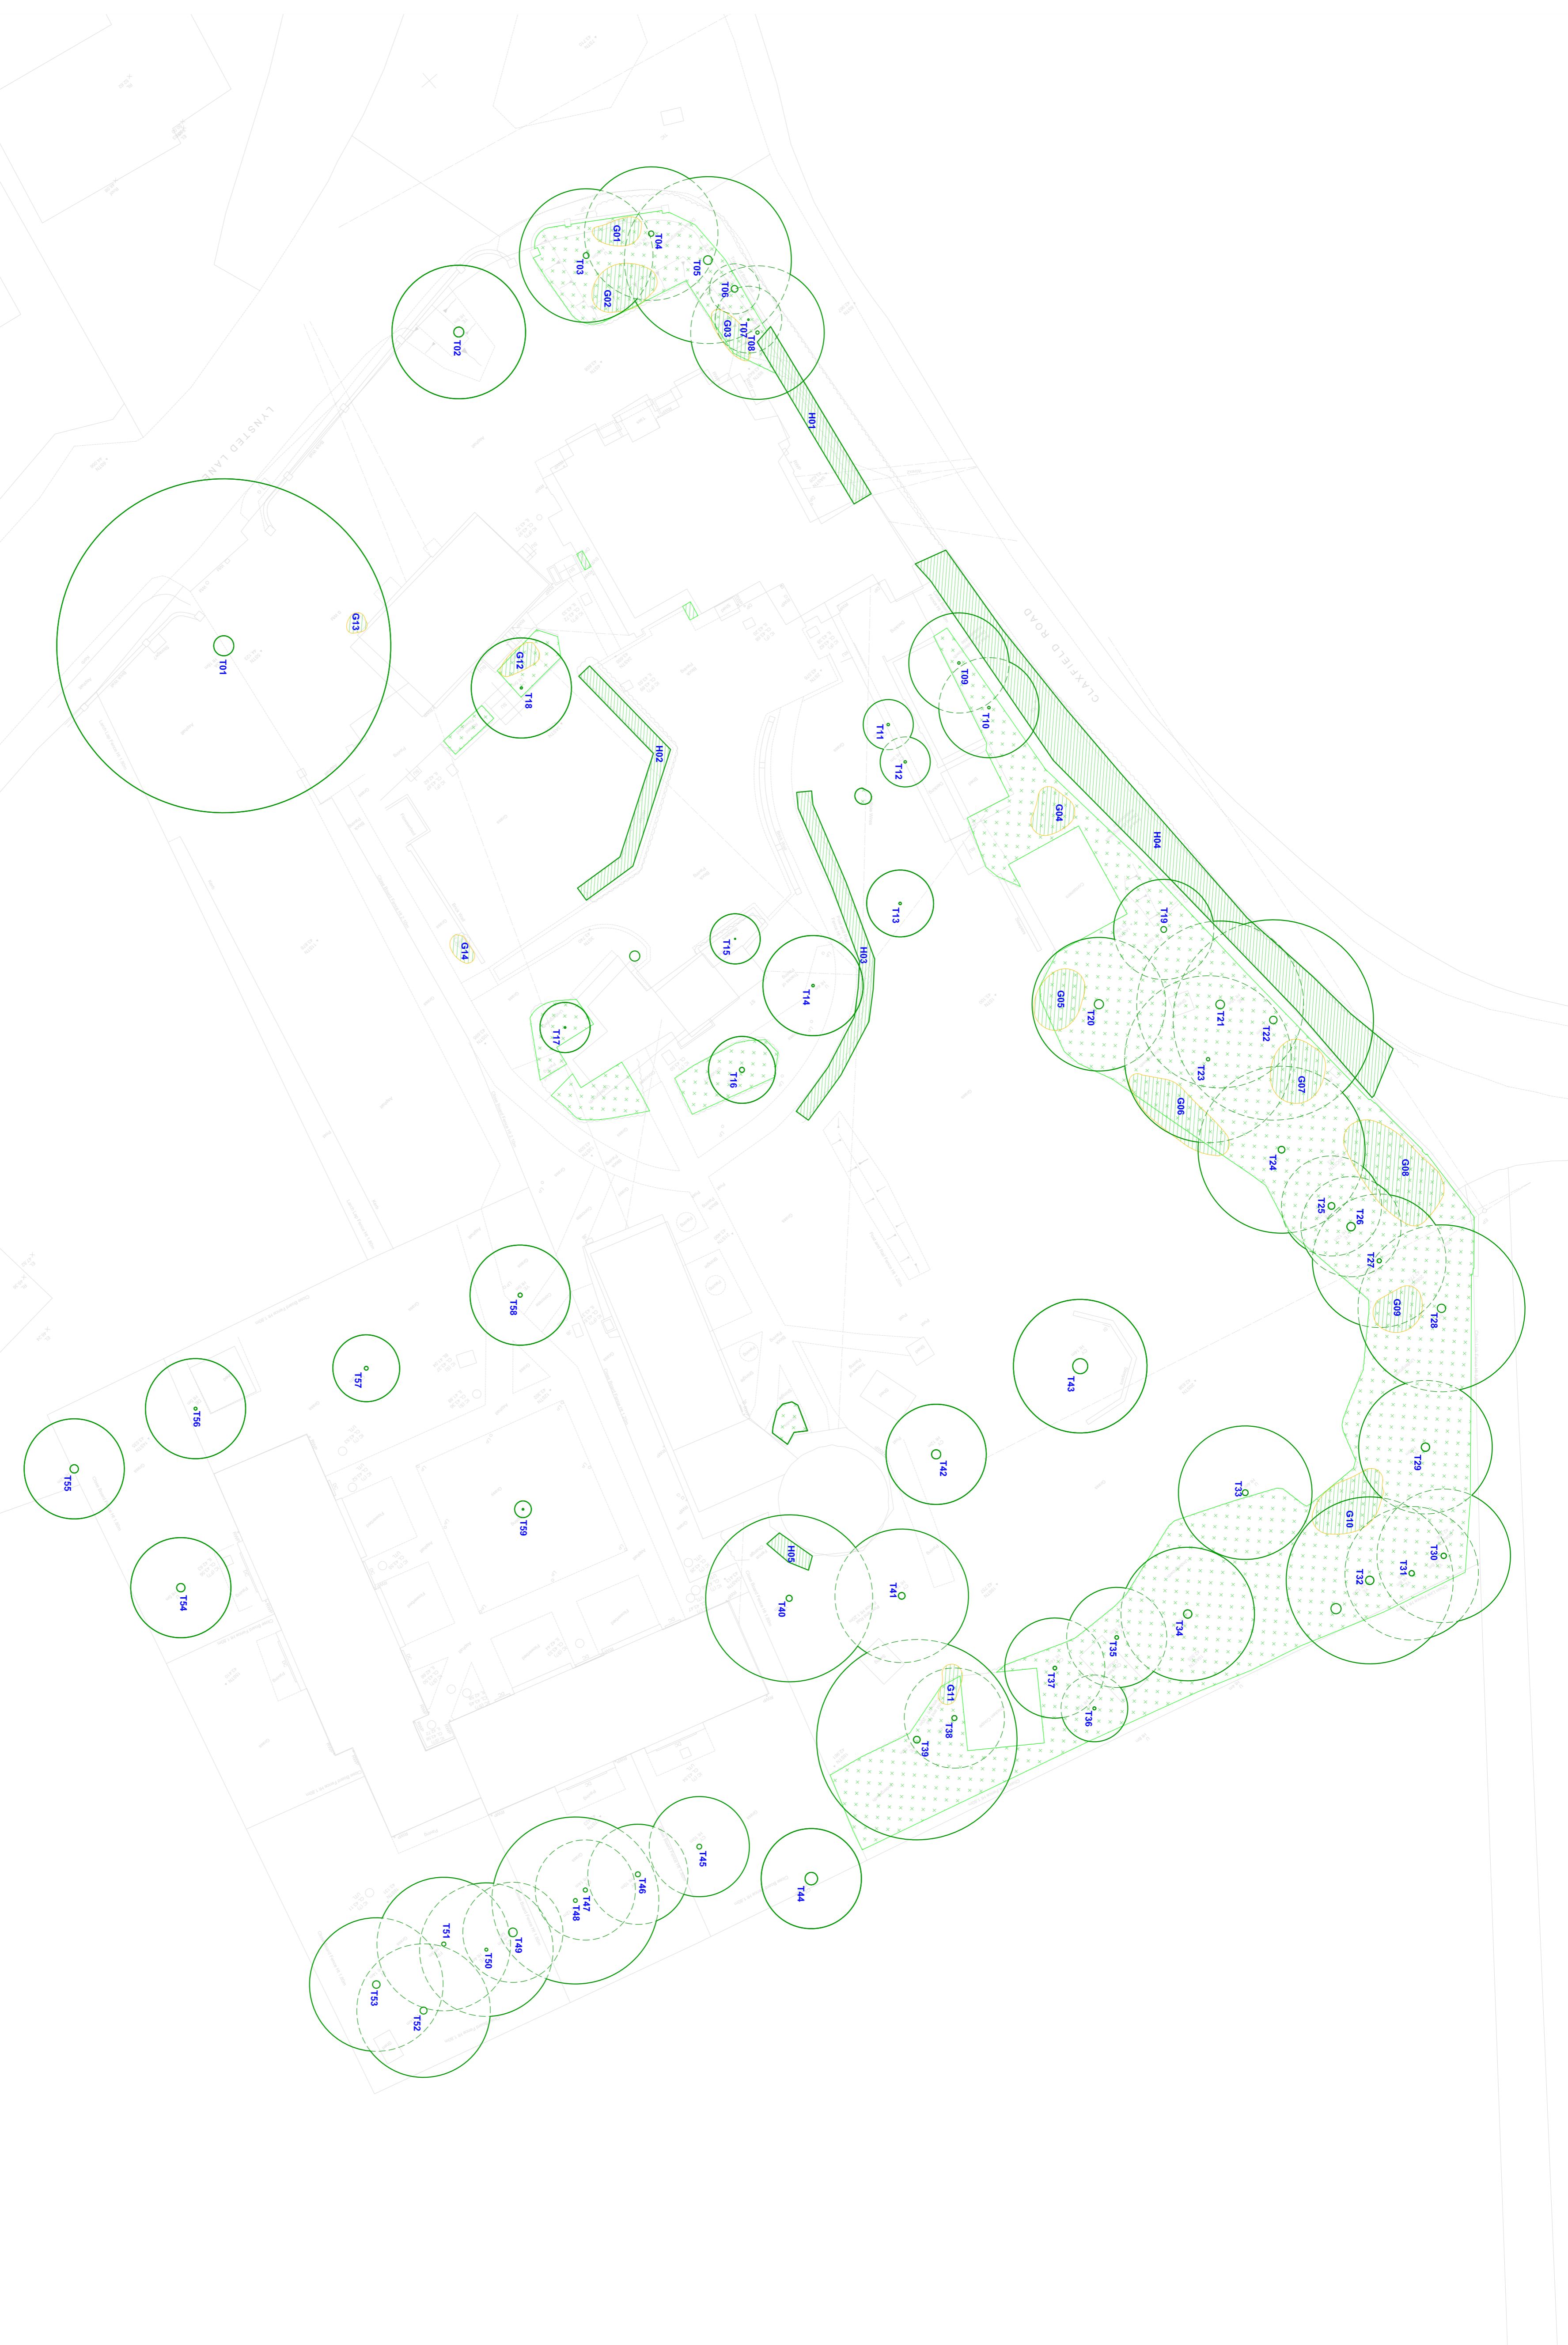
REF	BOTANICAL NAME	COMMON NAME	HEIGHT (m)	SPREAD (m)	GIRTH (cm)	DIAMETER (cm)	STEMS	CONDITION	PROTECTED	NOTES
T01	<i>Quercus ilex</i>	Holme Oak	12	10	360	115	1	(A) Healthy	YES	
T02	<i>Taxus baccata</i>	Yew	7	4	60	20	7	(A) Healthy	YES	Ivy Growth to be removed
T03	<i>Taxus baccata</i>	Yew	8	4	45	15	8	(C) Poor Condition	YES	Dense Ivy Growth to be removed
T04	<i>Taxus baccata</i>	Yew	7	4	127	41	3	(B) Good	YES	Low quality tree development, and in competition with larger pre-established trees
T05	<i>Taxus baccata</i>	Yew	9	5	210	67	1	(A) Healthy	YES	Ivy Growth to be removed
T06	<i>Ilex aquifolium</i>	Holly	4	1.5	10	4	1	(C) Poor Condition	NO	Poor tree development, and in competition with larger pre-established trees
T07	<i>Ilex aquifolium</i>	Holly	6	2	36	12	1	(C) Poor Condition	YES	Poor tree development, and in competition with larger pre-established trees
T08	<i>Fagus sylvatica f. purpurea</i>	Copper Beech	9	4	50	16	4	(B) Good	YES

T09	<i>Taxus cuspidata sp.</i>	Japanese Yew	9	3	-	-	-	(A) Healthy	YES	Not being maintained, and outgrowing small space behind building.
T10	<i>Taxus baccata</i>	Yew	9	3	-	-	-	(A) Healthy	YES	
T11	<i>Juniperus sabina</i>	Savin Juniper	2.5	1.5	17	6	1	(B) Good	NO	Building side of plant is exposed with no foliage, where growing against trellis
T12	<i>Juniperus sabina</i>	Savin Juniper	2.5	1.5	10	4	1	(B) Good	NO	Building side of plant is exposed with no foliage, where growing against trellis
T13	<i>Prunus avium</i>	Sweet Cherry	4.5	2	34	11	1	(A) Healthy	YES	
T14	<i>Laburnum anagyroides 'Medik'</i>	Common Laburnum	3	3	55	18	1	(A) Healthy	YES	
T15	<i>Alnus cordata</i>	Italian alder	5	1.5	10	4	2	(A) Healthy	NO	
T16	<i>Ilex aquifolium</i>	Holly	8	2	60	20	4	(A) Healthy	YES	
T17	<i>Taxus baccata</i>	Yew	4	1.5	30	10	4	(A) Healthy	YES	
T18	<i>Laburnum anagyroides 'Medik'</i>	Common Laburnum	5	3	50	16	1	(A) Healthy	YES

T19	<i>Pinus sylvestris</i>	Scots Pine	5	3	30	10	1	(B) Good	YES	Ivy Growth to be removed, Requires general maintenance, removing dead dying and damaged branches
T20	<i>Taxus baccata</i>	Yew	6	4	250	80	1	(A) Healthy	YES	
T21	<i>Tilia cordata</i>	Small-leaved Lime	10	5	200	64	1	(A) Healthy	YES	
T22	<i>Tilia cordata</i>	Small-leaved Lime	11	6	200	64	1	(A) Healthy	YES	
T23	<i>Taxus baccata</i>	Yew	6	4	106	34	1	(A) Healthy	YES	
T24	<i>Taxus baccata</i>	Yew	7	5	34	11	5	(B) Good	YES	Requires general maintenance, removing dead dying and damaged branches
T25	<i>Taxus baccata</i>	Yew	6	3	50	16	6	(A) Healthy	YES	
T26	<i>Taxus baccata</i>	Yew	6	3	70	23	3	(A) Healthy	YES	
T27	<i>Taxus baccata</i>	Yew	7	4	70	23	4	(A) Healthy	YES	
T28	<i>Crataegus monogyna</i>	Hawthorn	5	3	50	16	1	(B) Good	YES	Ivy Growth to be removed. A top heavy tree, relying on wall for support
T29	<i>Rhus typhina</i>	Stag's Horn	4	4	18	6	2	(A) Healthy	NO

T30	<i>Taxus baccata</i>	Yew	7	3	90	29	1	(B) Good	YES	Ivy Growth to be removed, Requires general maintenance, removing dead dying and damaged branches
T31	<i>Taxus baccata</i>	Yew	8	4	150	48	1	(A) Healthy	YES	
T32	<i>Taxus baccata</i>	Yew	9	5	120	39	1	(A) Healthy	YES	
T33	<i>Laburnum anagyroides 'Medik'</i>	Common Laburnum	6	4	65	21	2	(A) Healthy	YES	
T34	<i>Taxus baccata</i>	Yew	7	4	75	24	10	(A) Healthy	YES	Ivy Growth to be removed
T35	<i>Chamaecyparis lawsoniana</i>	Lawson Cypress	11	3	126	41	1	(A) Healthy	YES	
T36	<i>Ilex aquifolium</i>	Holly	8	2	45	15	1	(C) Poor Condition	YES	Poor tree development, and in competition with larger pre-established trees
T37	<i>Chamaecyparis lawsoniana</i>	Lawson Cypress	12	3	127	41	1	(A) Healthy	YES	
T38	<i>Chamaecyparis lawsoniana</i>	Lawson Cypress	10	3	90	29	1	(A) Healthy	YES	
T39	<i>Taxus baccata</i>	Yew	12	6	150	48	1	(A) Healthy	YES	
T40	<i>Taxus baccata</i>	Yew	10	5	150	48	1	(A) Healthy	YES

T41	<i>Chamaecyparis lawsoniana</i>	Lawson Cypress	12	4	175	56	1	(A) Healthy	YES	
T42	<i>Thuja occidentalis</i>	Northern White Cedar	8	3	210	67	1	(A) Healthy	YES	
T43	<i>Chamaecyparis lawsoniana</i>	Lawson Cypress	12	4	150	48	3	(A) Healthy	YES	
T44	<i>Chamaecyparis lawsoniana</i>	Lawson Cypress	16	3	130	42	1	(A) Healthy	YES	
T45	<i>Chamaecyparis lawsoniana</i>	Lawson Cypress	12	3	100	32	1	(A) Healthy	YES	
T46	<i>Ilex aquifolium</i>	Holly	10	3	90	29	1	(C) Poor Condition	YES	Poor tree development, and in competition with larger pre-established trees
T47	<i>Chamaecyparis lawsoniana</i>	Lawson Cypress	12	3	95	31	1	(B) Good	YES	Growing in dense competition amongst other trees
T48	<i>Ilex aquifolium</i>	Holly	10	5	75	24	1	(B) Good	YES	Growing in dense competition amongst other trees
T49	<i>Chamaecyparis lawsoniana</i>	Lawson Cypress	8	3	90	29	2	(B) Good	YES	Growing in dense competition amongst other trees

T50	<i>Taxus cuspidata sp.</i>	Japanese Yew	4	3	45	15	2	(B) Good	YES	Growing in dense competition amongst other trees
T51	<i>Ficus carica</i>	Fig	3	4	15	5	3	(A) Healthy	NO	
T52	<i>Pinus sylvestris</i>	Scots Pine	12	4	150	48	1	(B) Good	YES	Require formative pruning. Height suggest tree is of age where this will become a risk of falling into adjacent buildings
T53	<i>Pinus sylvestris</i>	Scots Pine	12	4	140	45	1	(B) Good	YES	Require formative pruning. Height suggest tree is of age where this will become a risk of falling into adjacent buildings
T54	<i>Prunus lusitanica</i>	Portuguese Laurel	6	3	75	24	1	(A) Healthy	YES	
T55	<i>Taxus baccata</i>	Yew	12	6	150	48	1	(A) Healthy	YES	
T56	- unidentifiable -	-	5	3	70	23	1	D - Dead	YES	Dead
T57	<i>Chamaecyparis lawsoniana</i>	Lawson Cypress	12	2	85	28	1	(B) Good	YES	Requires general maintenance, removing dead dying and damaged branches
T58	<i>Taxus baccata</i>	Yew	5	3	50	16	3	(A) Healthy	YES
