TIMBER SURVEY

BRADES FARM, BRADES ROAD, PREES, WHITCHURCH, SY13 2DX

APPLICANT: MR. & MRS. ROGER FORD

DATE: JULY 2023 (REV B)

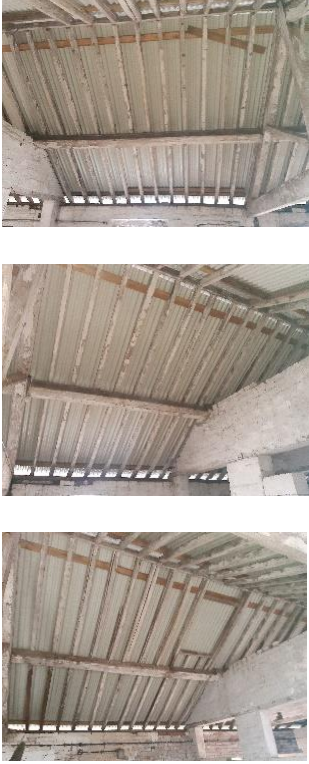
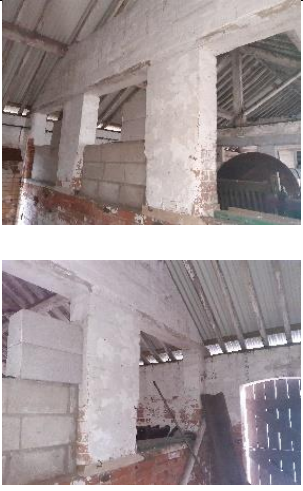
<p>GGT1</p> <p>The internal wall will be modified to create a divisional wall within Unit 2.</p> <p>The bonding timer will be lost and a suitable replacement will be utilised within the works.</p> <p>No primary timber is affected.</p>
