STRUCTURAL ASSESSMENT REPORT

Green Oak Barn, Stonham Road, Mickfield

Date: October 2022

Reference: GT/2170/srep02

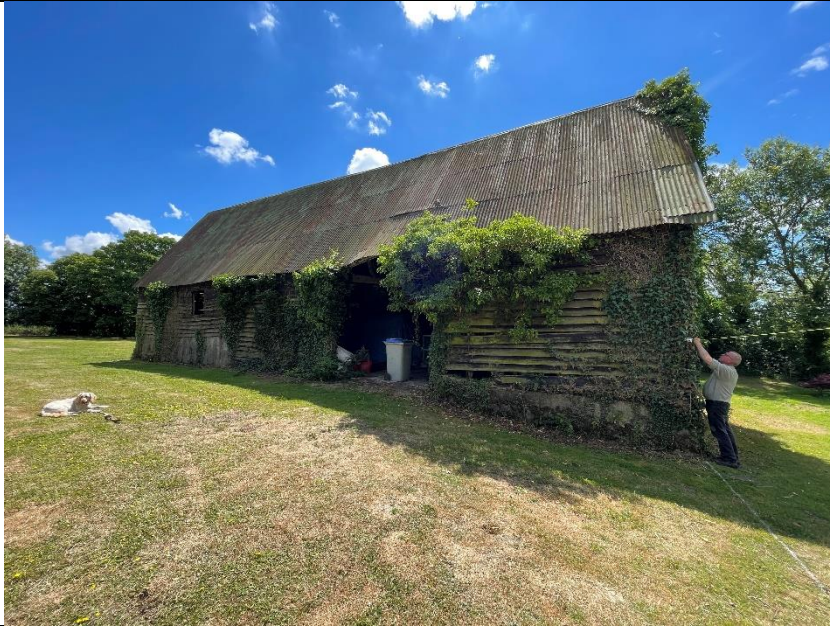
Photograph 01
North Elevation

- 3.4 The brick plinth has been historically repaired with concrete along the north elevation over half its length. The repair has been carried out in a manner of shuttering the existing walls and pouring concrete in situ to stabilise the brickwork and timber. This repair continues at plinth level along the east elevation and to the mid-stray outshoot on the south elevation.
