Venbridge House, Cheriton Bishop, EX6 6HD

Design and Access Statement, Statement of Significance and Schedule of Works

December 2022 revision A

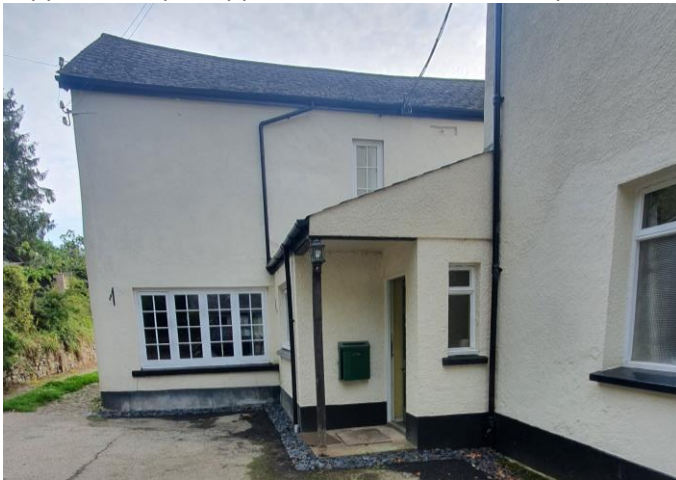
- g. W9 and D3: small modern timber window and timber door: to be infilled. Altered layout supported in pre-app. – See annex alterations point 6 below.

- h. D3 to be relocated on adjacent wall. Existing door to be re-employed.

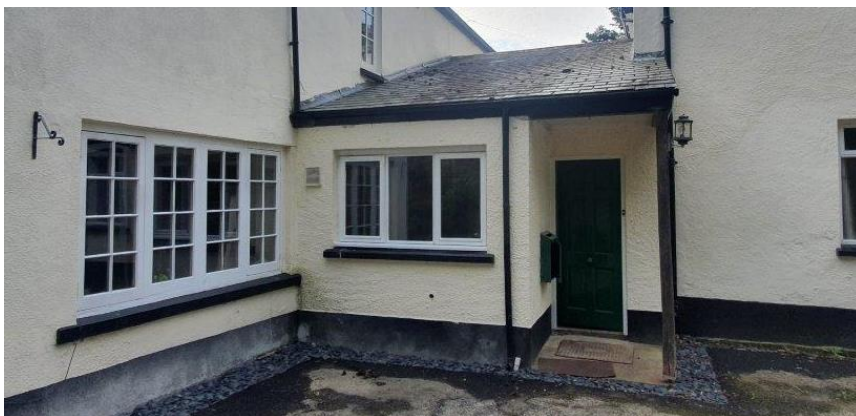
Photo above: W10 left of door; W11 to left hand side of photo

- i. W10 and W11: No proposed changes as present.
