## Preliminary Roost Assessment

Witham Wood, Marley Lane, Haslemere, West Sussex, GU27 3PZ

Claire Coleman

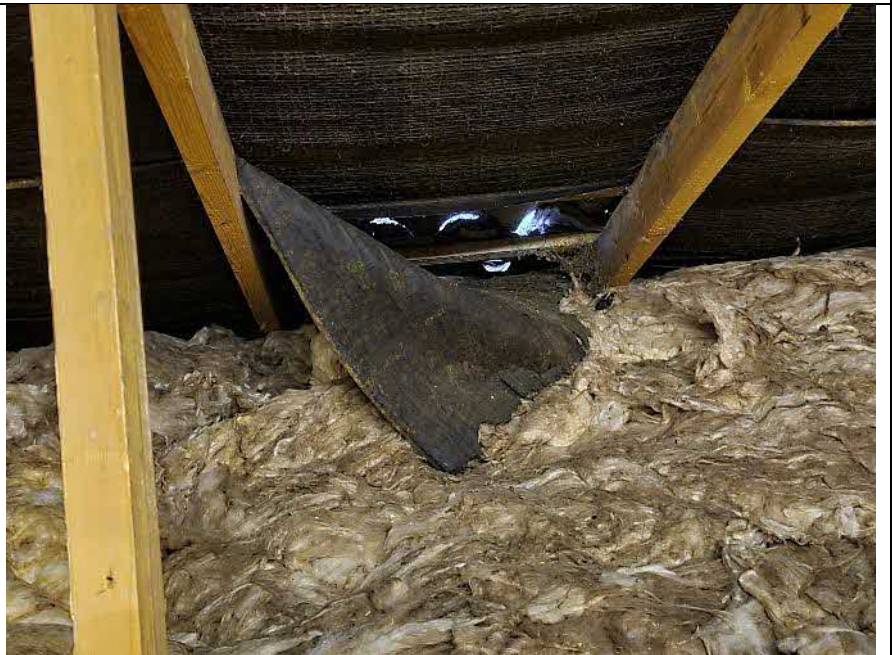
<p>B1 – Evidence of bats (L1)</p> <p>Picture 10</p>	<p>Bat droppings were identified on the walls of L1. Examples are circled in the picture opposite. A sample of these droppings was retained should DNA analysis be required.</p>

<p>B1 – suitability assessment</p>	<p>B1 is identified as a confirmed roost, due to the presence of bat droppings in L1.</p> <p>Overall, the building is judged to provide <b>high</b> habitat value for roosting bats. There are features around B1 in which bats could roost. Internal features include the gable ends of loft spaces and in torn/sagging sections of bitumen roofing felt. External features include hanging tiles and under unsealed ridge tiles. There are also access points into both loft spaces: through the torn section of roofing felt shown in Picture 9 and the missing soffit shown in picture 5.</p>	
<p>B1 - breeding birds and other incidental observations</p>	<p>No evidence of breeding birds was observed around B1, however due to the missing soffit on the southern elevation of the garage birds could gain access and nest within.</p>
