**Existing windows – overview**

TITLE: Existing property - rear of property

REFERENCE: PPL1080/existing-rear

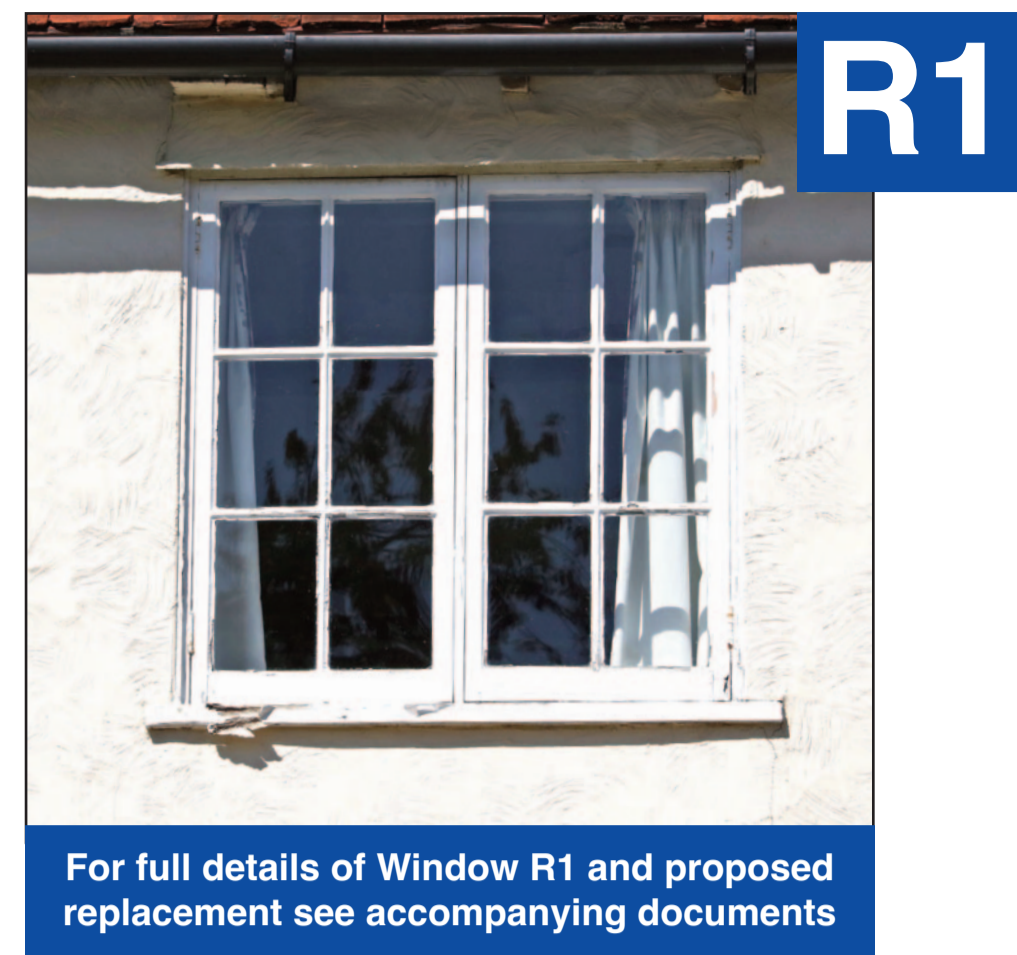
For full details of Window R1 and proposed replacement see accompanying documents

The casement windows marked R1 and R4 are constructed of timber and are in need of replacement.
