SITE PHOTOGRAPHS AND BUILDING PHOTOGRAPHS POST LBC APPROVAL – 1  
MAIN STREET, LOW VALLEYFIELD ‘WESTEND COTTAGE’.

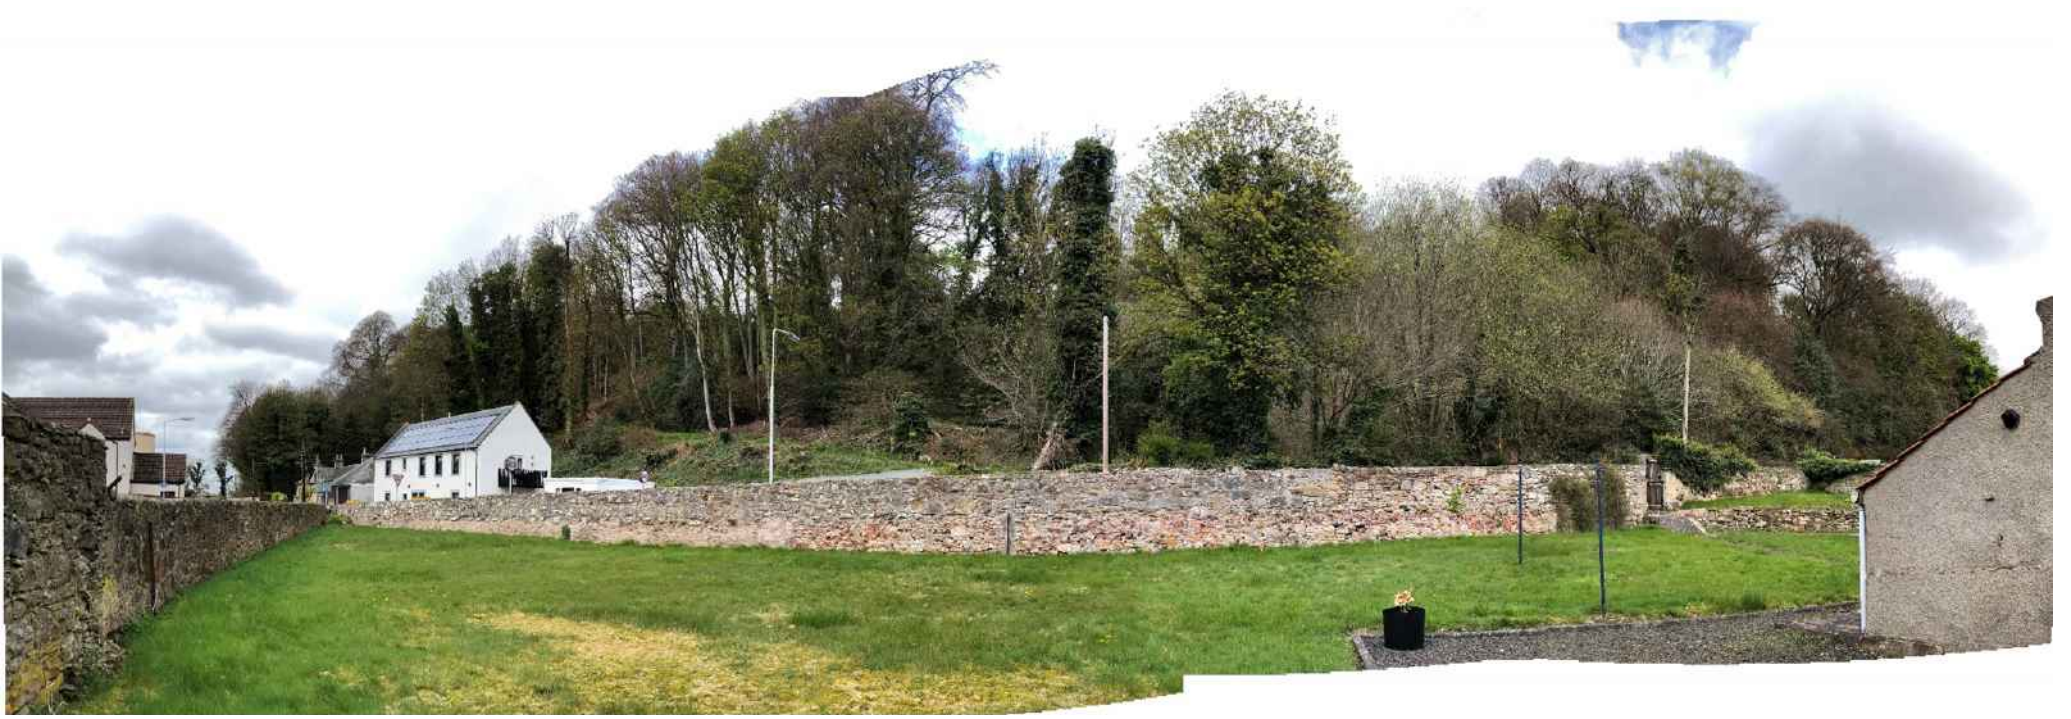
*Figure 1: panoramic view of rear garden showing northern boundary wall and change of elevation of site*

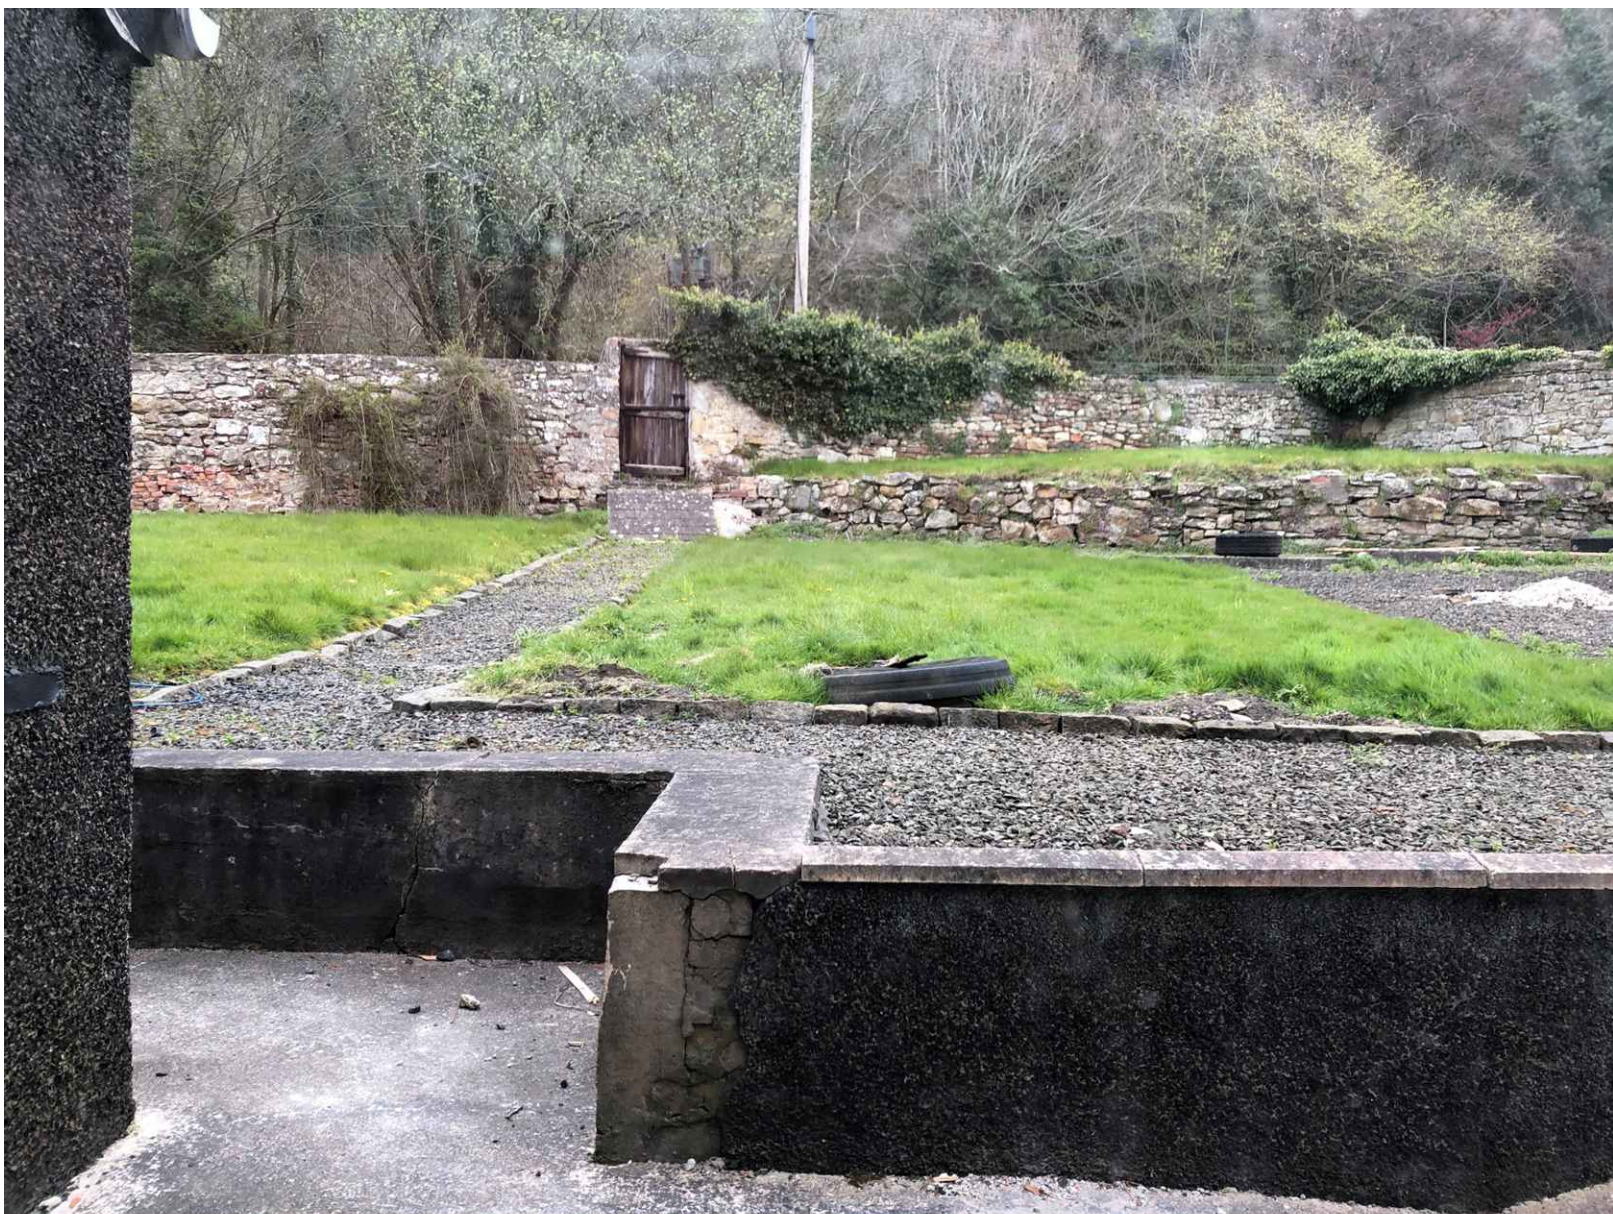
*Figure 2: View from back door to northern boundary wall. Northern boundary wall is between 1.8m and 2m high meaning there is no clear line of sight into the rear garden from Low Causeway*

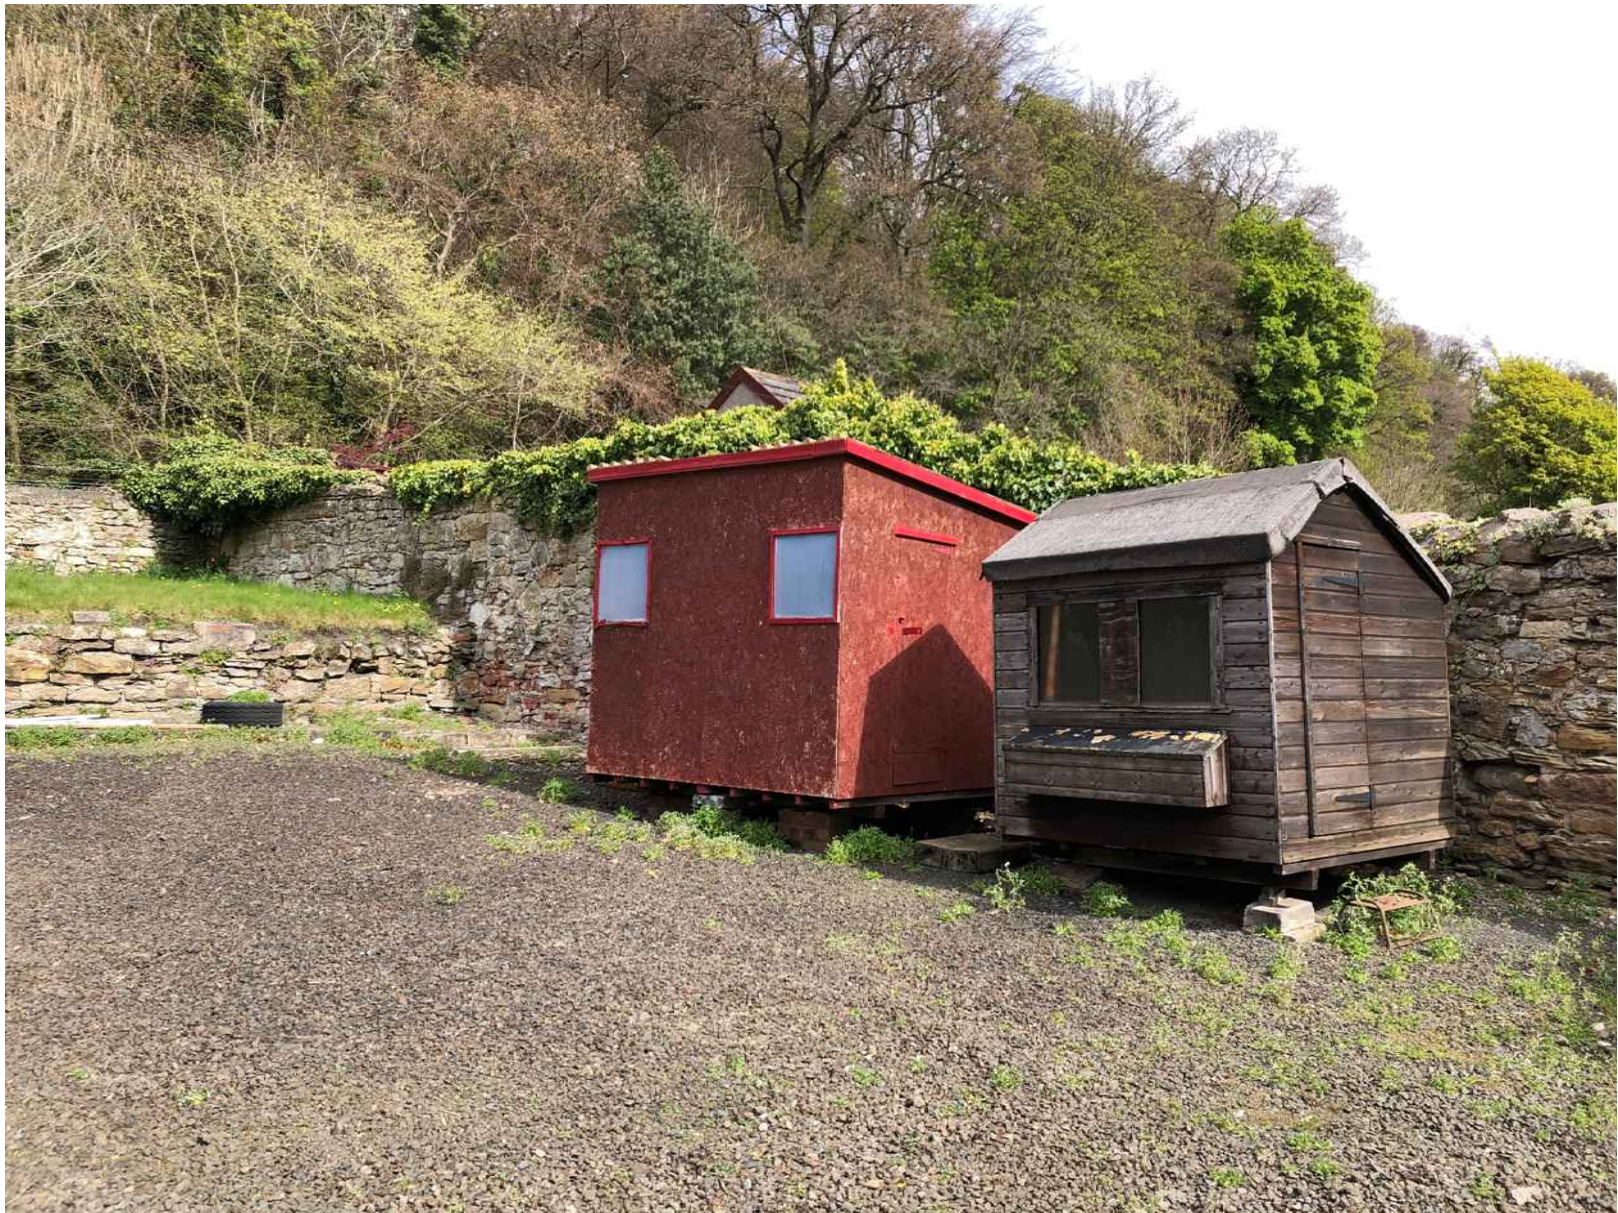
*Figure 3: Small sheds on eastern boundary wall with top of gable of rear neighbour's garage protruding above the top of the boundary wall*

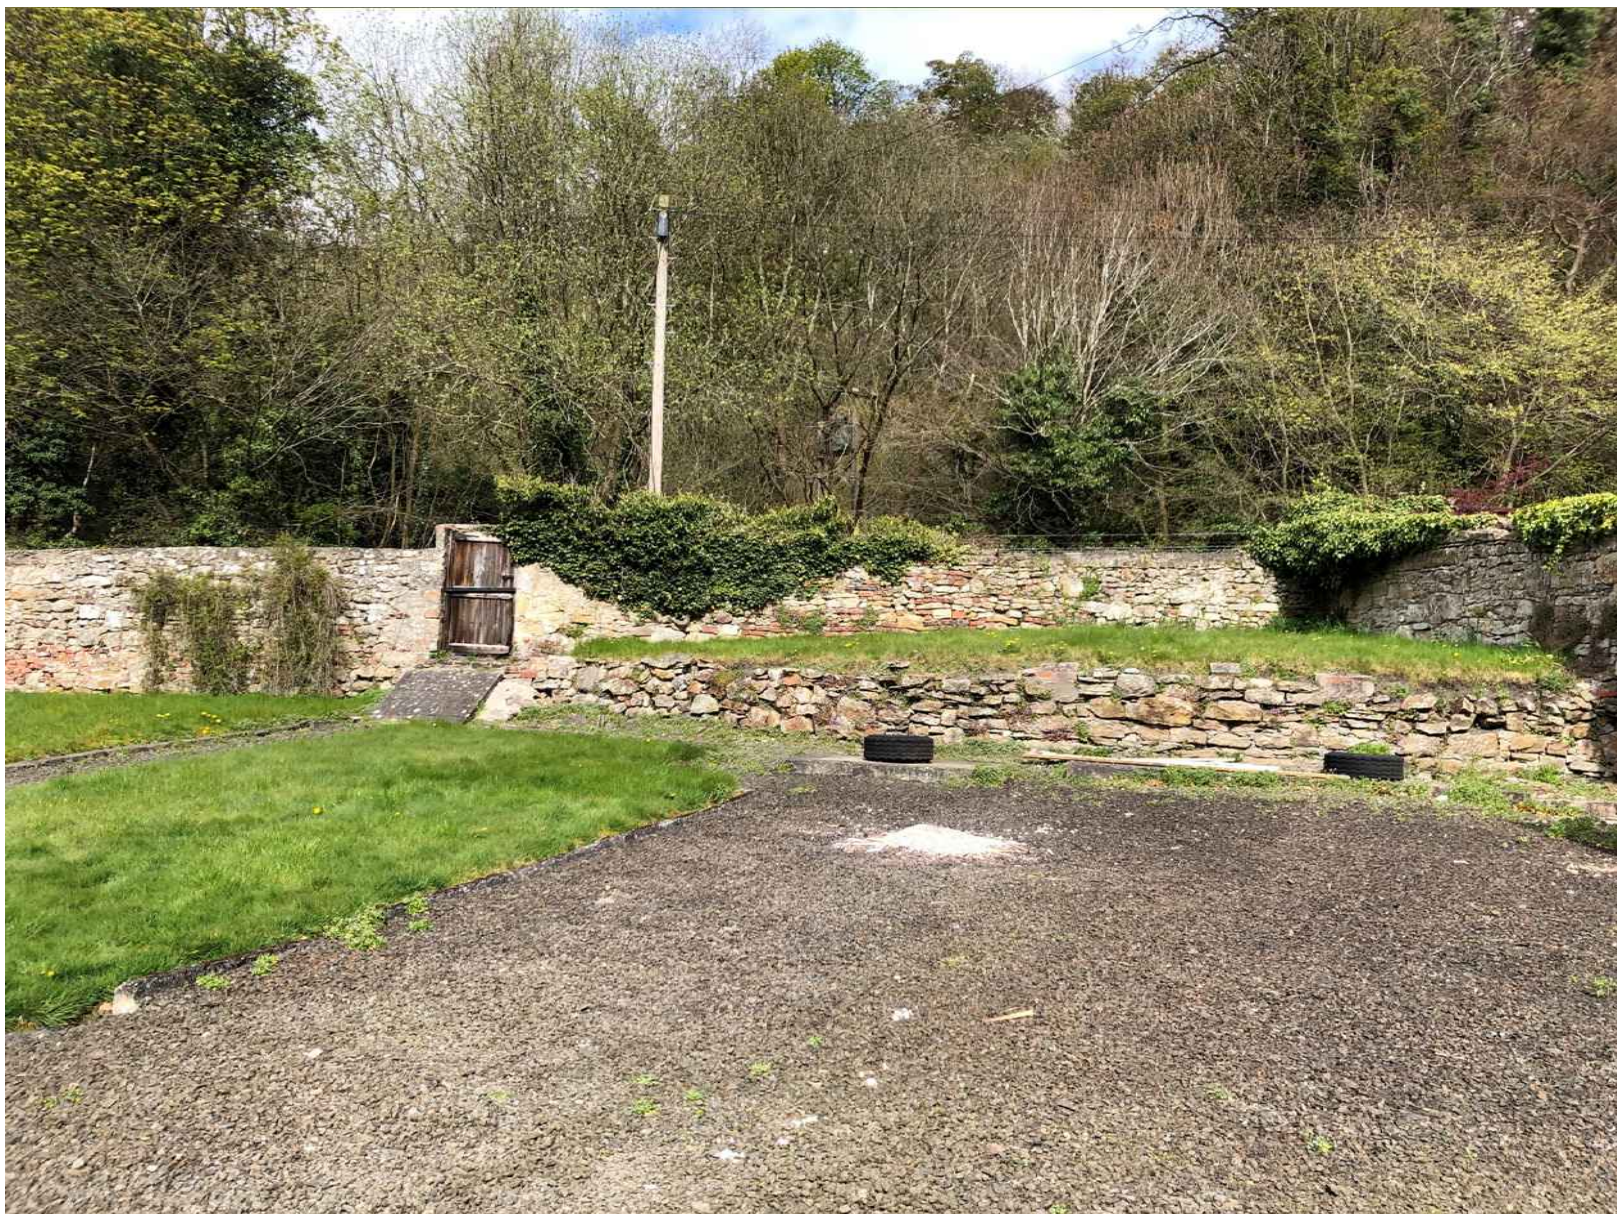
*Figure 4: View of northern boundary wall and change in height of rear garden. The rear extension will sit down into the site by approximately 1.5m where the grass section is shown to the left of this photograph.*

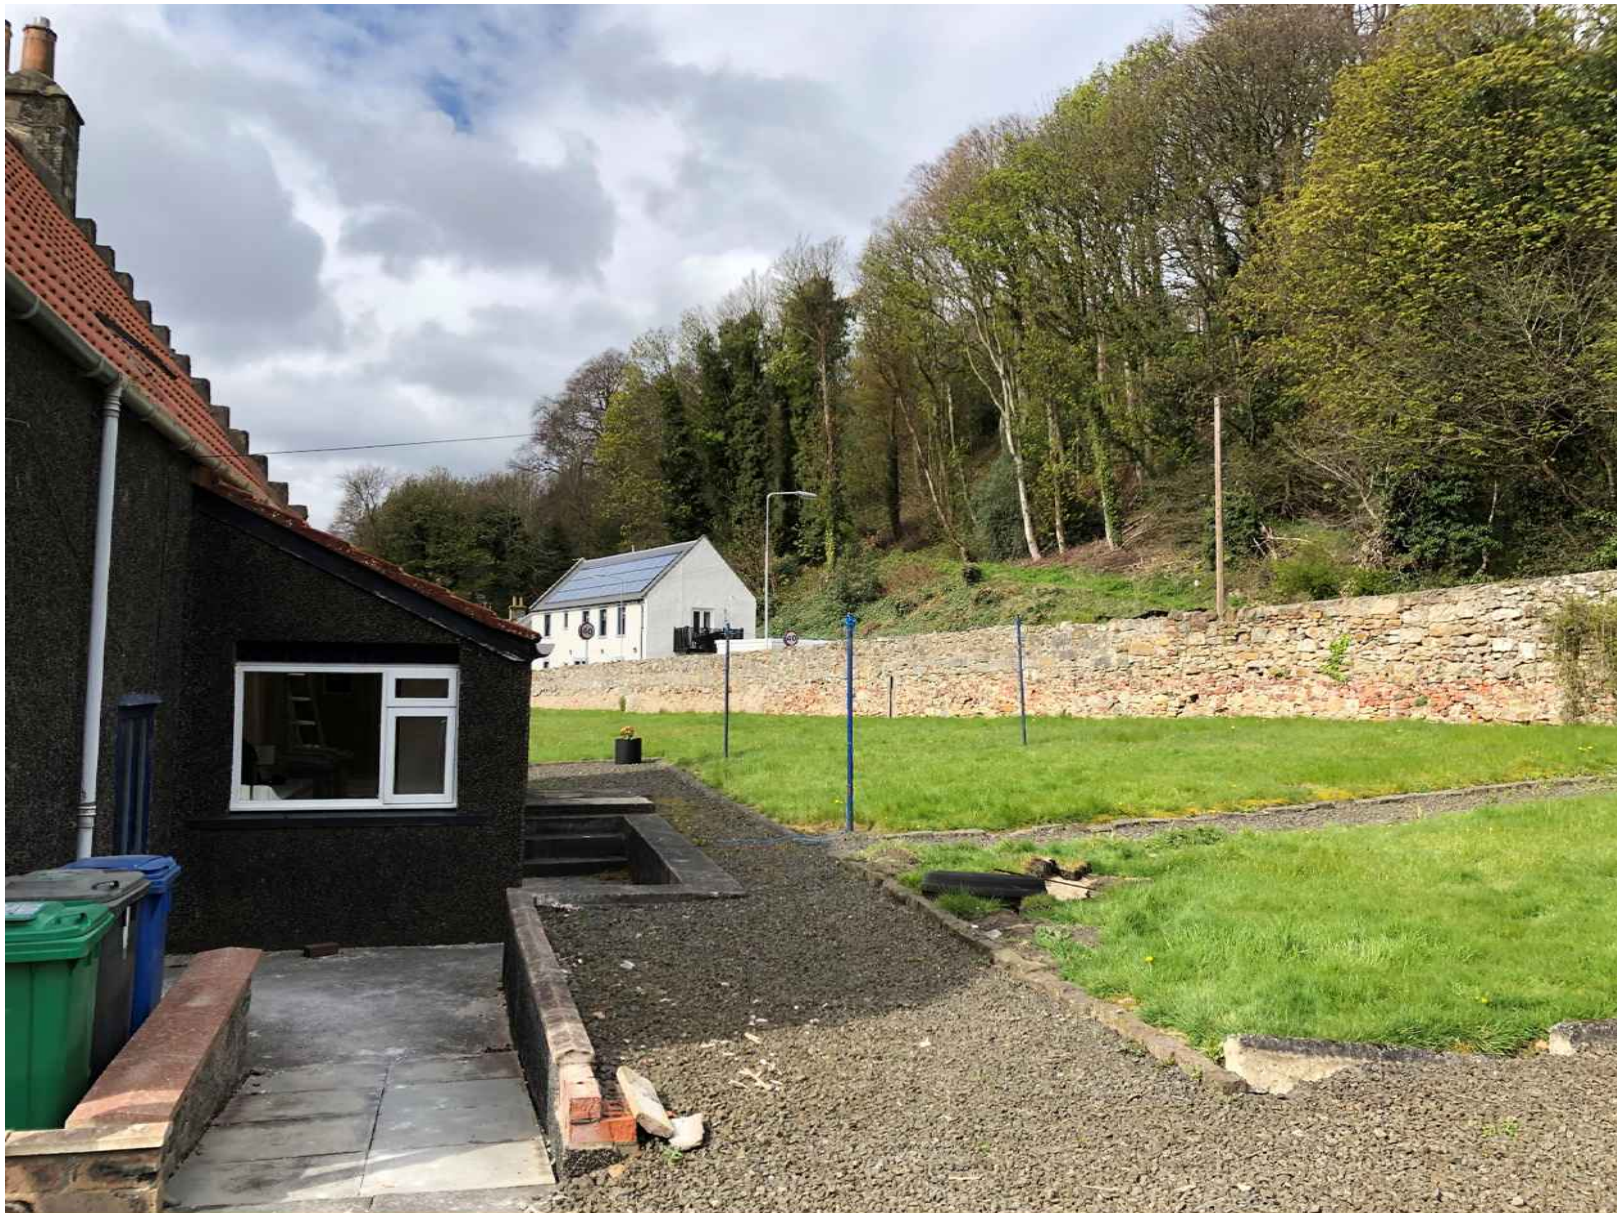
*Figure 5: View of the rear garden looking west to the new property that is located at the junction of Low Causeway and Main Street. This building is a 2 storey building designed with no regard to Westend Cottage or Culross CA which begins approximately 100m to the west*

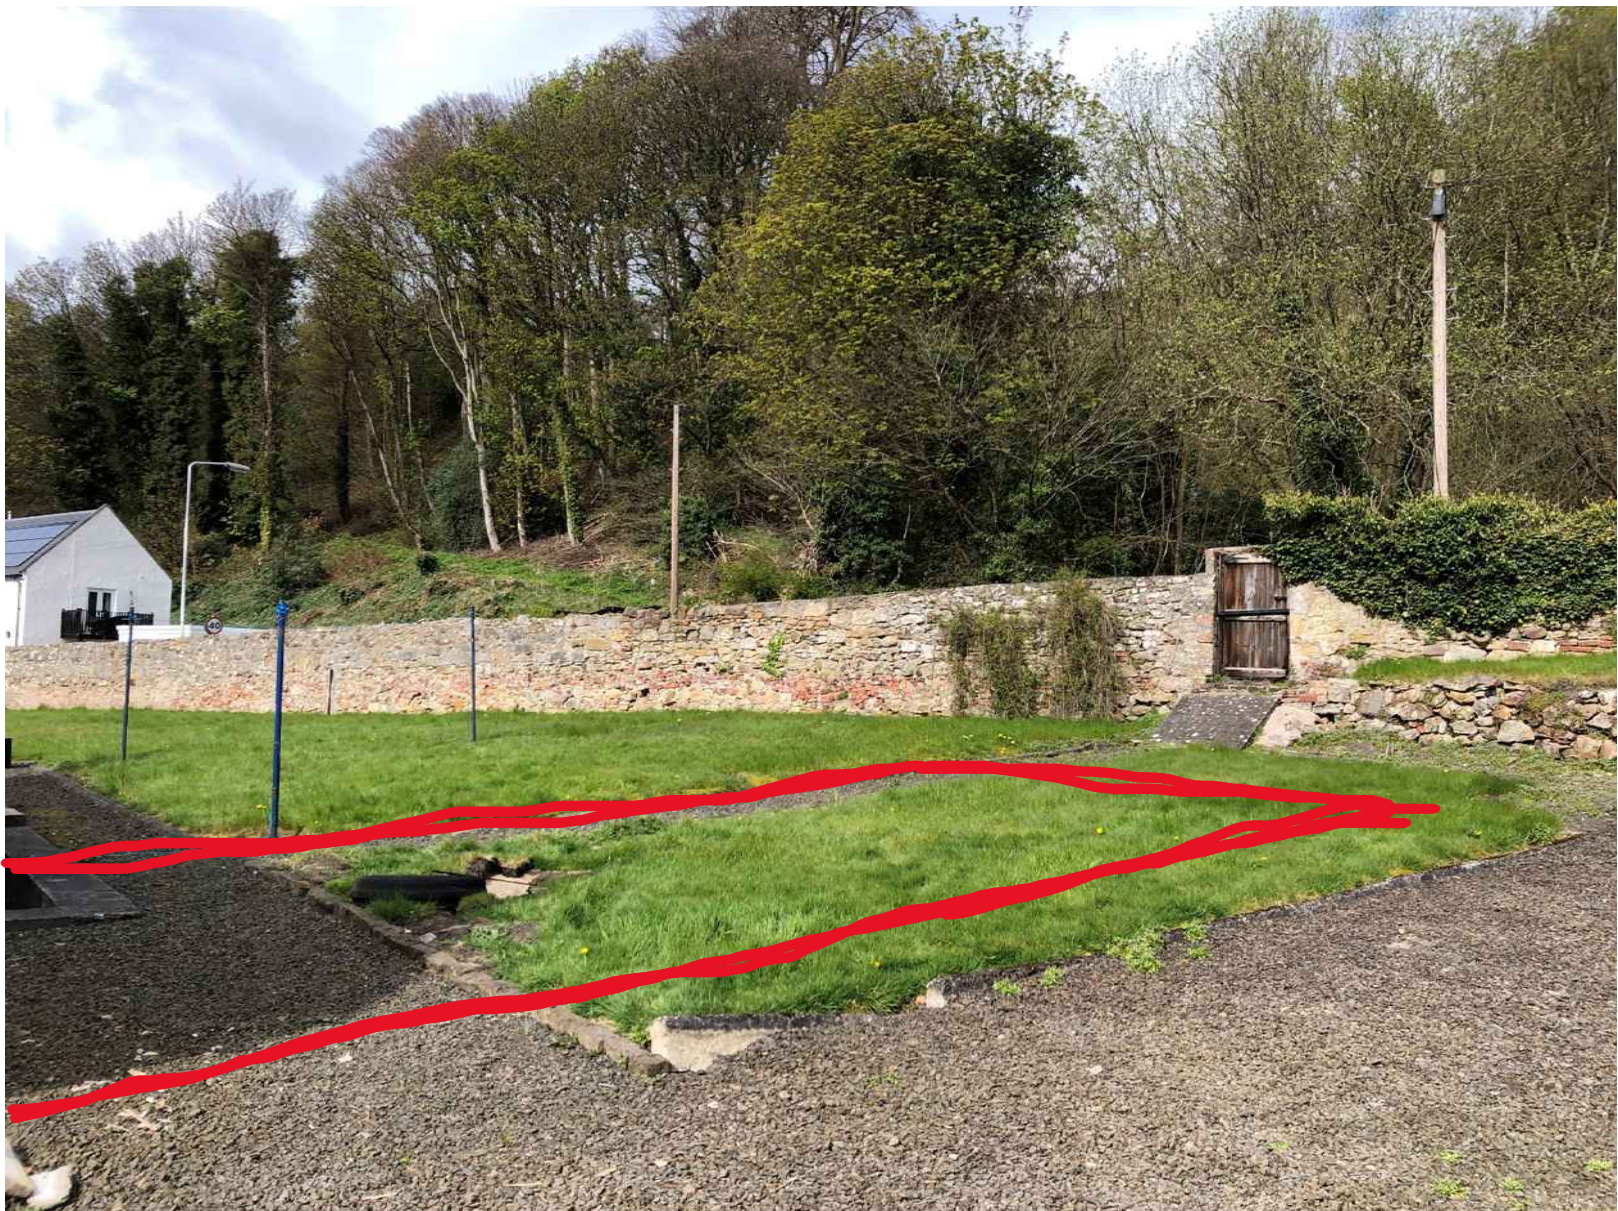
*Figure 6: View of rear garden to the northern boundary wall. The rear extension will be located where the red outline is shown*

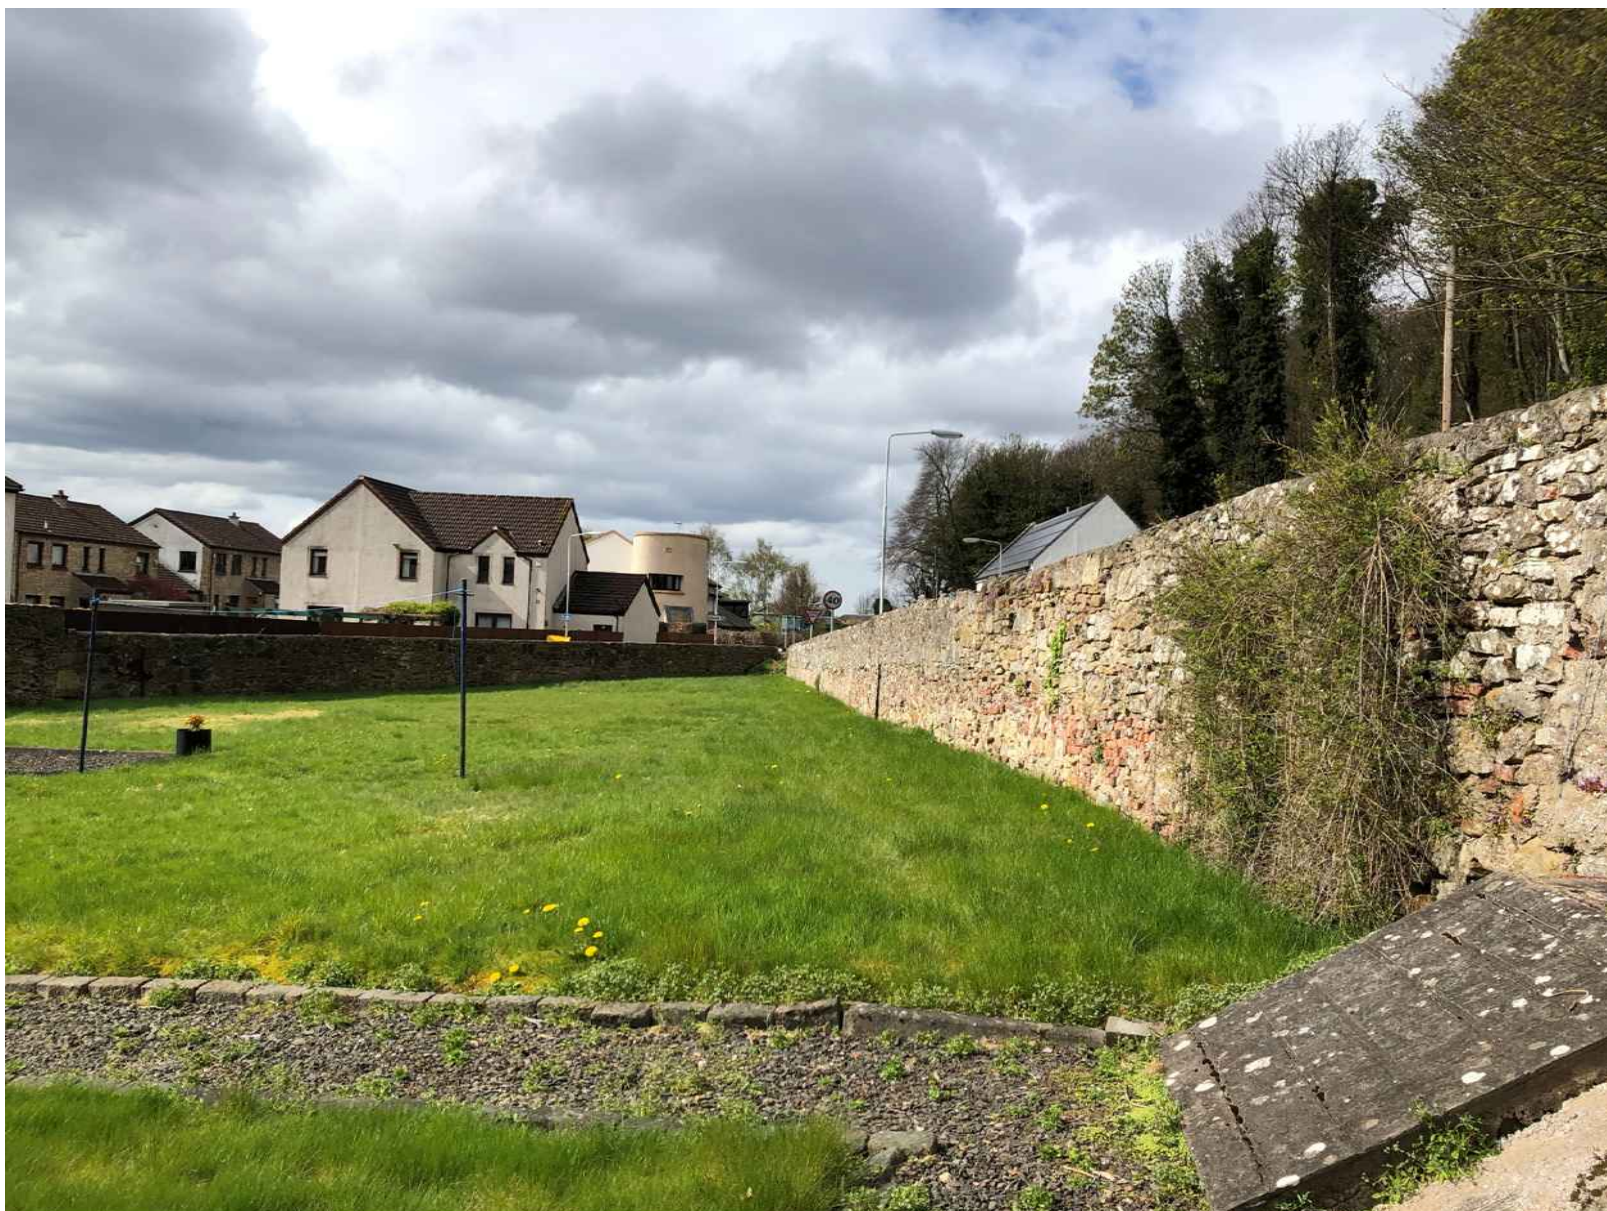
*Figure 7: View looking west from northern boundary of the site showing the impact of the development at Veere Park on the visual amenity of the listed building and the Conservation Area further west*

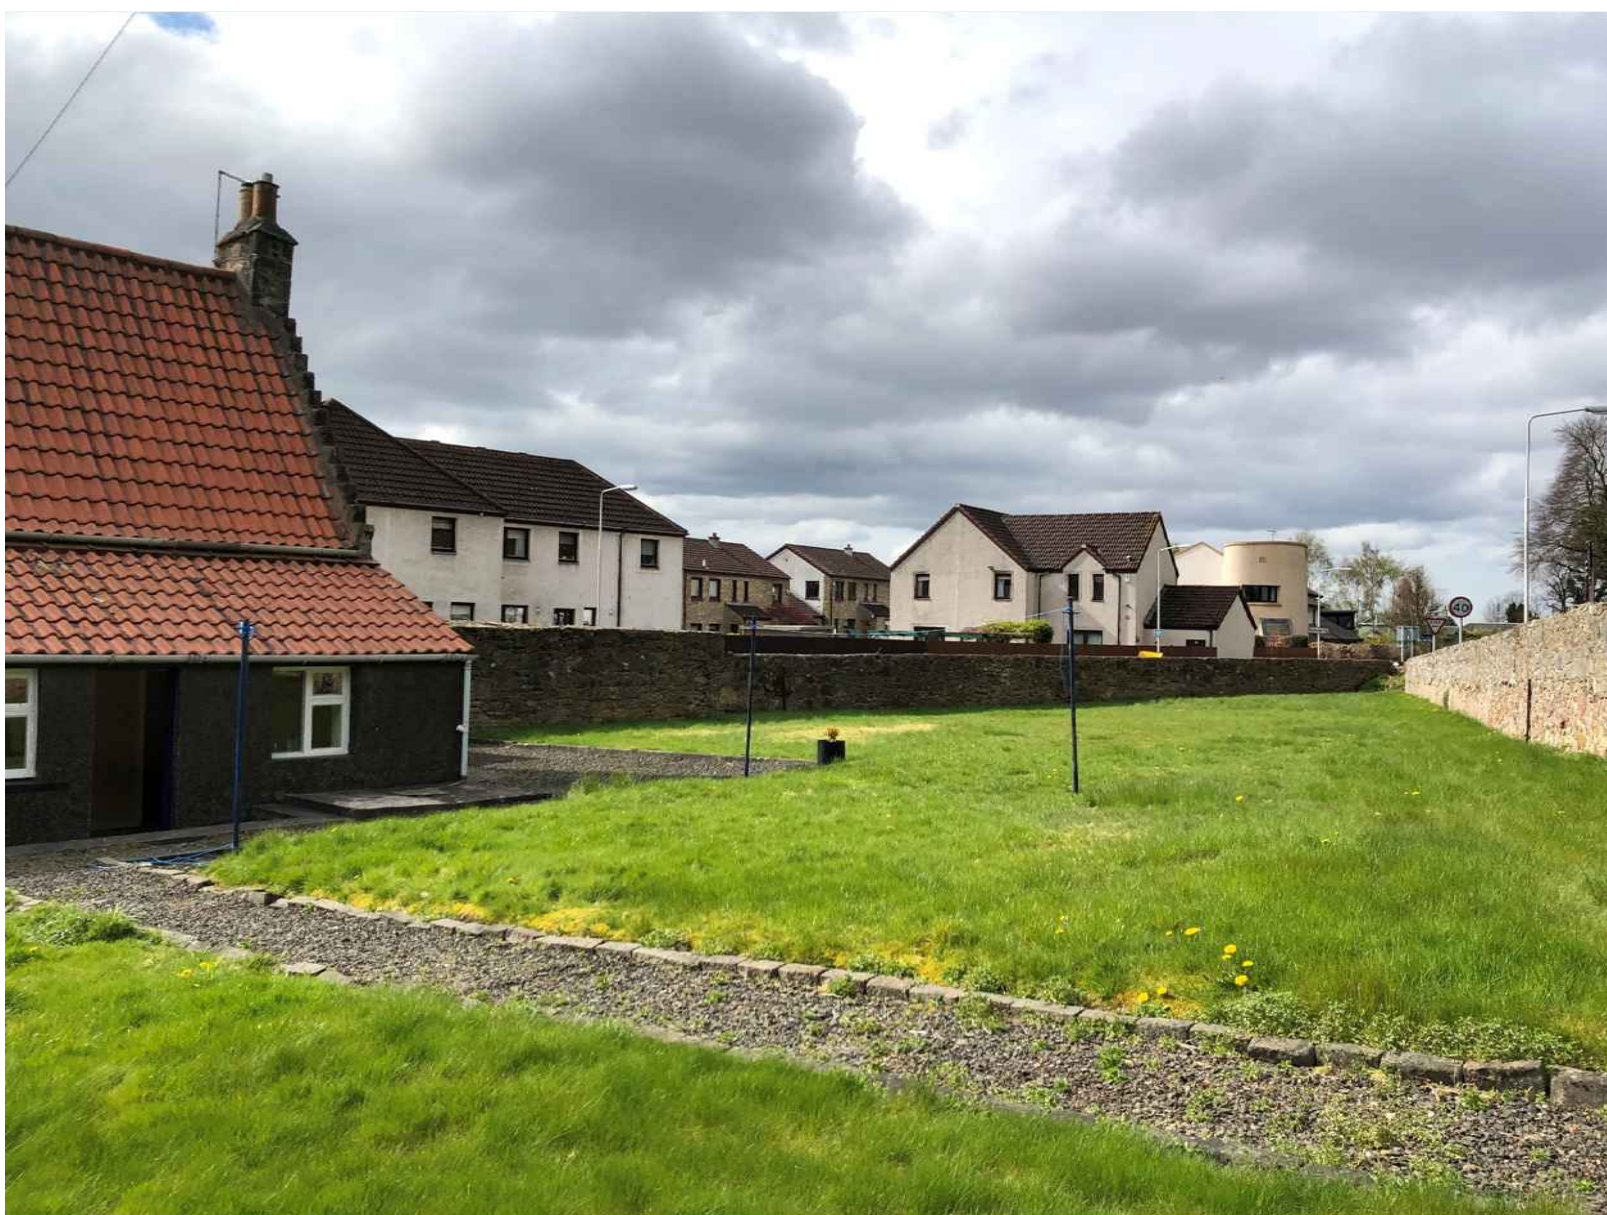
*Figure 8: View looking west from northern boundary of the site showing the impact of the development at Veere Park on the visual amenity of the listed building and the Conservation Area further west*

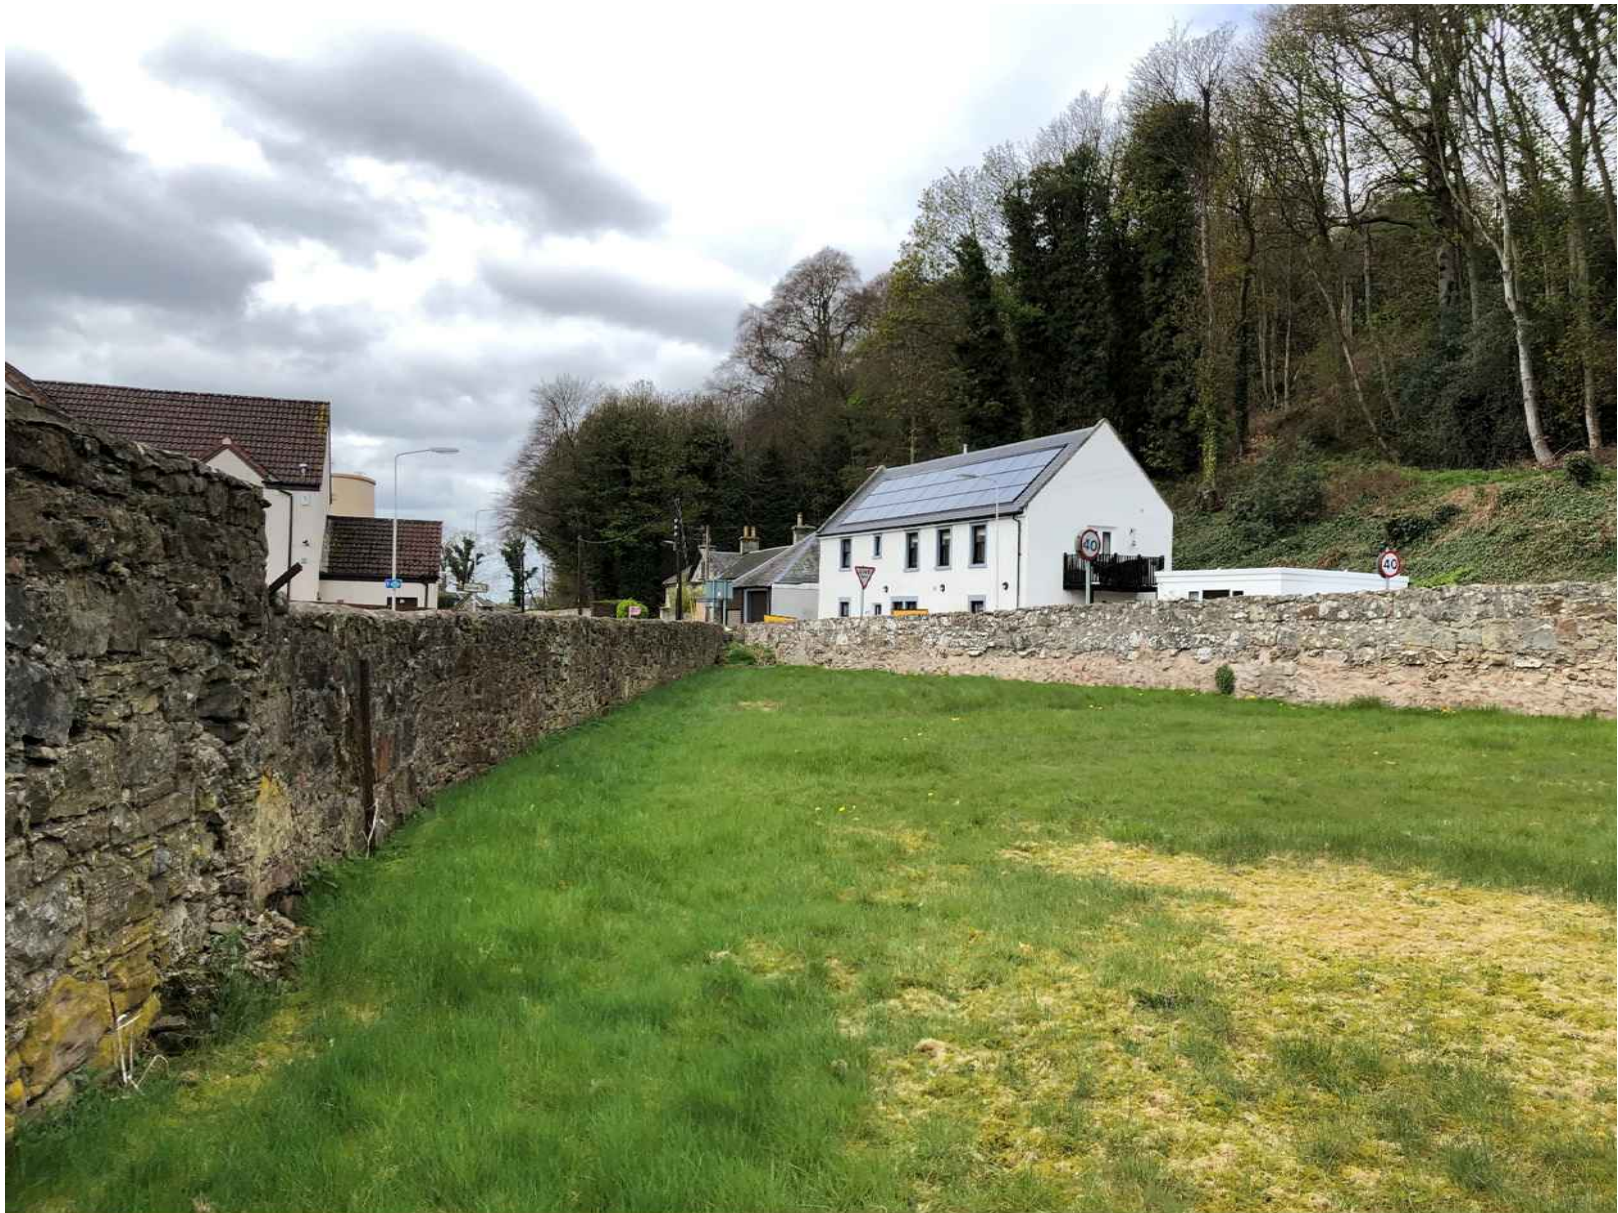
*Figure 12: View looking west from southern boundary of the site showing the impact of the development at Veere Park on the visual amenity of the listed building and the Conservation Area further west and the impact of the new two storey building at the junction of Low Causeway and Main Street to the west of the property. These developments have a far greater impact on the listed building and the Conservation Area than the proposed extensions*

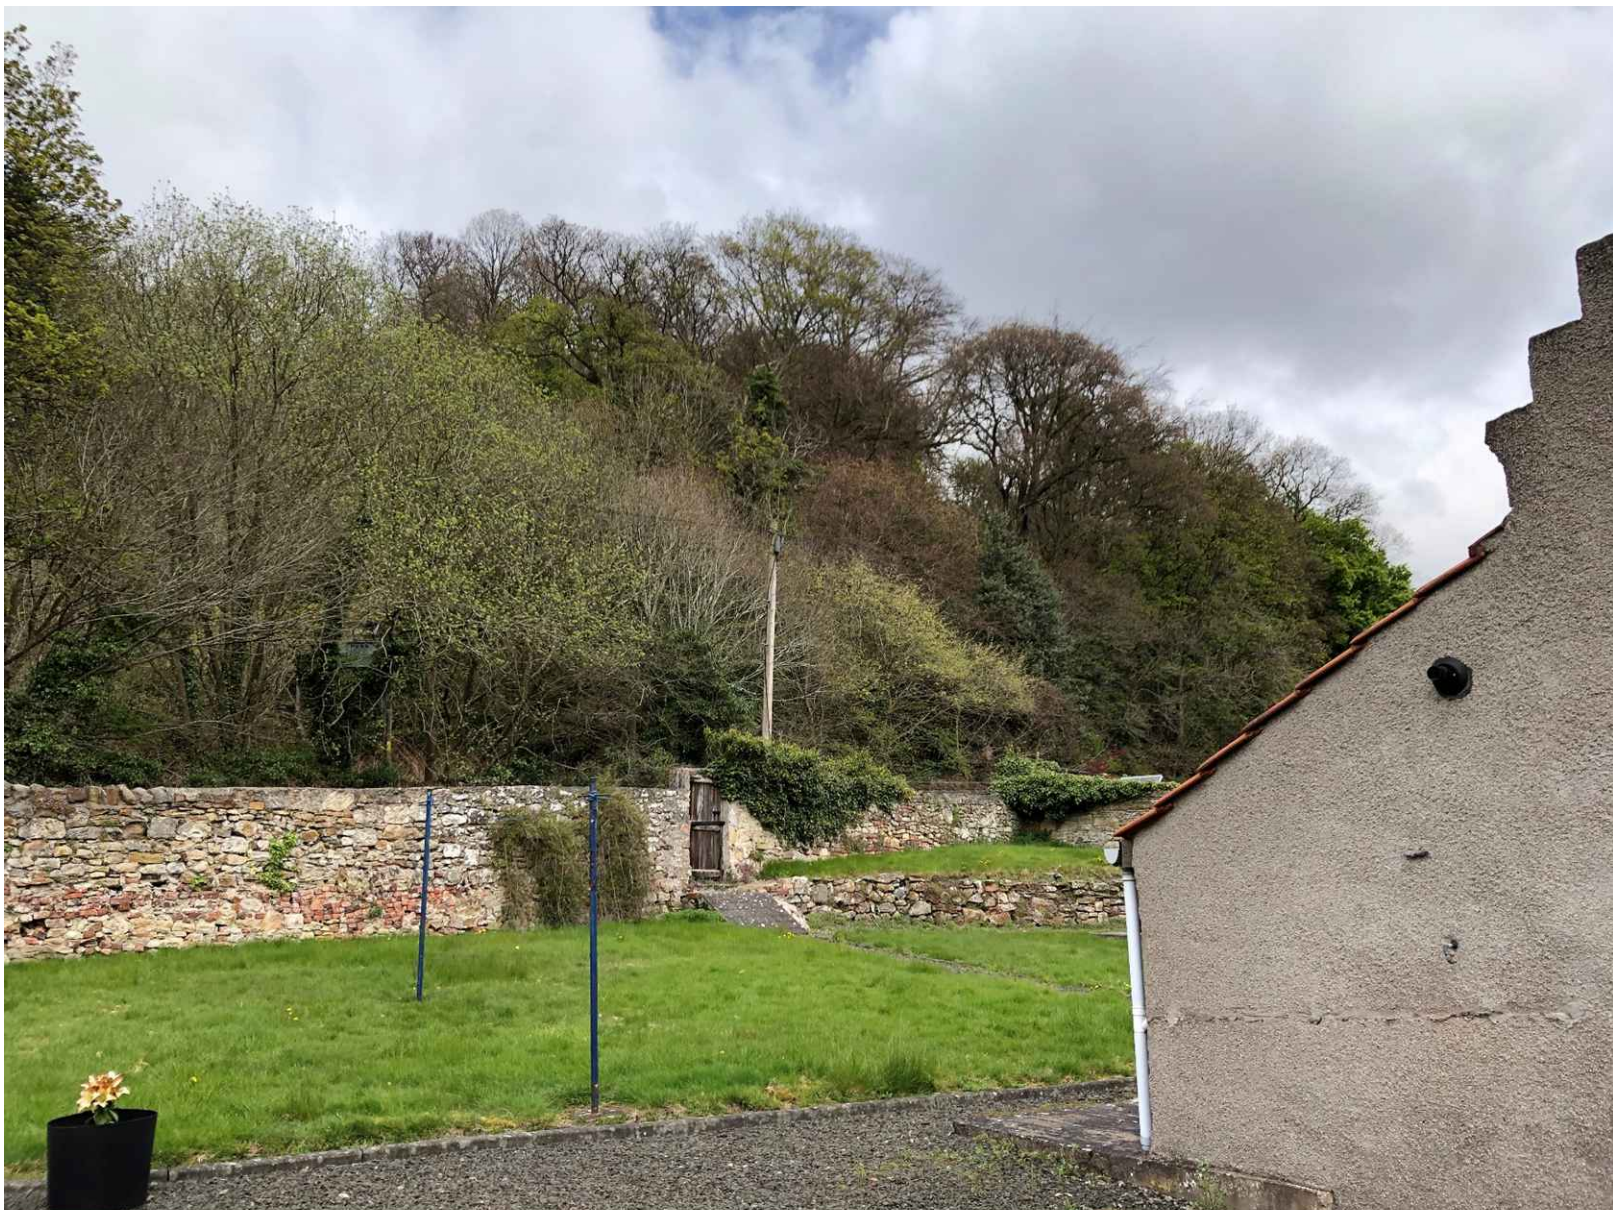
*Figure 11: View of site looking north from south boundary wall showing the late Victorian kitchen extension*

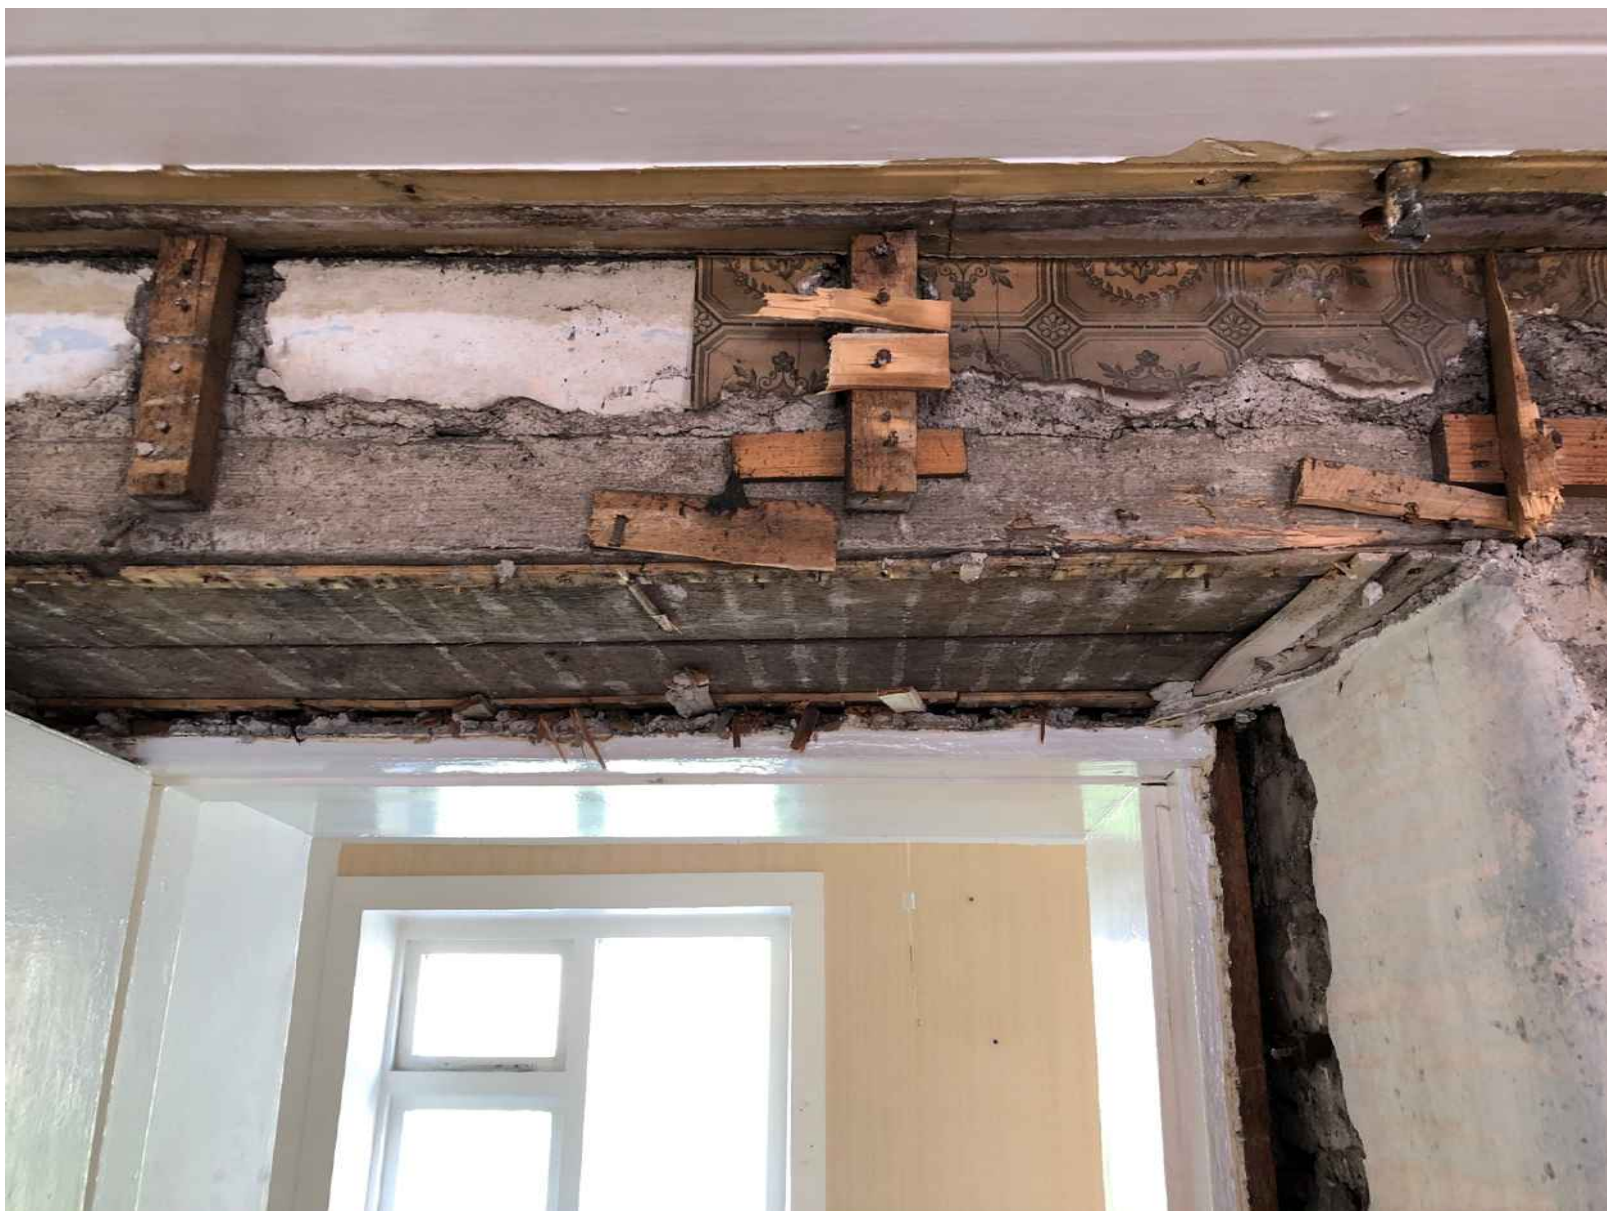
*Figure 13: View of poor changes to the interior of the listed building from the mid-20th century*
