SITE PHOTOGRAPHS AND BUILDING PHOTOGRAPHS POST LBC APPROVAL – 1  
MAIN STREET, LOW VALLEYFIELD ‘WESTEND COTTAGE’.

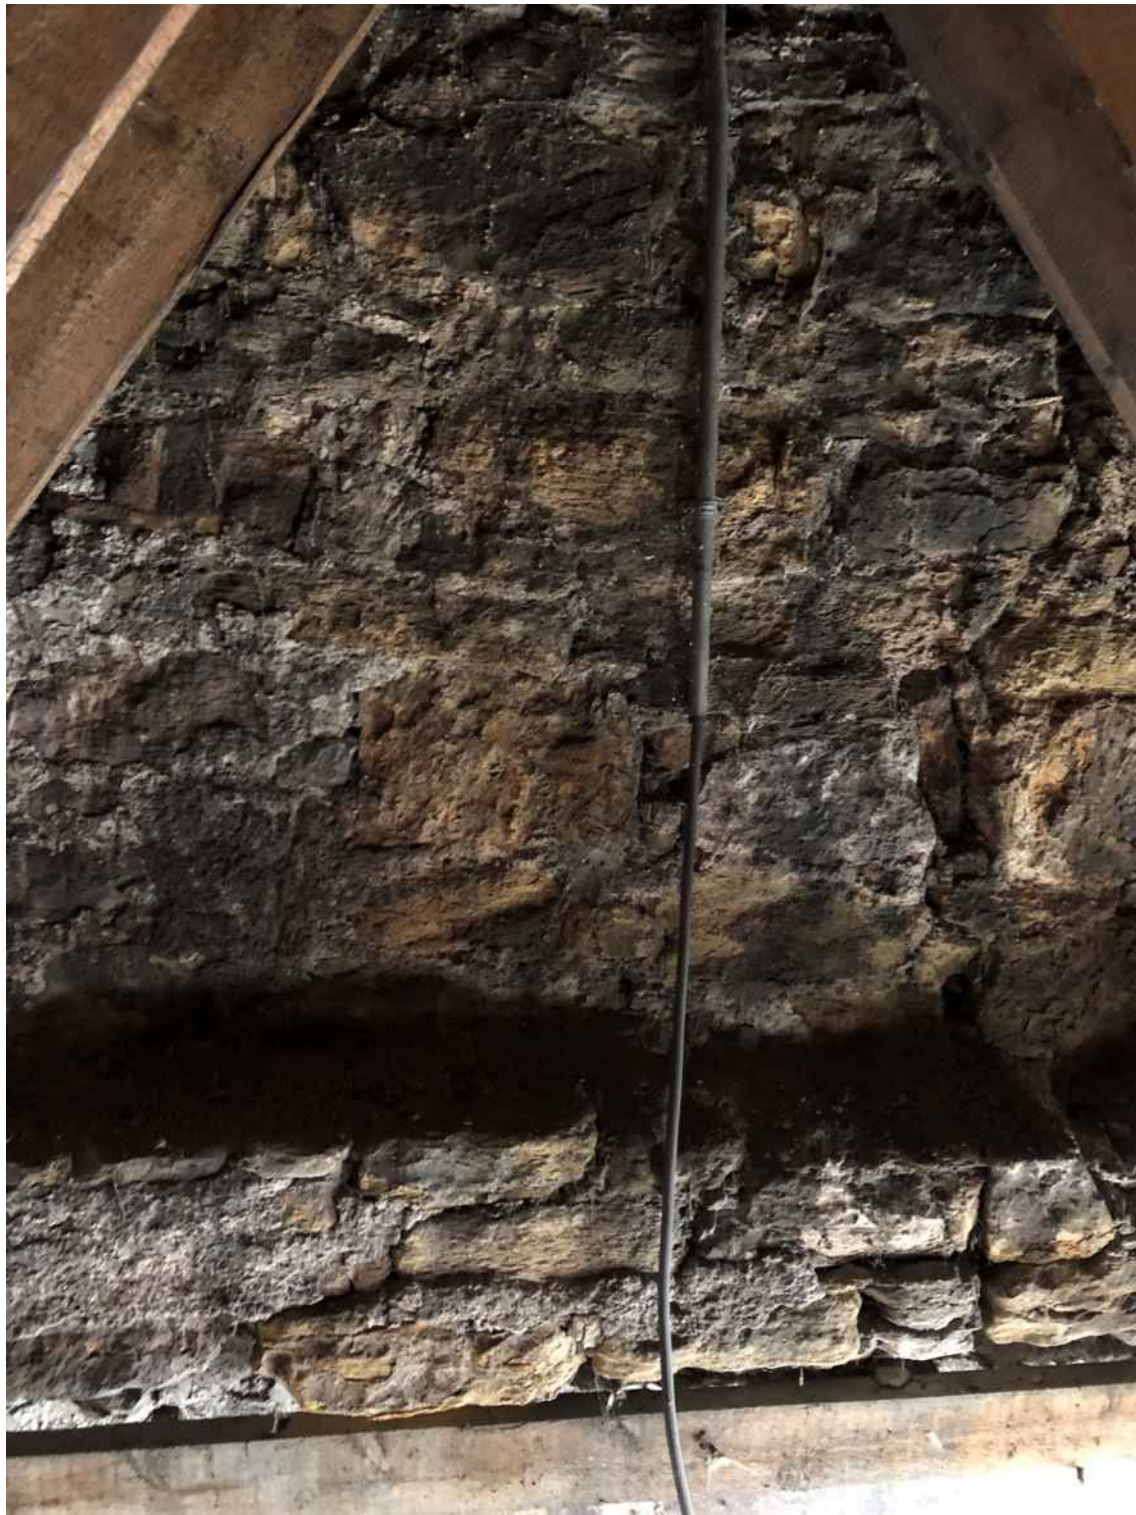
*Figure 17: Eastern gable wall showing thickening of wall at the base of the rake to allow for the original roof structure above, removed in the 1960's and replaced again in the 1980's*
