Pratts Green Farmhouse, Kirtling

As instructed, we met at the property with Alan Smith of Snell David Architects on 9 November 2021. The purpose of our visit was to visually inspect the structure of the property and in particular the cracking adjacent to the area of earlier underpinning.

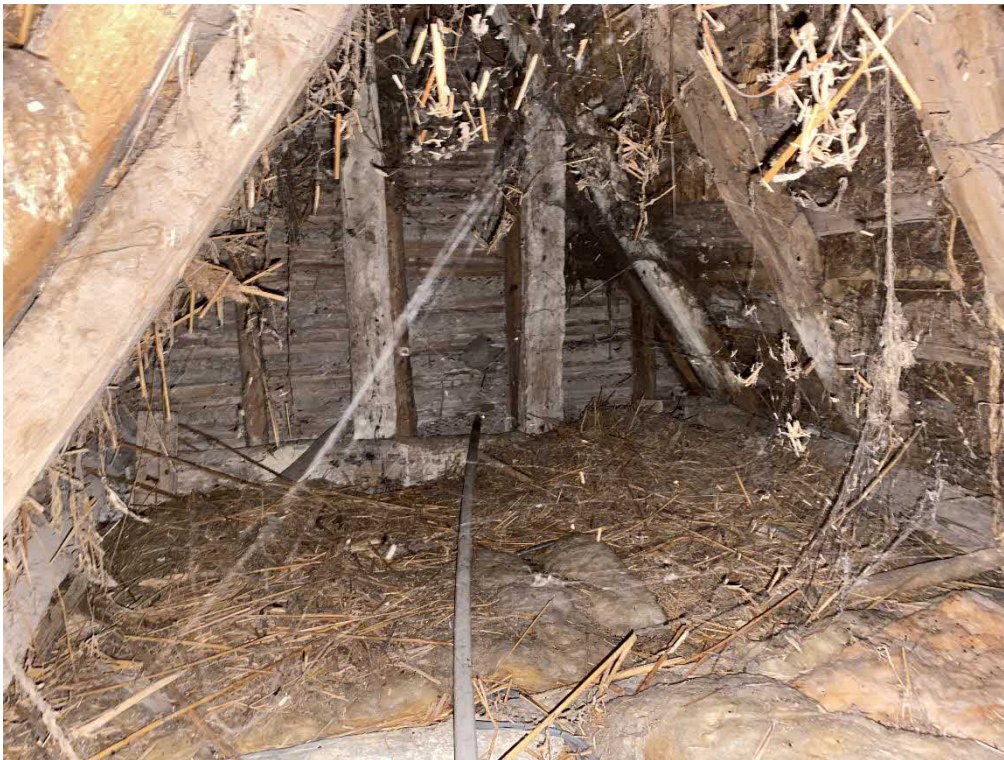
Photograph 14

An inspection within the roof space was difficult due to the fragile nature of the ceiling joists and lack of access to the roof above the original wing of the cottage. It is apparent that the roof structure is relatively weak, but again typical for this type and age of construction (refer to Photographs 12, 13 and 14). There appears to have been insect damage to the original roof and additional rafters have been added (refer to Photograph 15). From our inspection it is apparent that further opening up to gain access to the roof structure will be required and it is anticipated that it will be necessary to undertake roof strengthening works.
