DESIGN, ACCESS AND HERITAGE STATEMENT

ADDRESS: Yew Cottage, Station Road, Eynsford, Kent DA4 0ER

PROPOSED WORKS: Replacement of 2 dormer windows, repair works to dormer, plus repair and refurbishment works to smaller side window and rear ground floor window.

Condition Report & Specification of Works

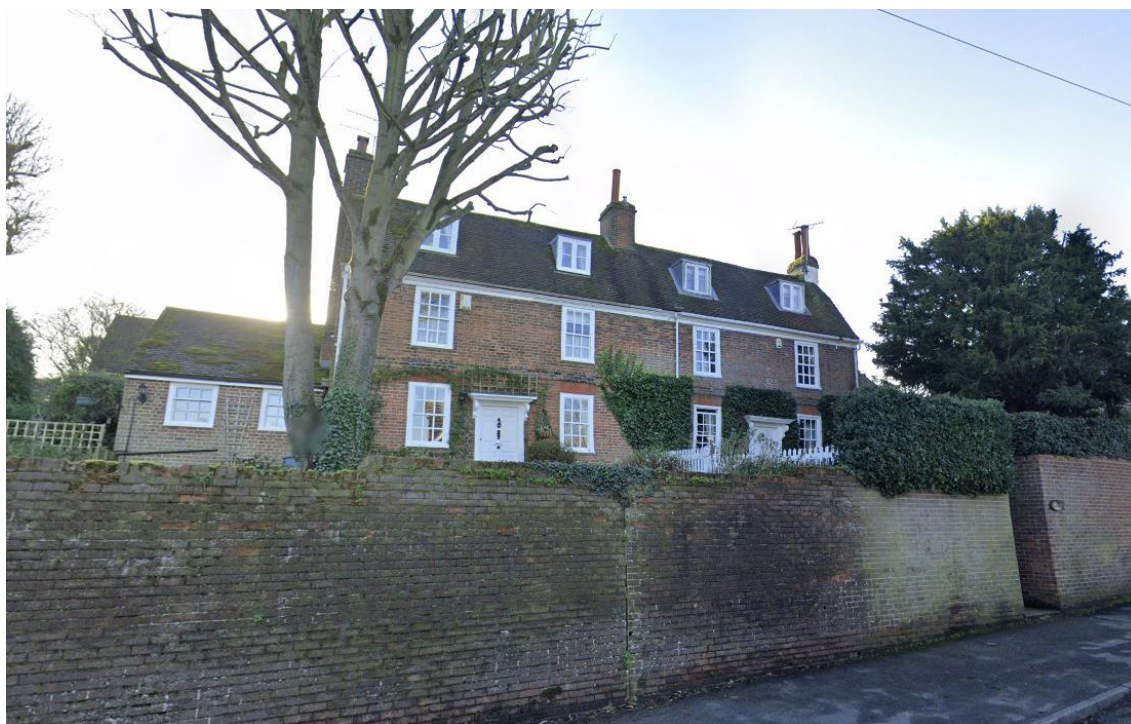
Yew Tree Cottage & Yew Cottage (Application Site)

The dormer windows are visible on the street scene. Considering the asset as a whole, as the listing includes both properties, it should be noted that dormer windows to the neighbouring Yew Tree Cottage feature a heavier frame compared to the application property. Along with refurbishment works which were carried out to the application property in the 1960s, it can be considered that the dormer windows to the building are not entirely original and this has had some impact on the significance of the asset.
