Our Ref: B25239-JNP-XX-XX-RP-S-0001 Chkd: VW

Re: Bell Farm Avenue

The purpose of this report is to inspect and report on the existing structural arrangement, size of members and any visual defects. It also includes the findings from the CCTV survey and the Damp and Timber survey which can be found in the appendices.

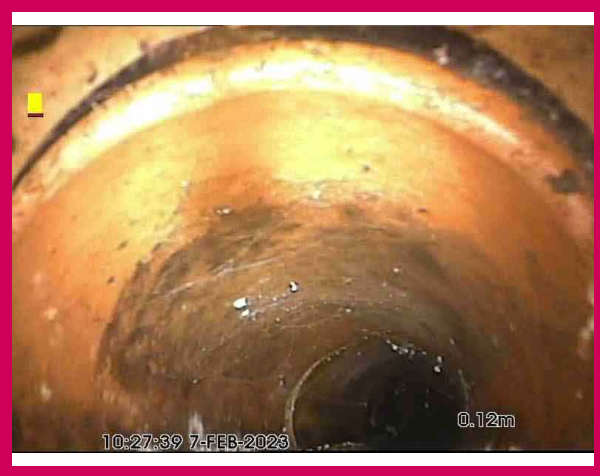
Section Pictures - 07/02/2023 - LINE BX

1, 00:00:05, 0.14 m
Joint displaced, medium

Section 9. MH07- LINE B. Dia-150mm. Defect- JDM at 0.14m. Repair- 1x 600 CIPP Liner.

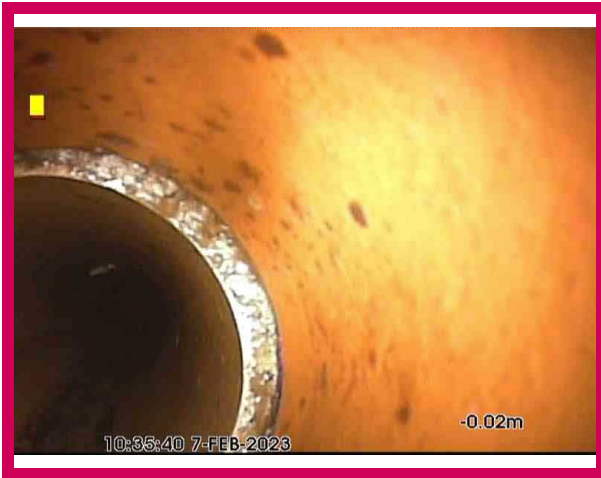
Section Pictures - 07/02/2023 - LINE AX

1, 00:00:03, 0.10 m
Joint displaced, medium

Section 11. MH05- LINE A. Dia-100mm. Defect- JDM at 0.10m & crack at 1.24m. Repair- 2x 600 CIPP Liner.

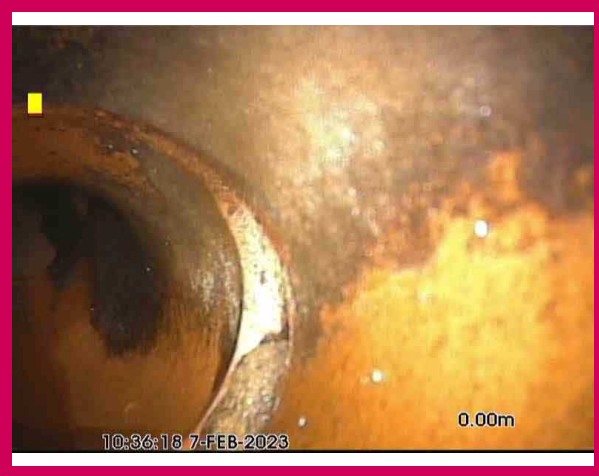
Section Pictures - 07/02/2023 - LINE BX

1, 00:00:03, 0.20 m
Joint displaced, medium

Section 12. MH05- LINE B. Dia-100mm. Defect- JDM at 0.20m. Repair- 1x 600 CIPP Liner.

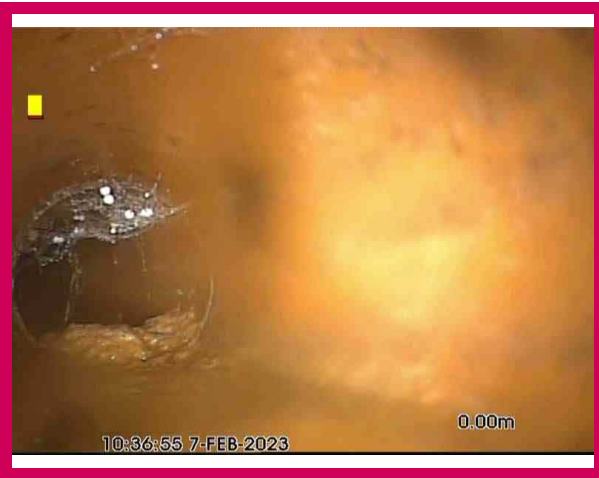
Section Pictures - 07/02/2023 - LINE CX

1, 00:00:05, 0.30 m
Attached deposits, fouling from 4 o'clock to 7 o'clock, 10% cross-sectional area loss

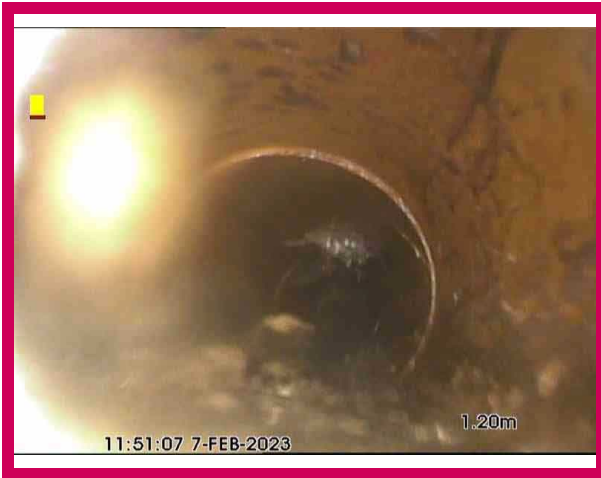
Section Pictures - 07/02/2023 - MH12X

1, 00:00:05, 1.27 m
Attached deposits, encrustation from 3 o'clock to 7 o'clock,
10% cross-sectional area loss, start

Section 22. MH12- LINE X. Survey abandoned at 4.75m due to settled deposits. Repair- Clean & Resurvey.

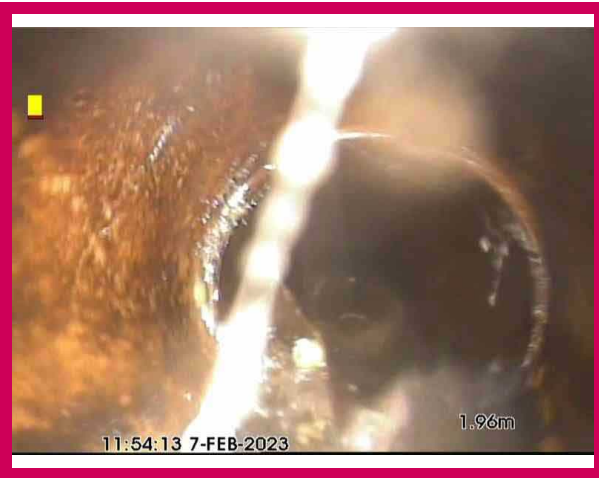
Section Pictures - 07/02/2023 - LINE BX

1, 00:00:11, 0.00 m
Attached deposits, fouling from 3 o'clock to 8 o'clock, 15%
cross-sectional area loss, start

Section 23. MH11- LINE B. Survey abandoned at 3.60m due to settled deposits. Repair- Clean & Resurvey.

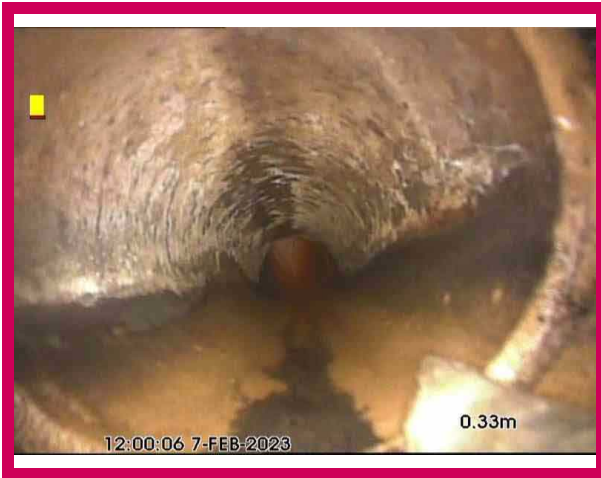
Section Pictures - 07/02/2023 - LINE BX

1, 00:00:06, 0.33 m
Joint displaced, medium

Section 26. MH13- LINE B. Dia-100mm. Defect- JDM at 0.33m. Repair- 1x 600 CIPP Liner.
