Countryside Consultants
Architects & Planners

The Shambles, Hexham

Column Condition Survey N1 - N2 - N3

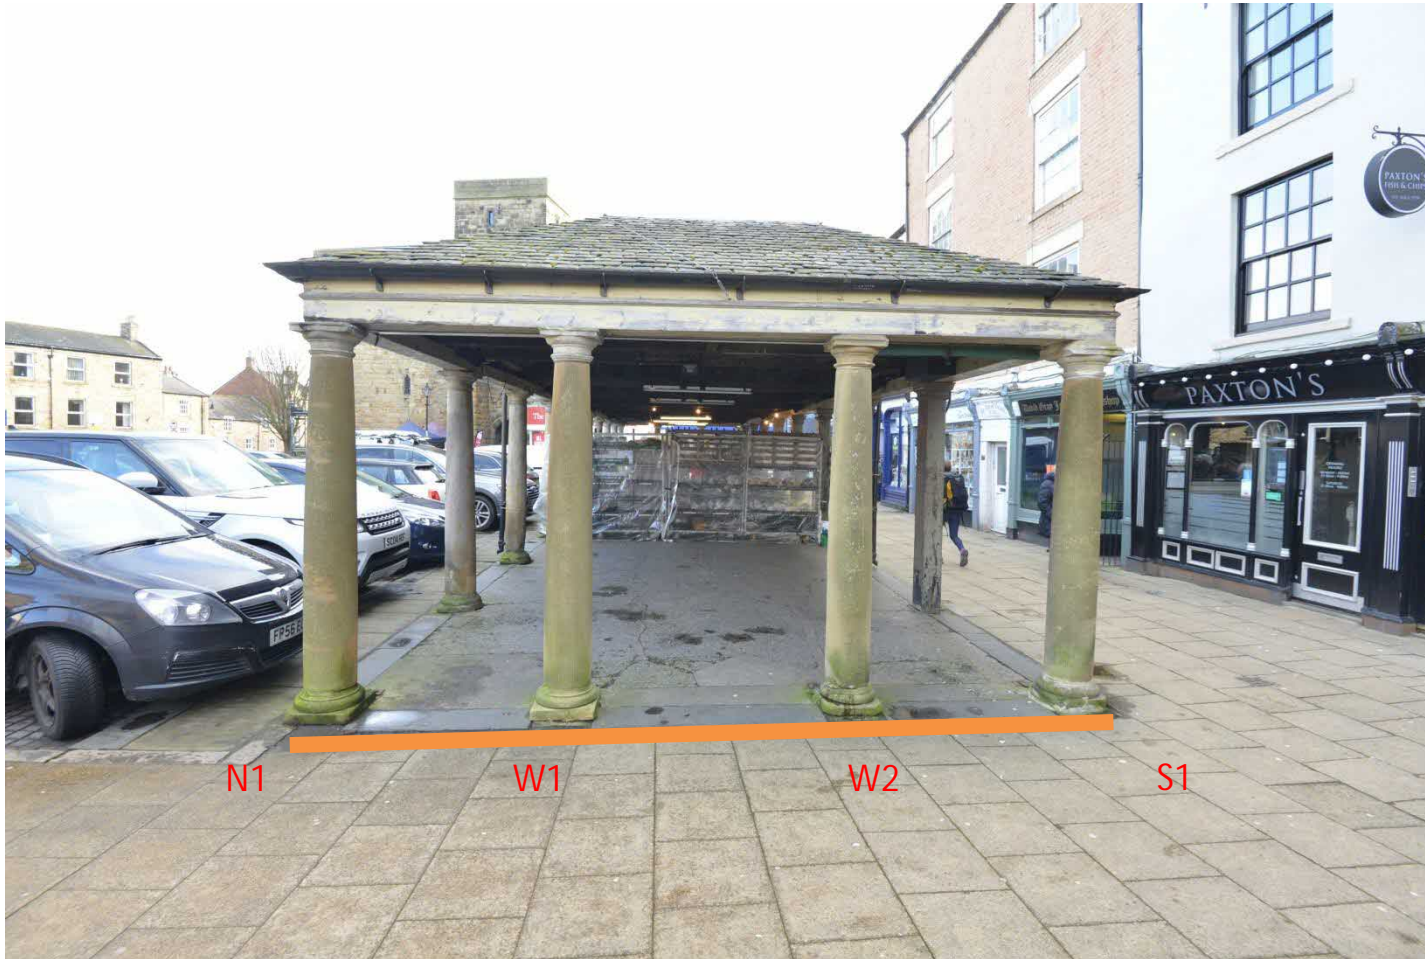
Figure 1

Lead work flat ridge

Green slate roof with mitred hops

Cast iron ogee gutters

Timber fascia

Sandstone columns

Basalt curbs

Insert drainage channel
along edge of kerb.

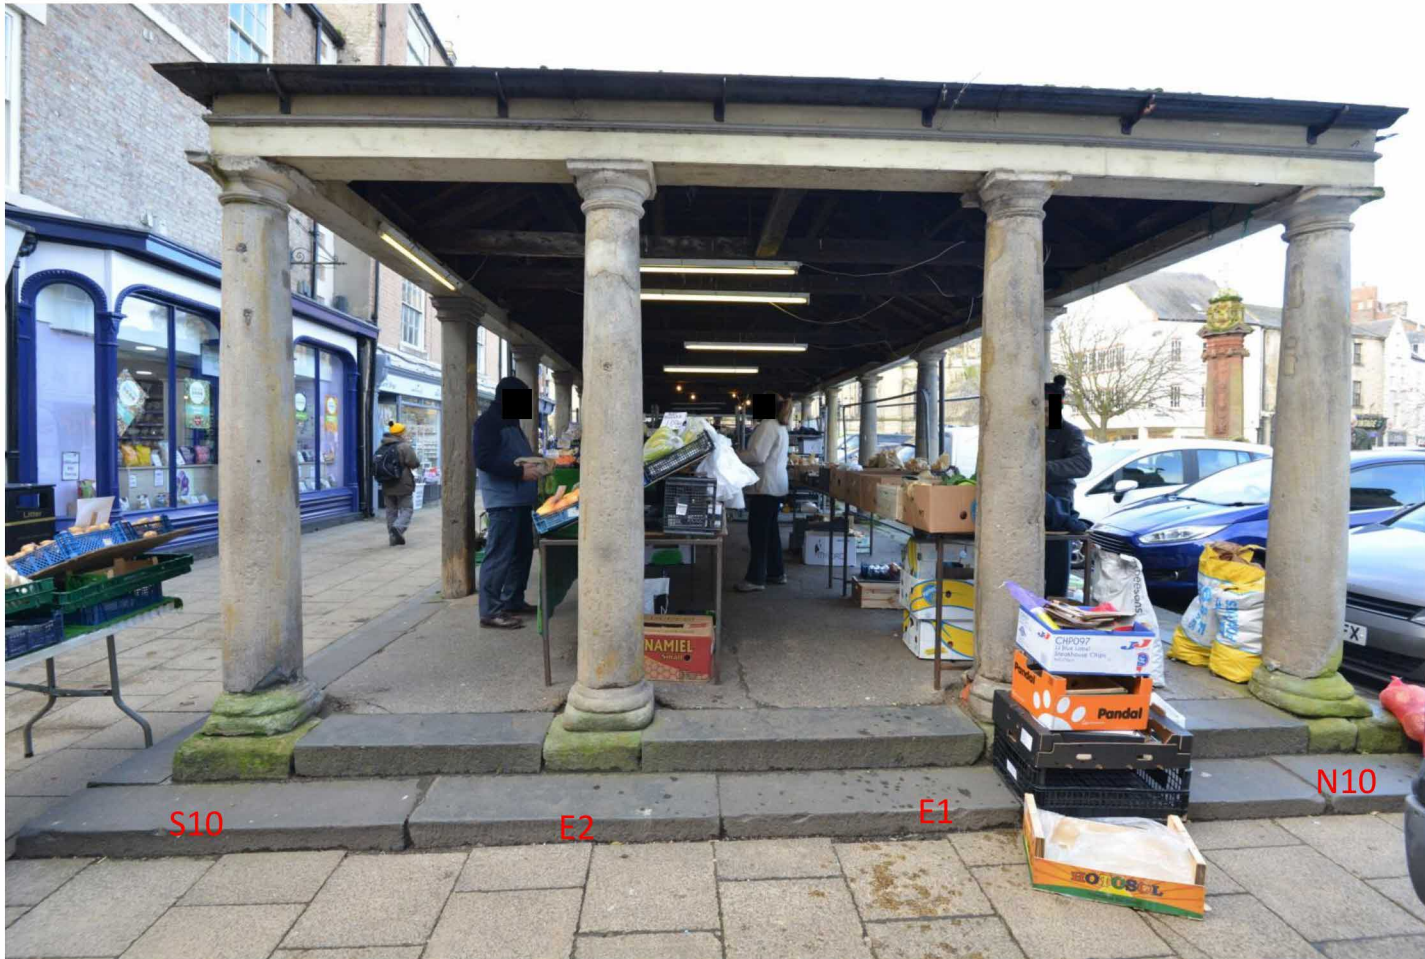
Figure 2

Lead work with flat ridge

Green slate roof with
mitred hips

Cast iron ogee gutters

Timber fascia

Sandstone columns

Basalt curbs
