ASHLEY LARGENT ASSOCIATES
BUILDING DESIGN AND CONSULTING ENGINEERS

Our Ref: **H059/AL/01**

Date: **1st Nov 2022**

Proposed Alterations & Extensions to 23 & 24 Park Cottages Church Road, Tattingstone - Structural Considerations

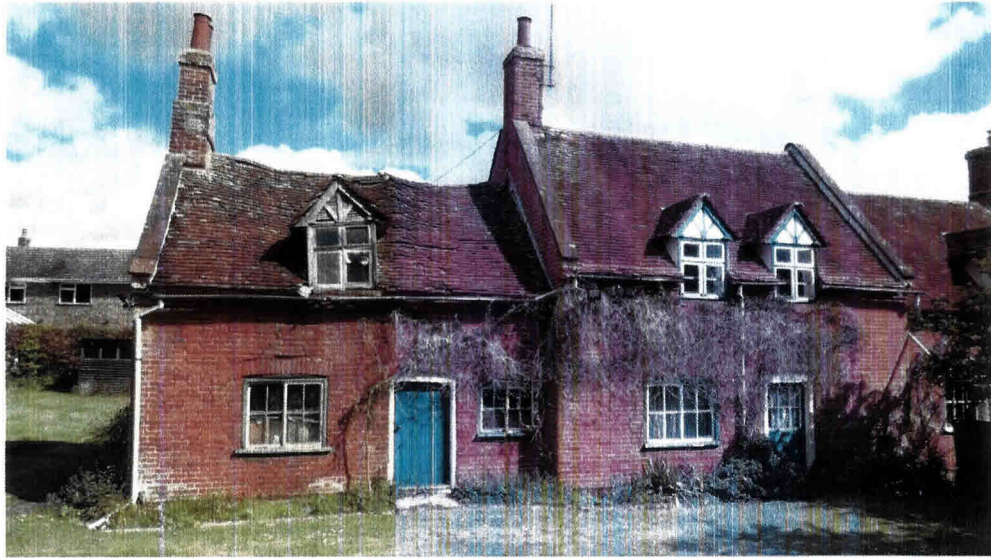
It was quite apparent that no 24, the derelict and smaller of the two cottages, was suffering with significant structural failure, by the undulating roof line and *bulging* external masonry walls. The roof tiles had been stripped, the roof framework covered with tarpaulin, and a temporary scaffolding support had been installed around the property to prevent further structural deflections.

View from South/Front

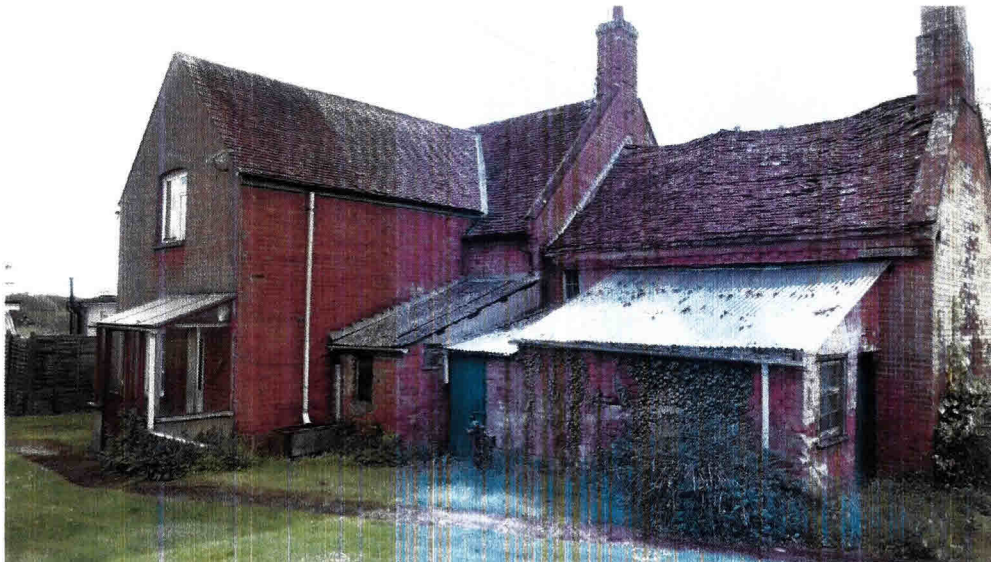
View from North/Rear
