Arboricultural Method Statement, Impact Assessment and Tree Protection Plan in Accordance with BS 5837:2012

38 PARKWOOD ROAD, BEXLEY, KENT, DA5 3NW

SouthOaks Arboricultural Consultancy

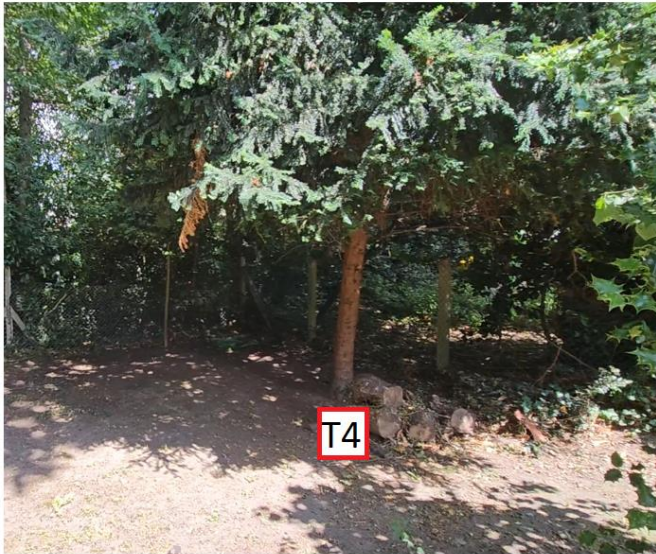
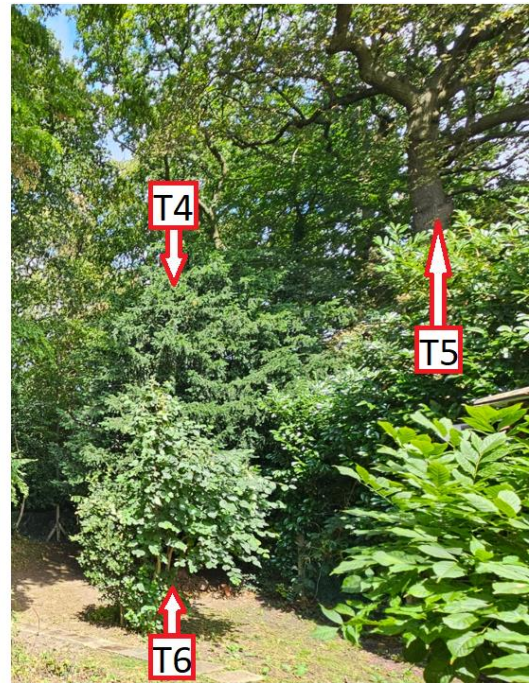
If necessary any small trees with a diameter of below 75mm diameter may be felled to accommodate for the proposed development and improve site access. T4 and T6 have been selected for removal to accommodate the proposed design. T6 is an unremarkable tree of very limited merit. T4 can only be seen from within the garden of the property and is currently suppressed by the neighbouring Oak tree (T5) and its growth will be significantly impacted over time owing to its position near to this tree. Any loss of trees will be mitigated through replacement planting in an alternative location.

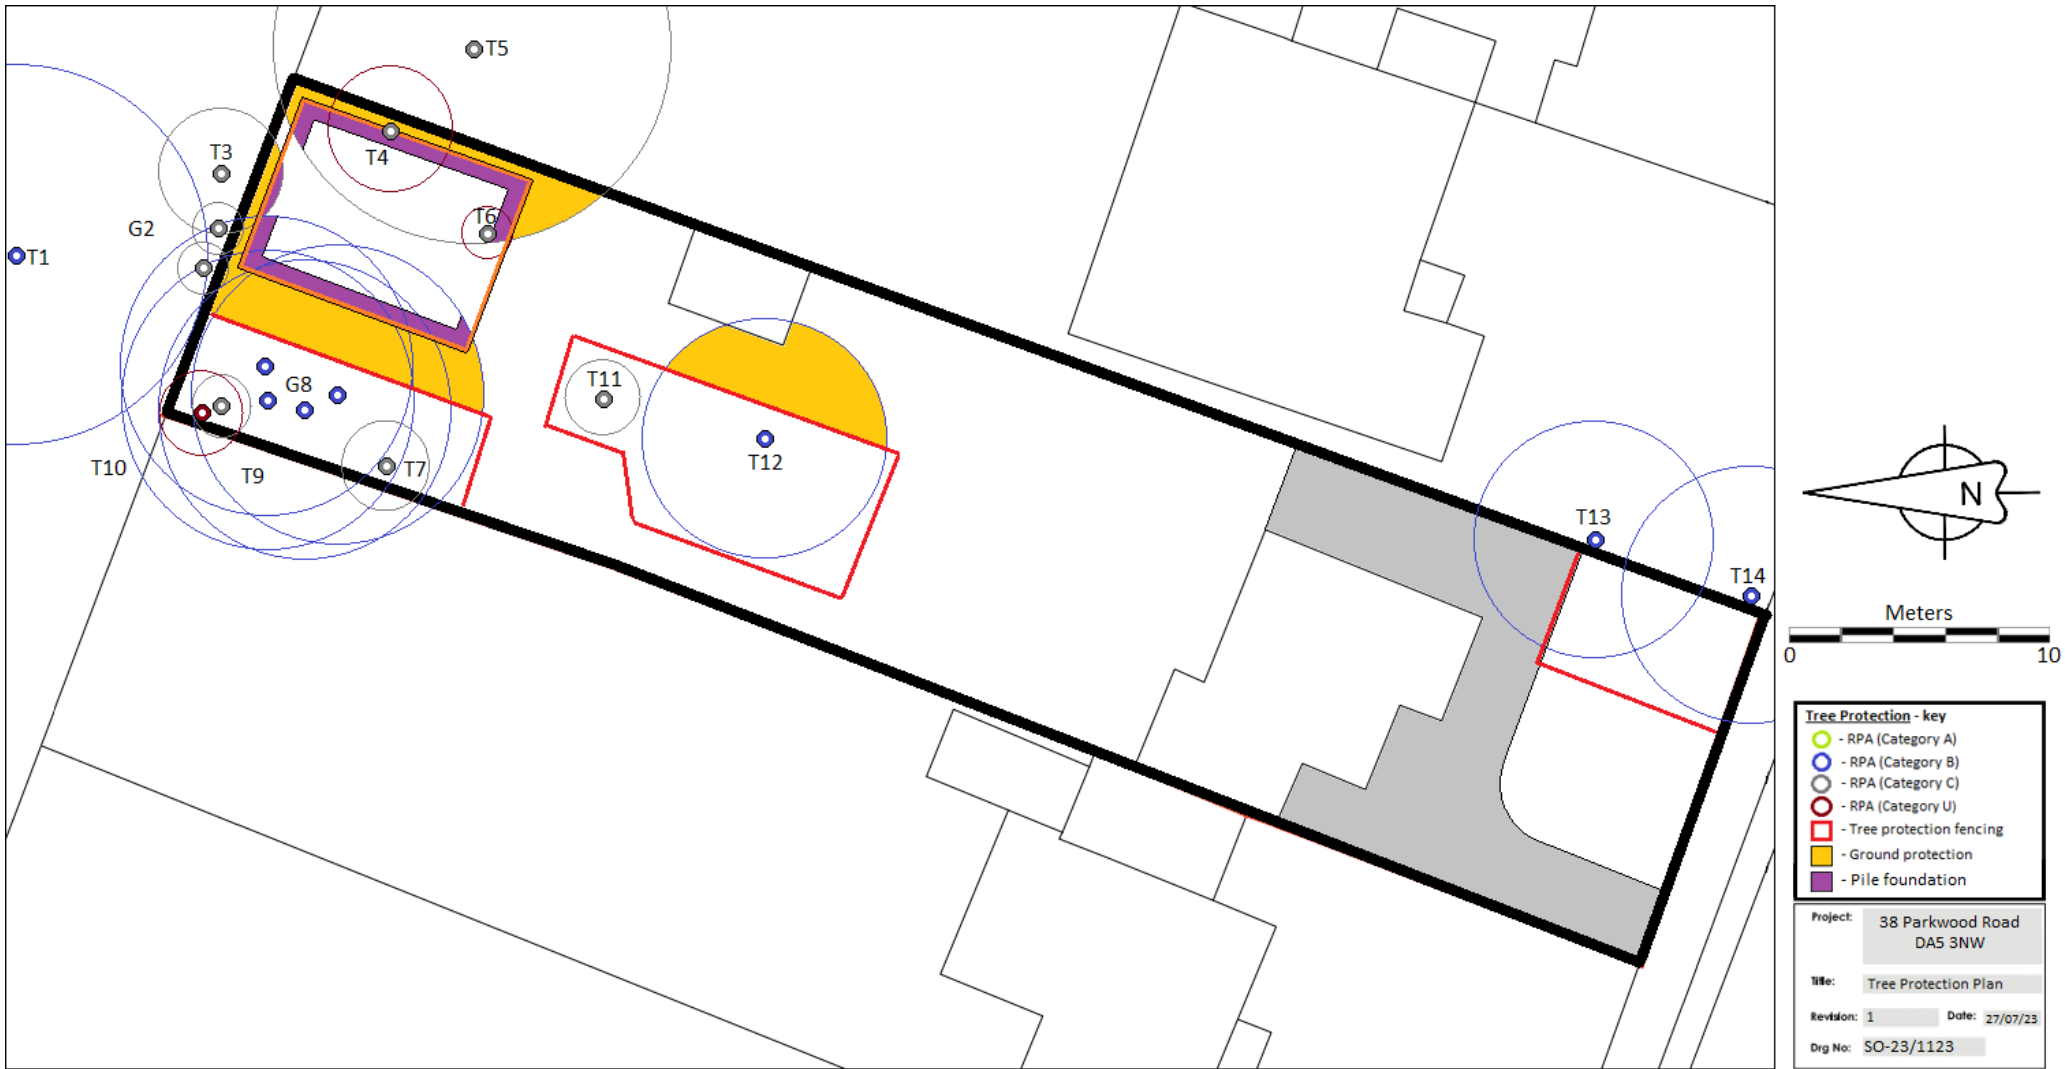
The proposed development falls within the unsurfaced RPA of three retained trees. Specialist construction techniques must be implemented to avoid potential root damage to the trees. To reduce the impact upon the trees an above ground beam resting on screw piles must be used, this must be completed under supervision of an arboricultural consultant. A method statement has been included within this report to outline best practice in regard this. To further guard the trees protection fencing and ground protection must be installed around the perimeter of the RPA's as indicated in the Tree Protection Plan.
