Cheynes Farm, Warren Lane, Cottered, Herts. SG9 9QD.
Historic building recording and analysis of the buildings. Recorded 09 11 2022.

This report describes and analyses the historic fabric and records of the buildings under study. This report adheres to Historic England Level 3 as outlined in Historic England. Understanding Historic Buildings – A guide to good recording practice. 2017. Page 25.

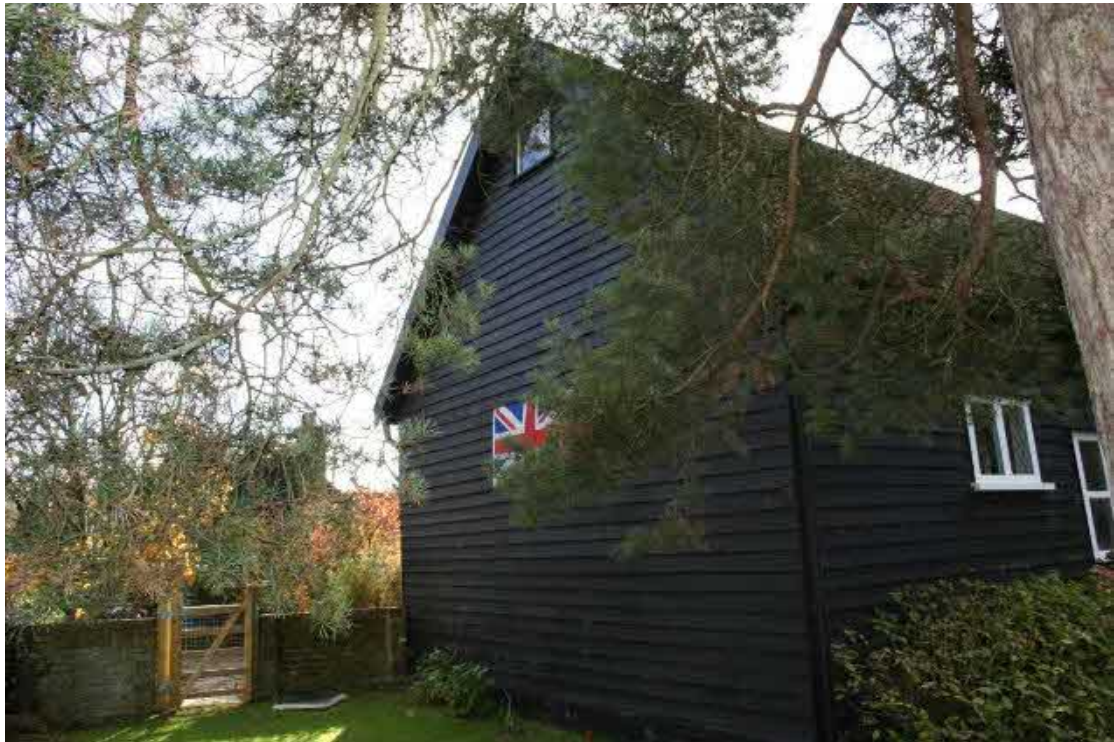
The east elevation of the Listed Barn.

The Barn has been converted in the LC20th and most likely after the sale of the site in 1994 with planning potential. See Appendix 1. All visible fabric is LC20th or C21st.

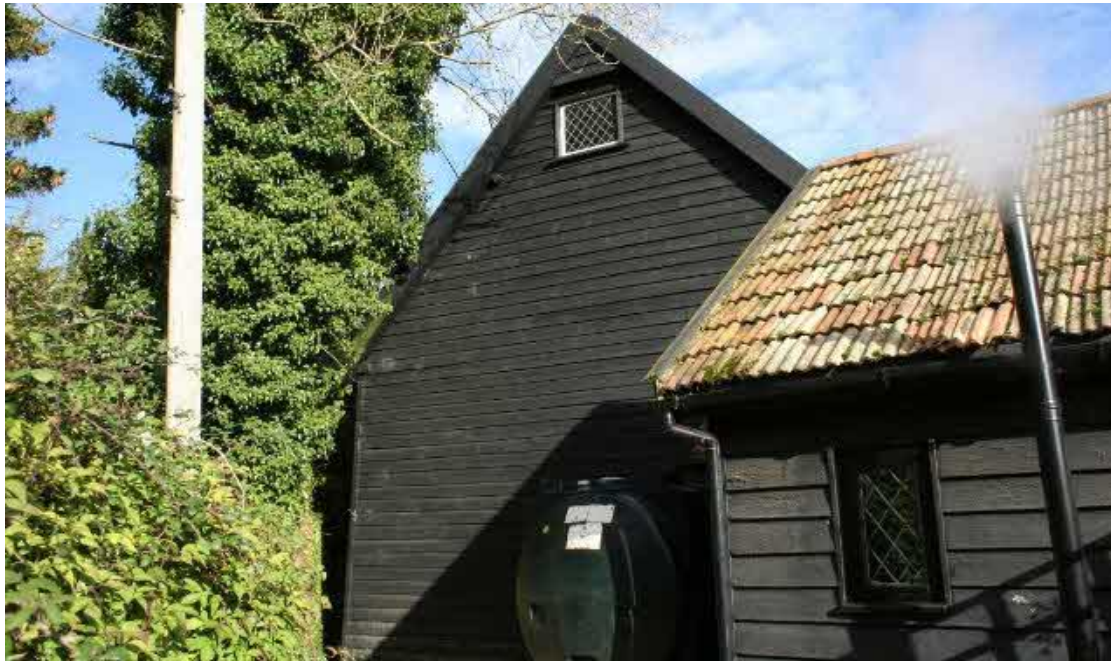
The west elevation of the Listed Barn.

Despite being Listed as C17th there is very little fabric to suggest a date this early. All the exterior weather-boarding is LC20th bandsawn or circular and fixed with mild steel nails. The roof is clad with single Roman tiles (not pan tiles as noted in the Listing). All the glazing is double glazed with applied taped leaded comes. There are no original external features. To the rear (north elevation) is an outshot under a catslide roof and these were most often engine bays to house a barn engine in the EC19th. It now is the setting for an internal fireplace inserted as part of the conversion.

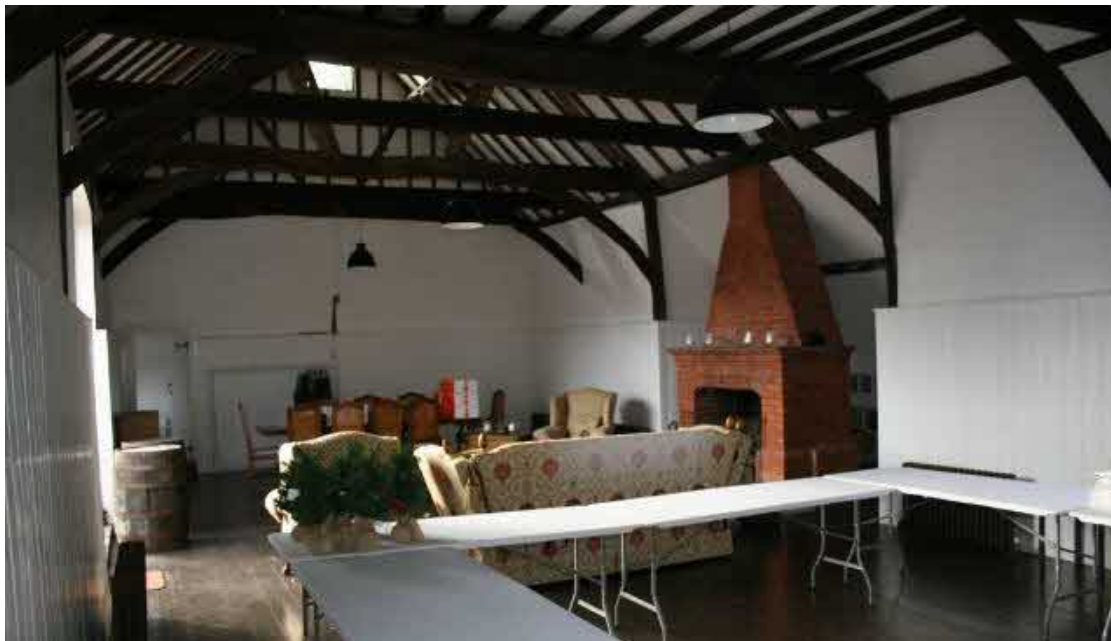
Looking W in the Barn.

The wall frames are hidden by plasterboard and a 7ft tall vertically boarded wainscoting to insulate the building. The roof timbers are exposed and there are seven bays. Two bays are floored over and the easternmost bay is enclosed with lightweight plasterboarded partitions to form rooms and a staircase. In the outshot is a LC20th interpretation of a brick firestack.

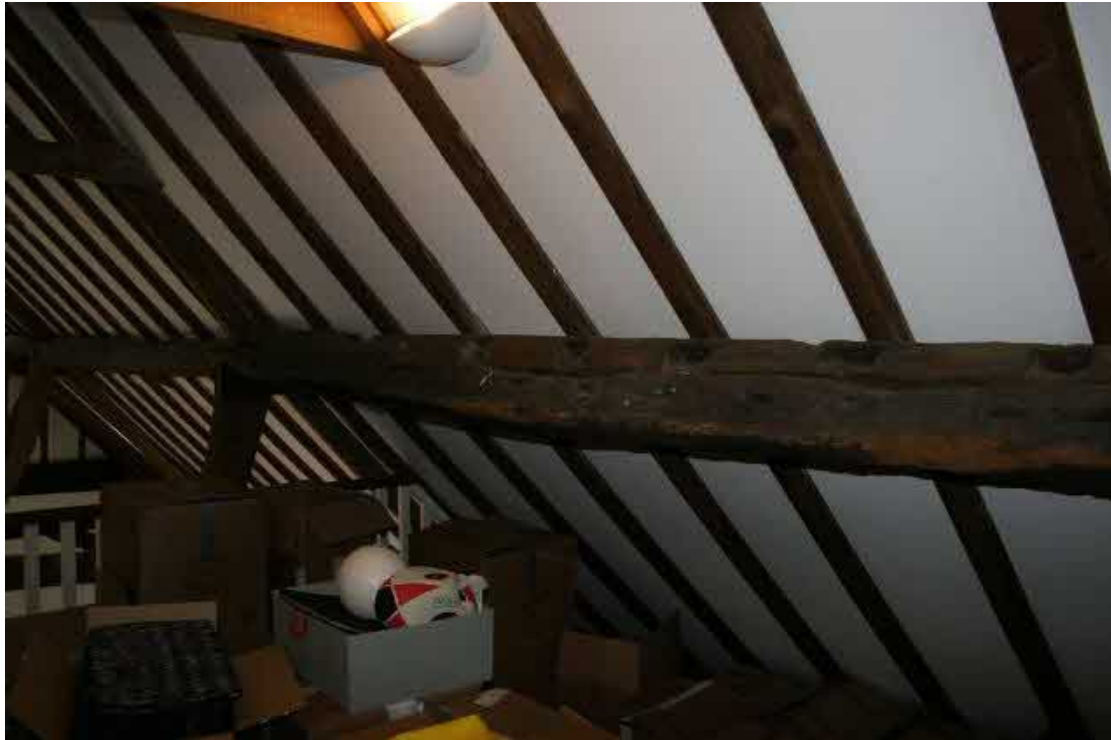
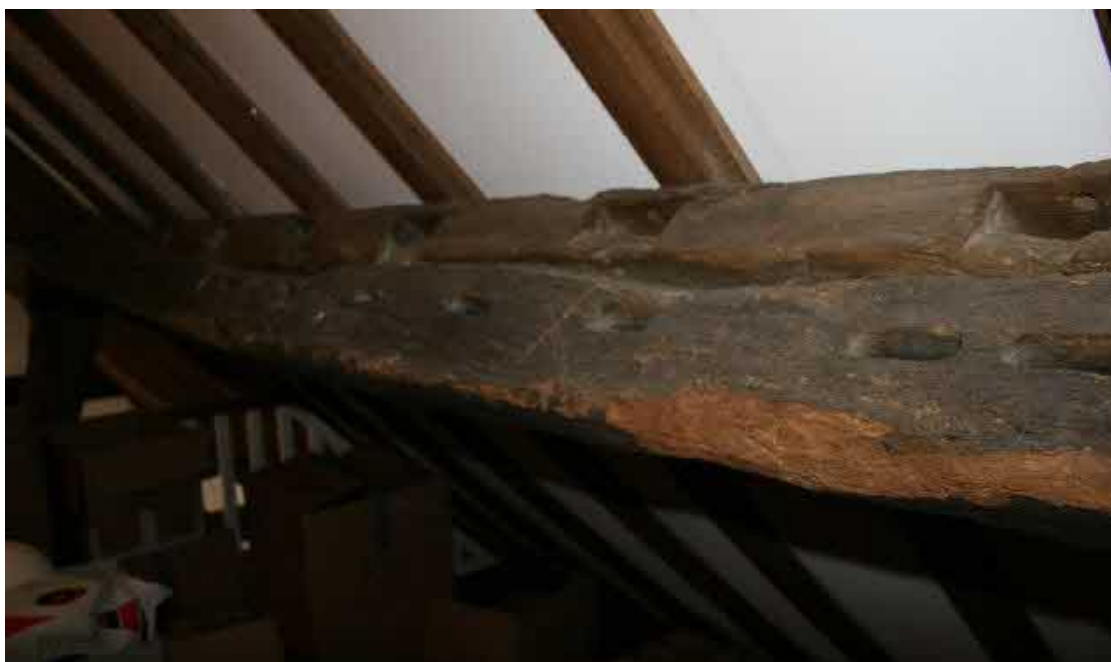
Doubled up purlins made from top-plates on the north side of the mezzanine.

Detail of doubled up purlins made from top-plates on the north side of the mezzanine.

Of interest is the use of top-plates and sawn down floor joists as purlins. There are two styles of top-plates with one having round ended mortices for close studding and window jambs. It is paired with a sawn down main joist which has mortices with soffit tenons and refined entries.

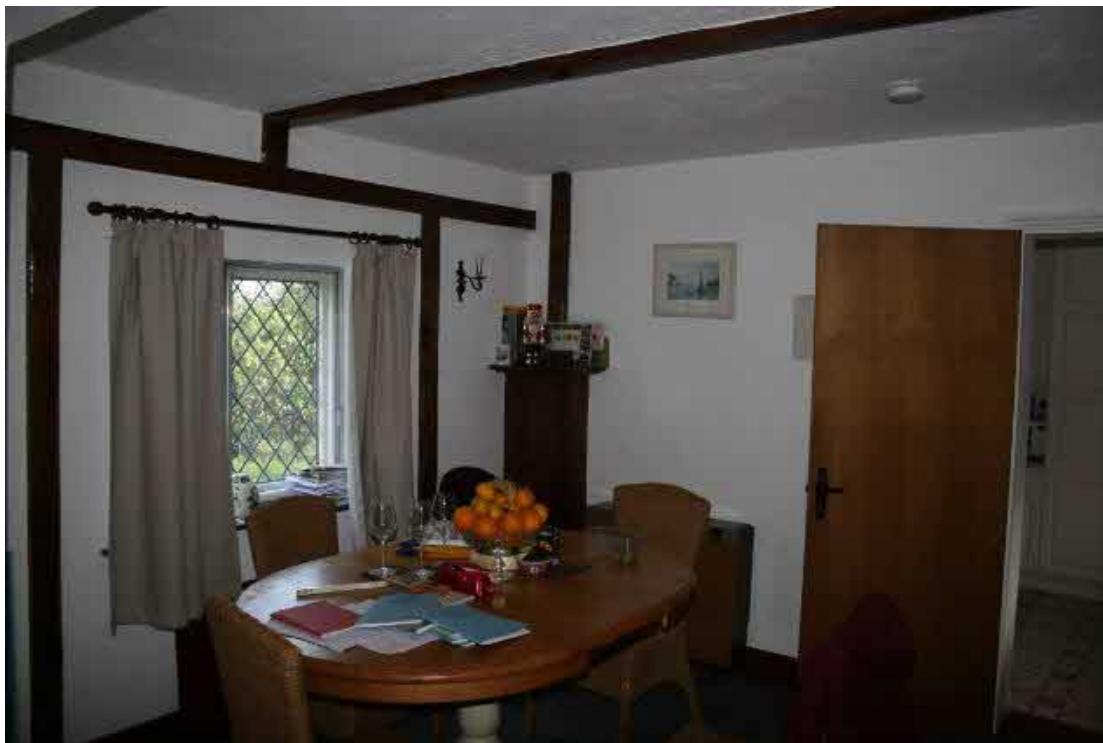
Looking S in the Living Room.

There are some applied fake timbers and a brick fireplace put in as part of the 1974 conversion.

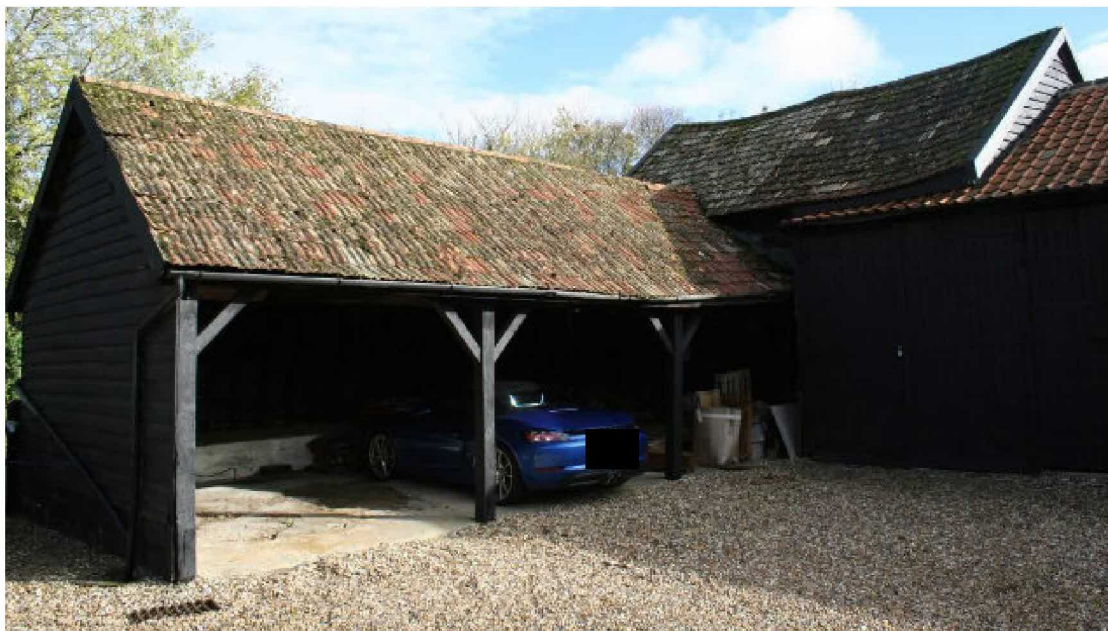
The west elevation of the Cart Lodge.

The Cart Lodge retains very little fabric older than the LC20th except for the roof tiles which are 1920's style triple Romans. The walls have been replaced with machine sawn softwood frames and weatherboarding fixed with mild steel nails. Some of the older principal timbers have been retained and are likely to be cut from elm but have been painted black and are not easily identified.

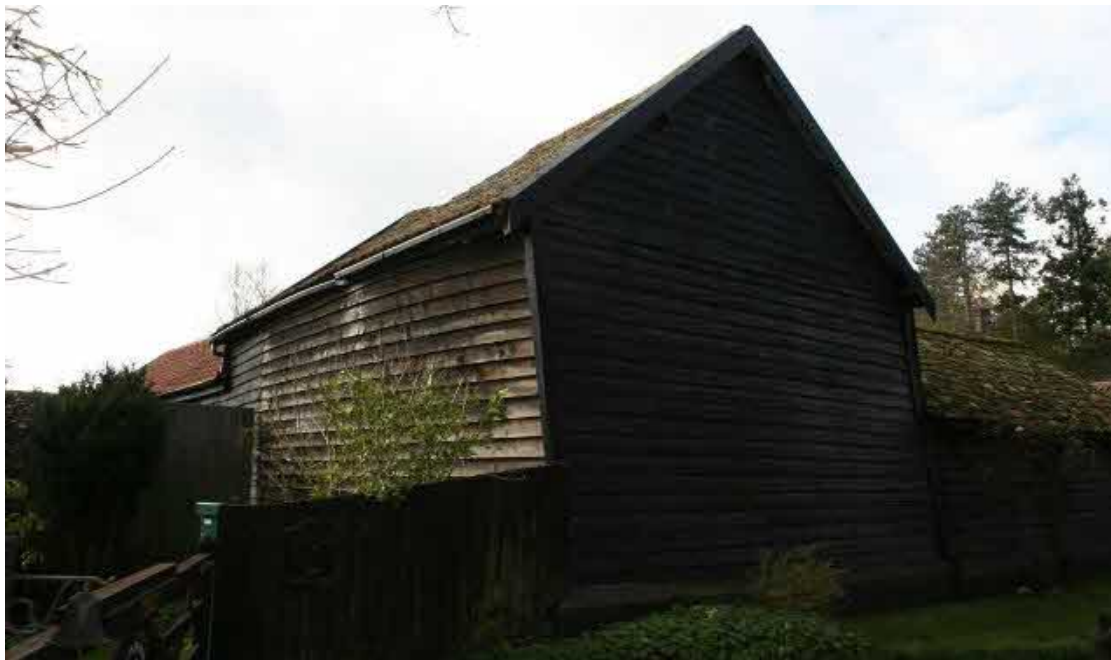
The south and east elevations of the Workshop. The building borders the neighbour's garden.

The whole range of buildings has been re-clad with LC20th weatherboarding finished with black cold brushing tar. The section of the north elevation that borders the neighbour's garden has not been treated and the weather-boards are seen as pressure treated and coated with creosote that has worn off. Creosote for amateur use was banned from use in 2003.

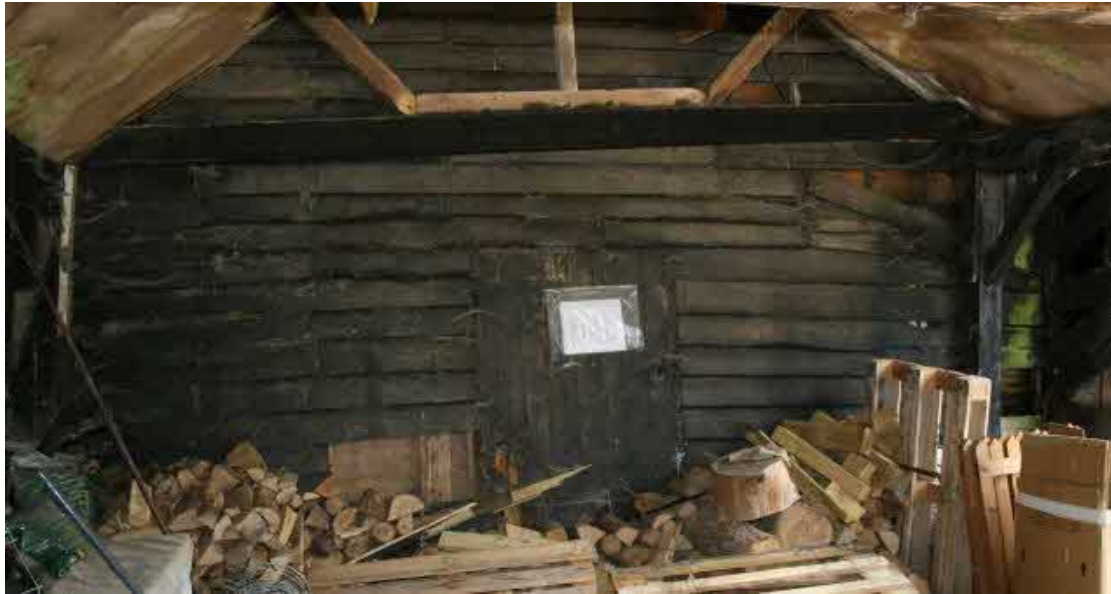
The north elevation of the Workshop retains some original C19th weather-boards.

The north elevation hidden in the Cart Lodge is clad with some original C19th weather-boards fixed with wrought iron nails. The door is vertically boarded and hung on mild steel reversible hinge with decorative hinge and strap.

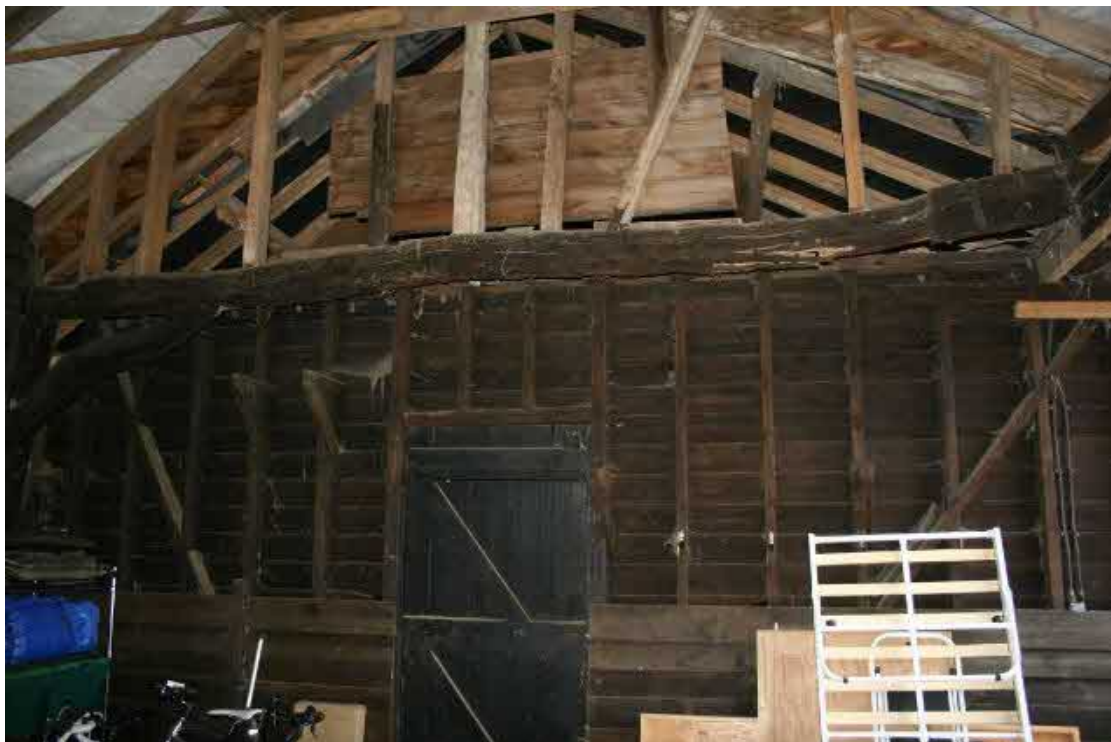
The west wall of the Workshop seen from inside looking W.

The west wall is made from primary braced interrupted studwork cut from 2x4in machined softwood with 3x4in door jambs for a centrally placed doorway with a MC20th gate and ledger door hung on mild steel reversible hinges. The pine weatherboards are MC20th.

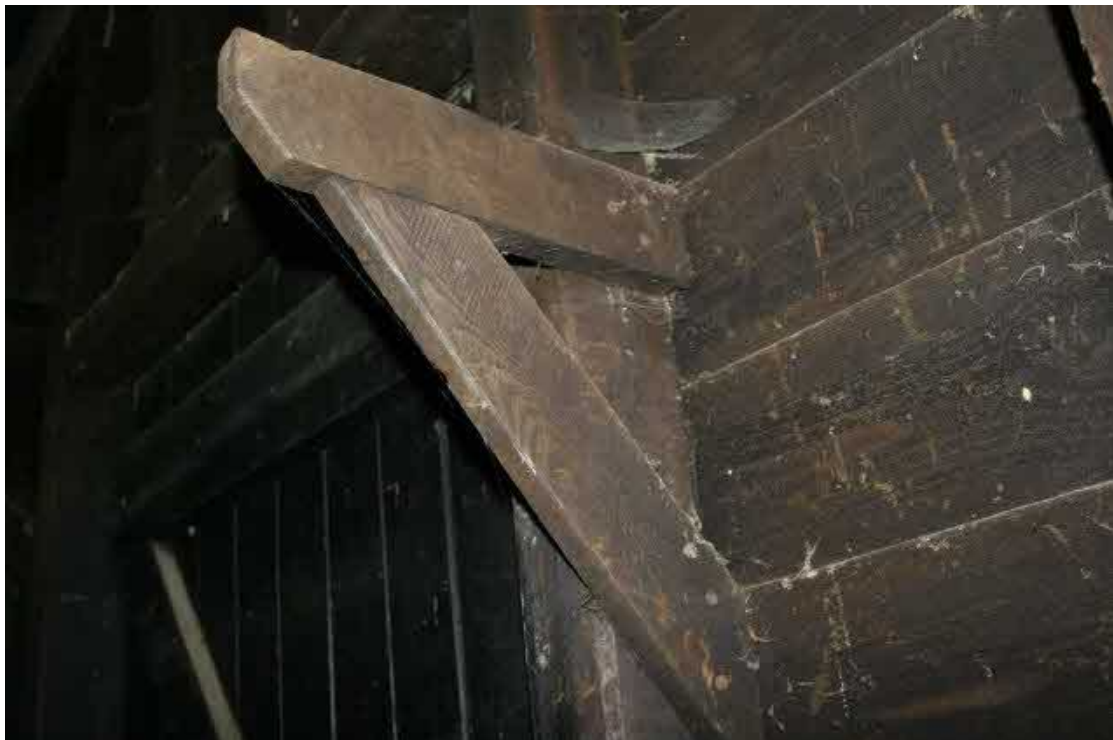
MC20th harness tree.

The Workshop appears to have been constructed in the MC20th by partitioning the building to form a tack room equipped with harness trees made from softwood members side nailed with mild steel nails. There are also two higher brackets that were most likely for a water tank.

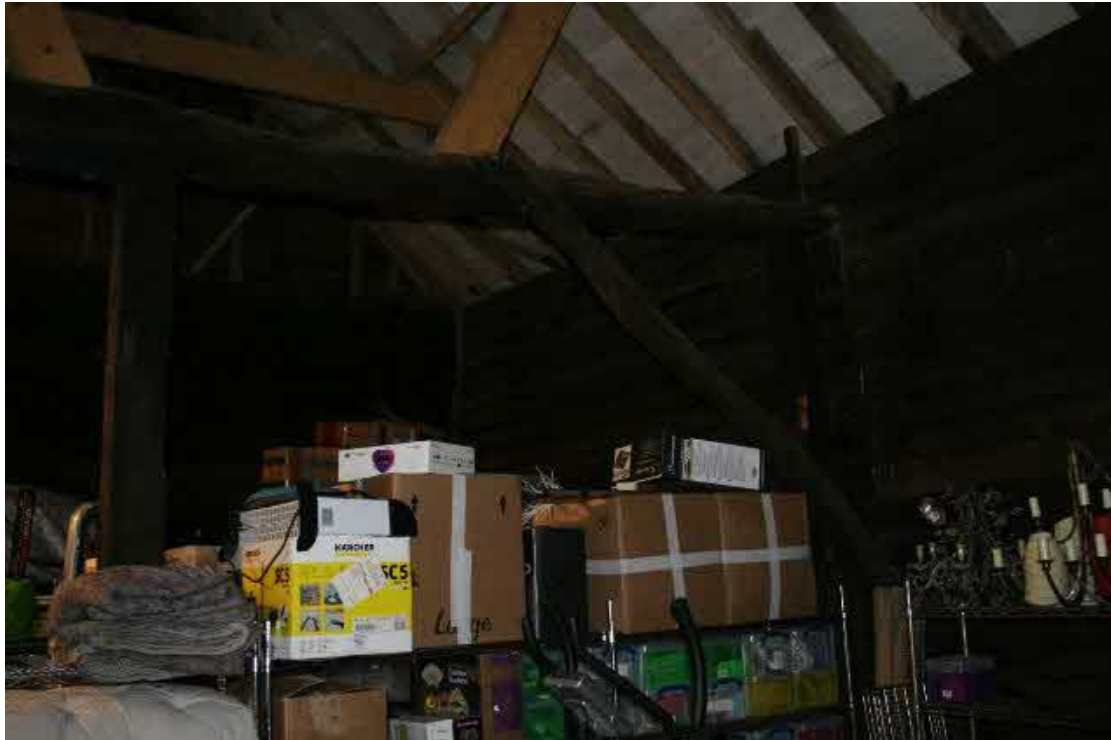
Looking SE in the Workshop.

The roof of the Workshop is entirely LC20th but with a vain attempt to preserve the original waney elm e-beams, both of which have subsequently failed.

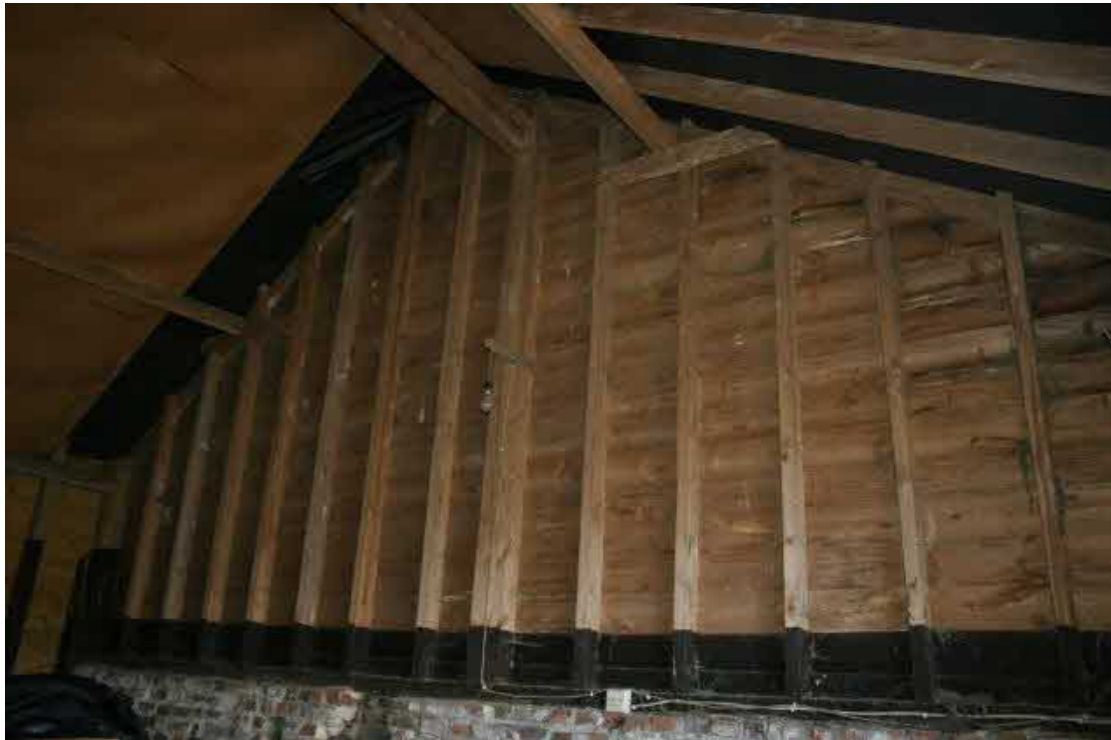
LC20th studwork in the west wall of the Garage.

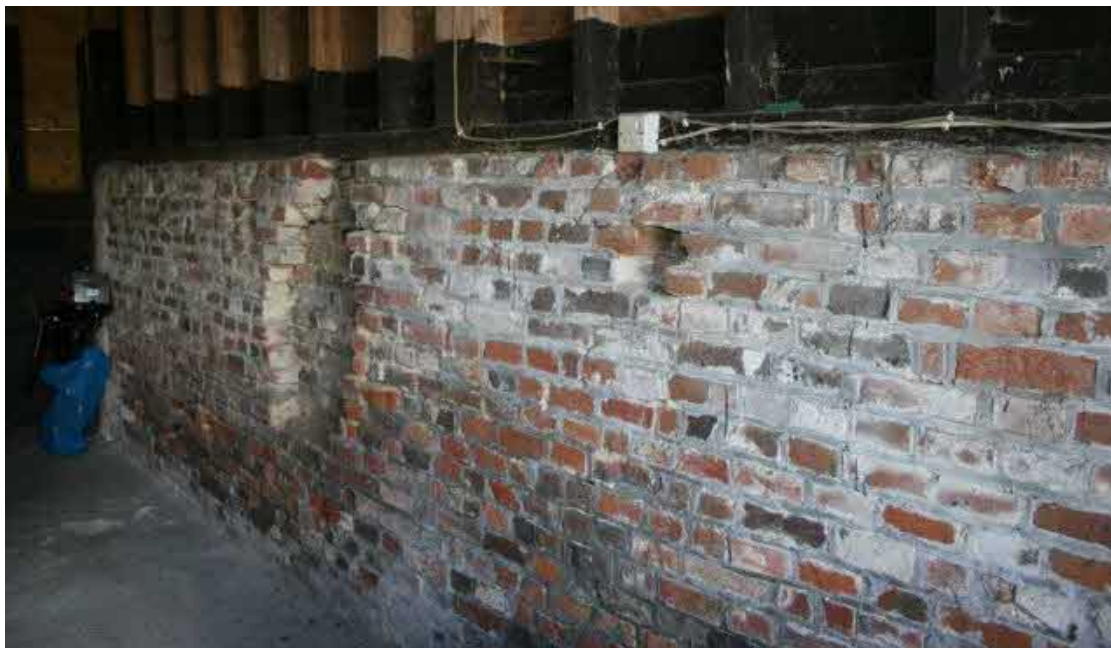
The partition is made from reused C19th bricks set in grey cement.

There is a partition wall made from reused C19th bricks that are set in lime mortar but heavily repointed in grey cement. The LC20th partition above is made from metric 50x100mm machined softwood clad with pine boards.

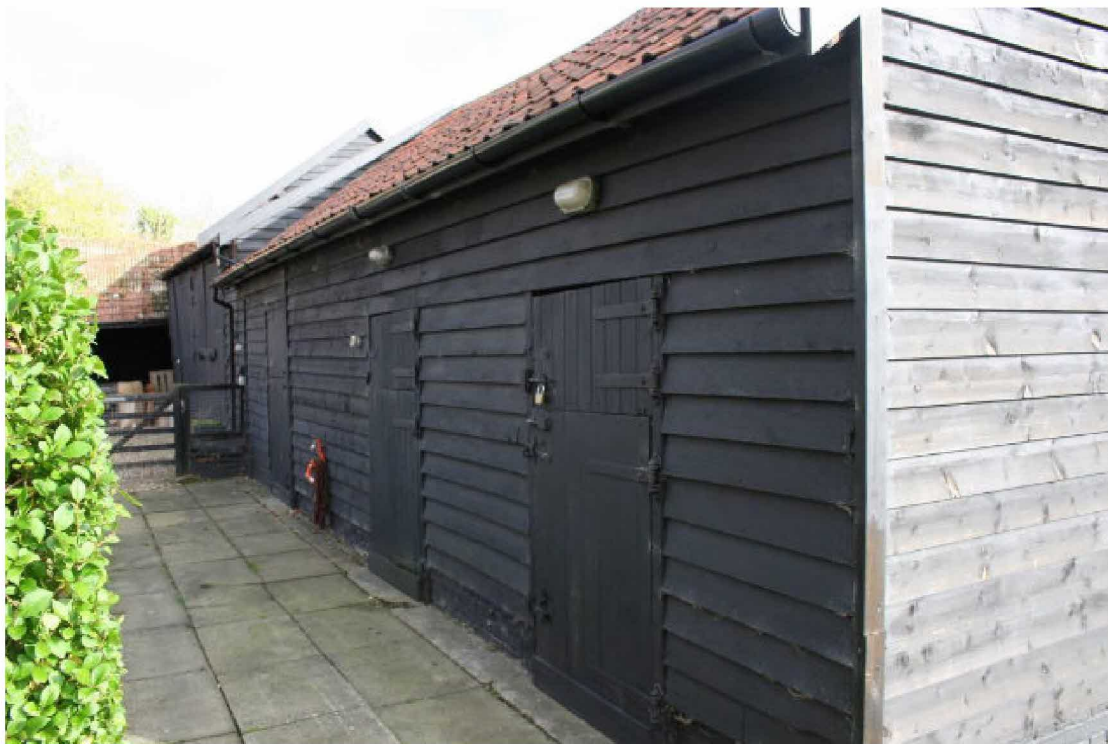
Detail of the north elevation looking SE.

The Stables is set up with doors that would serve at least five stalls, with three doors on the north side and two on the south. The split stable doors have MC20th carpentry commonly seen on 1930's buildings and are rehung on mild steel reversible hinges fixed with Pozidriv screws. The weather boards are all LC20th repairs. The roof is clad with single Roman tiles.

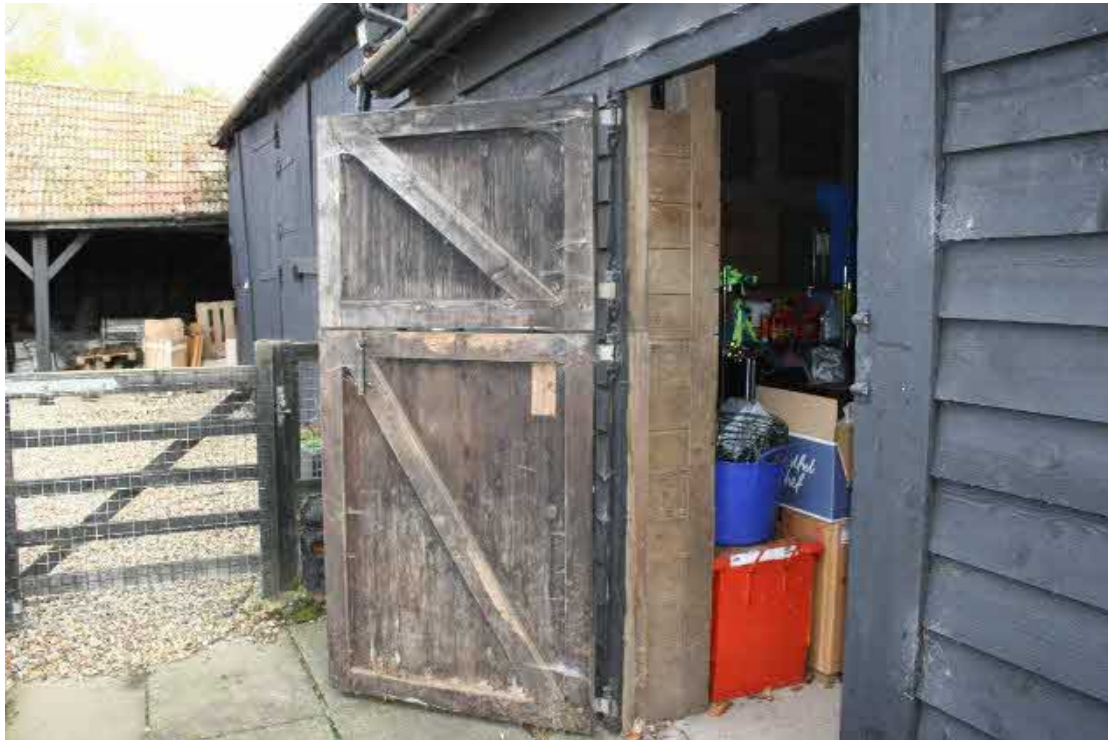
MC20th split stable door rehung in the LC20th with Pozidriv screws.

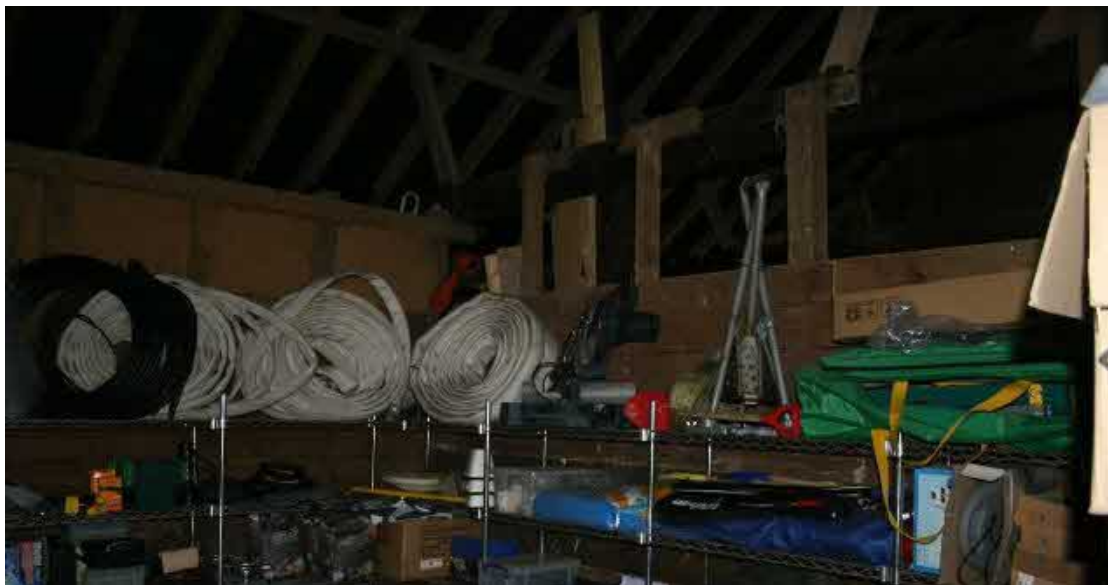
There is one large boarded out loose box. Looking SW.

Most of the wall frames and all of the roof has been replaced in the LC20th. The older members are also C20th and all are either circular sawn or bandsawn. There are four bays and two have been combined to form a loose box created in the LC20th from uprights nailed to the e-beams and horizontal plain boarding.

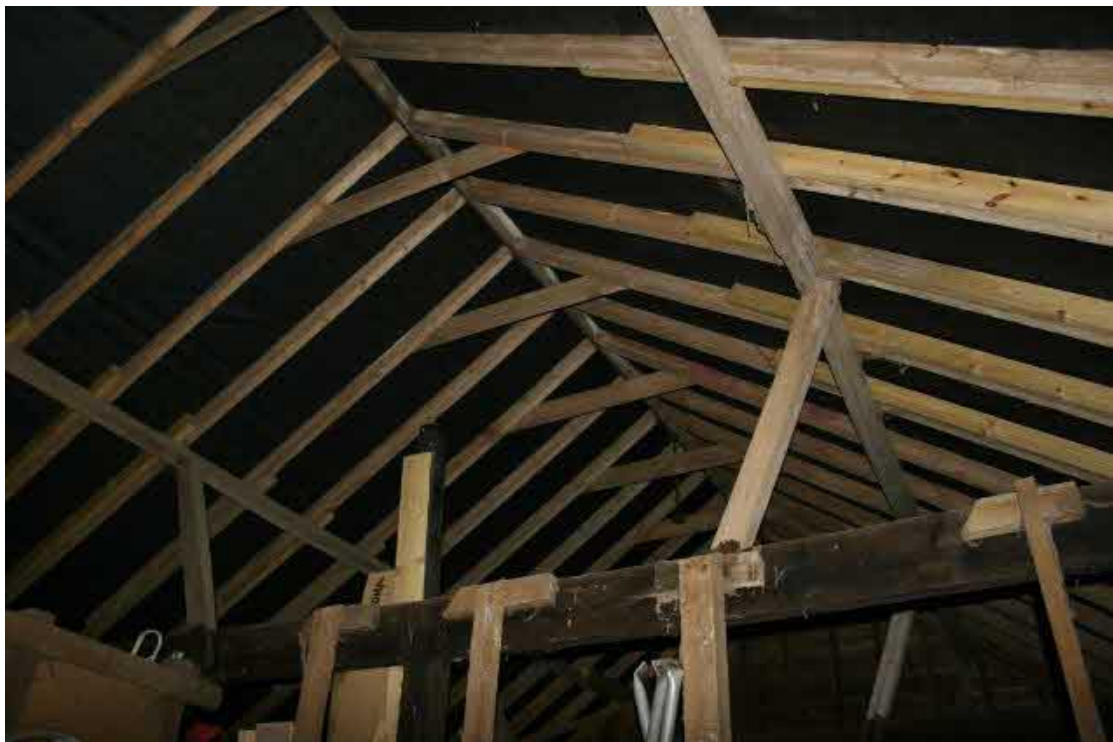
The roof structure above the loose box and stalls looking W.

The roof structure is entirely LC20th and is a simple side purlin roof with raking struts from the e-beams. The e-beams are MC20th machined deep section pine planks.

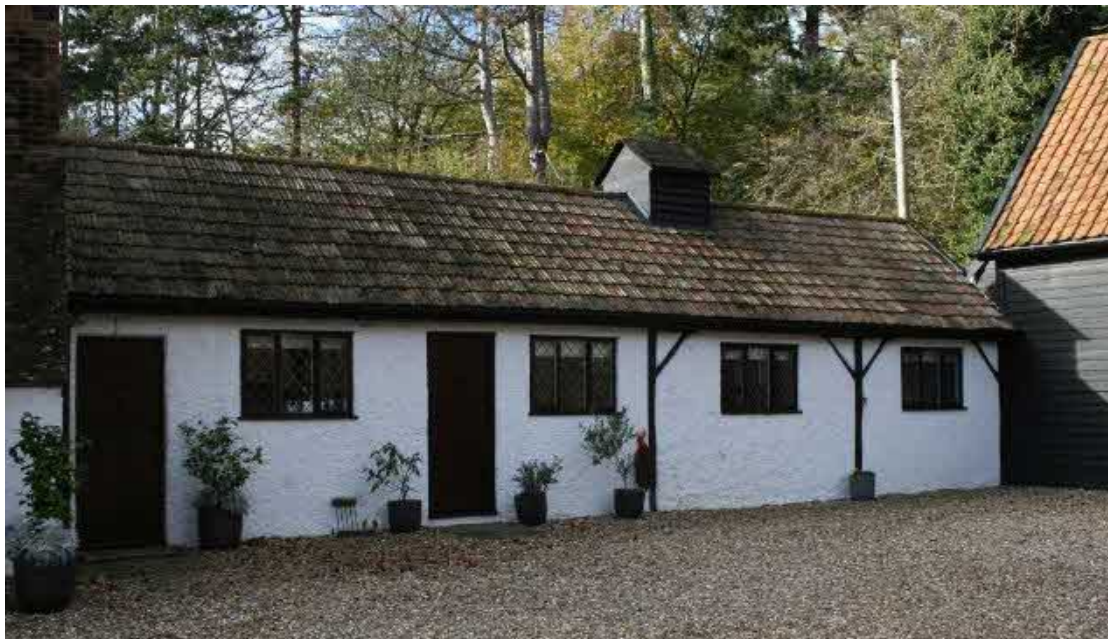
The eastern elevation dates to the LC20th.

The Kitchen has been converted from an open-sided shelter in the LC20th. Planning permission was given in 1969 for an extension to the House which was probably built in 1974 as part of the extensive works done then. The roof has 1920's style triple Roman tiles. The walls are blockwork finished with roughcast leaving only a hint of the open-sided frame.

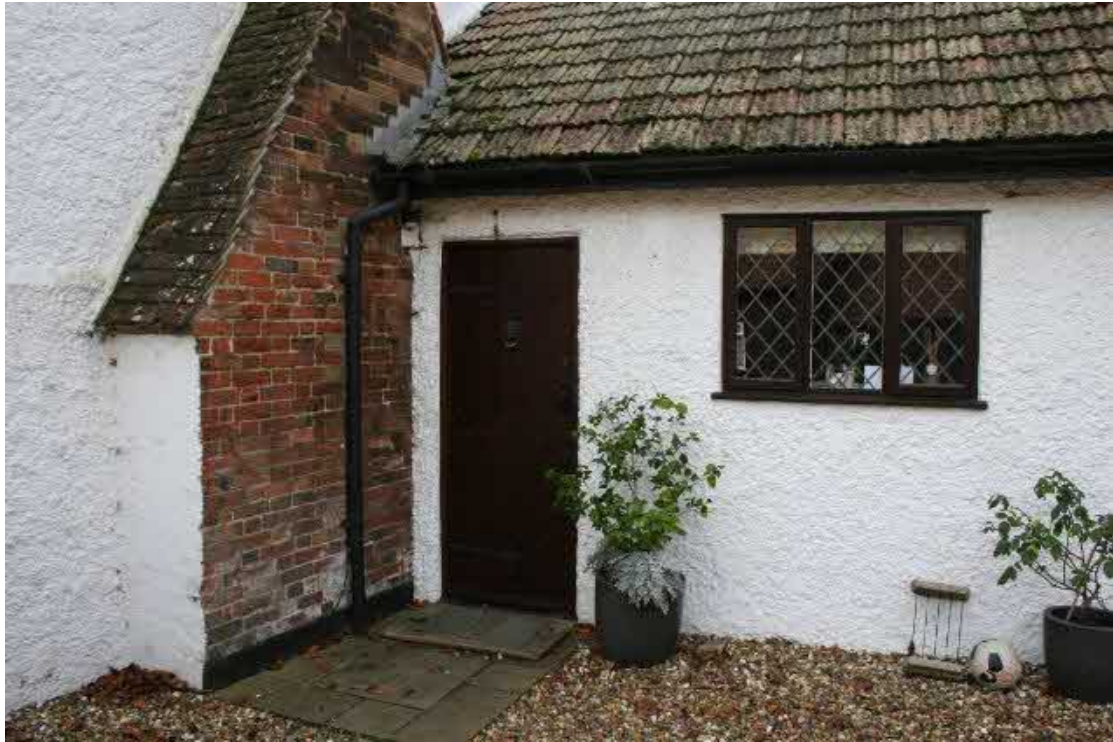
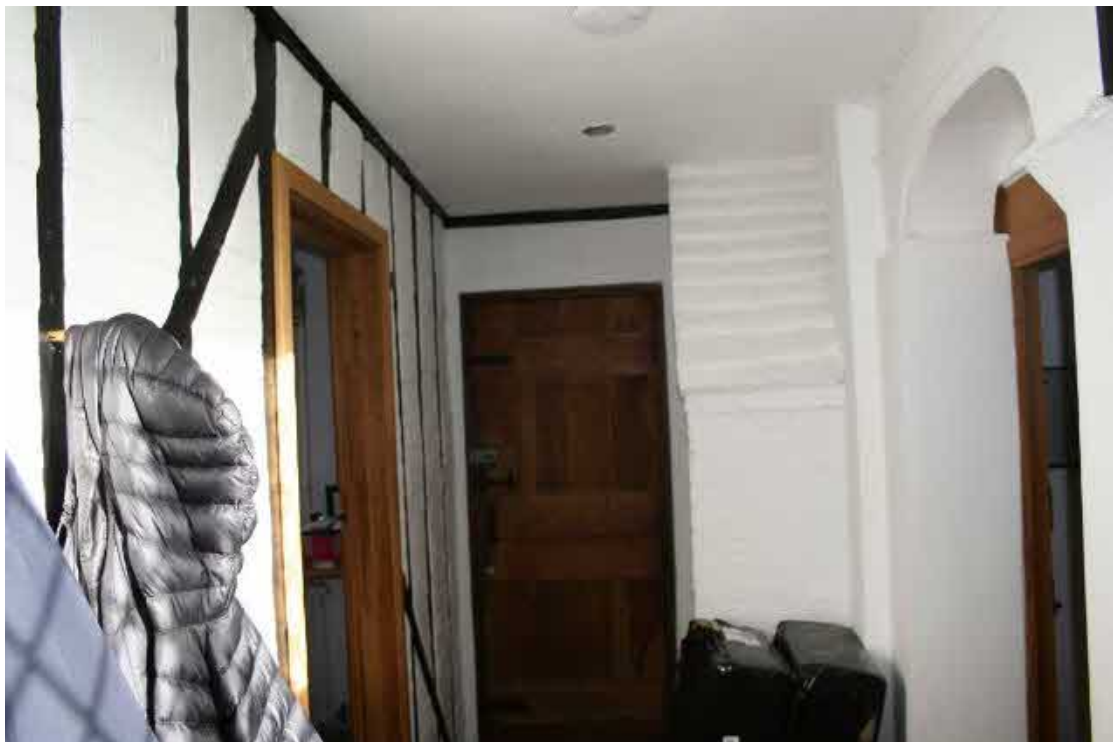
The entrance to the Kitchen hallway. Note the C19th firestack.

Looking E in the Kitchen hallway. Again note the C19th firestack.

In the Kitchen Hallway is an exposed scantling frame with nailed, interrupted studwork of c.1800 character that denotes the original end wall of the Kitchen when an open shelter.

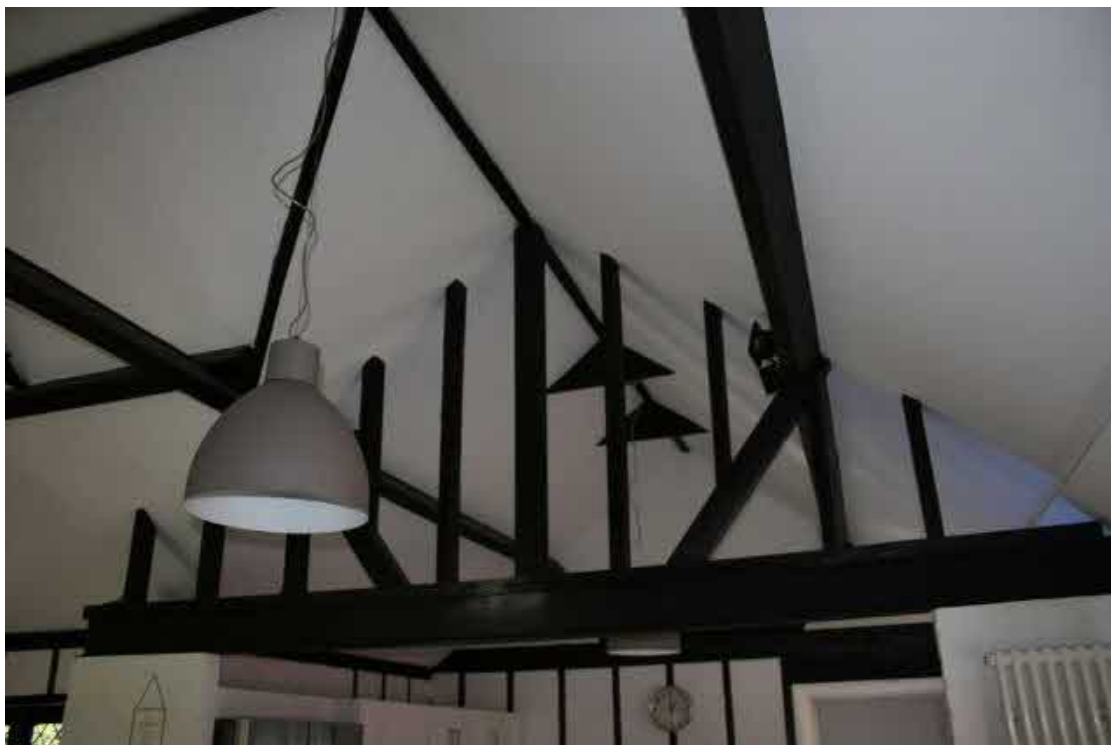
The central truss over the Kitchen.

The Kitchen has been created by converting an open-sided shelter leaving only the main posts in the walls and three roof trusses with machined softwood tie-beam and central struts and raking struts for a clasped side purlin roof. Interstitial studs have been added presumably to close up the original bays but now appear decorative. This work probably dates to 1994.

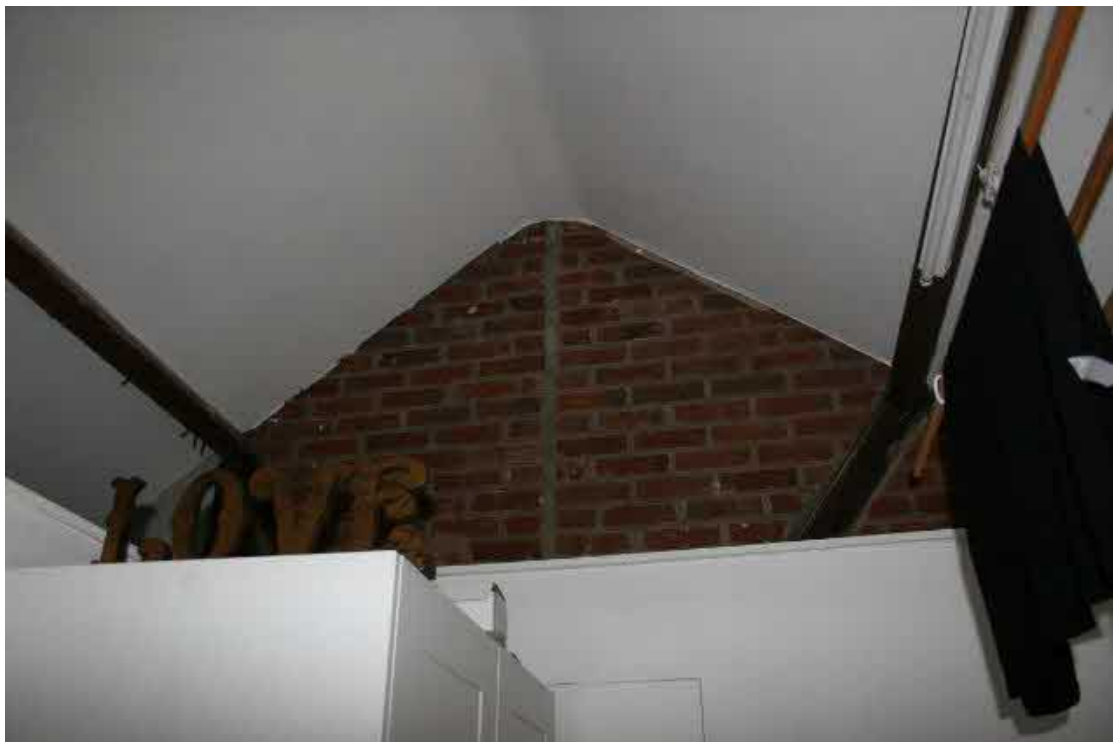
The brick wall seen in the Utility Room is LC20th.

The north part of the Kitchen is partitioned off to form a Utility Room. None of the exposed fabric is older than 1994.

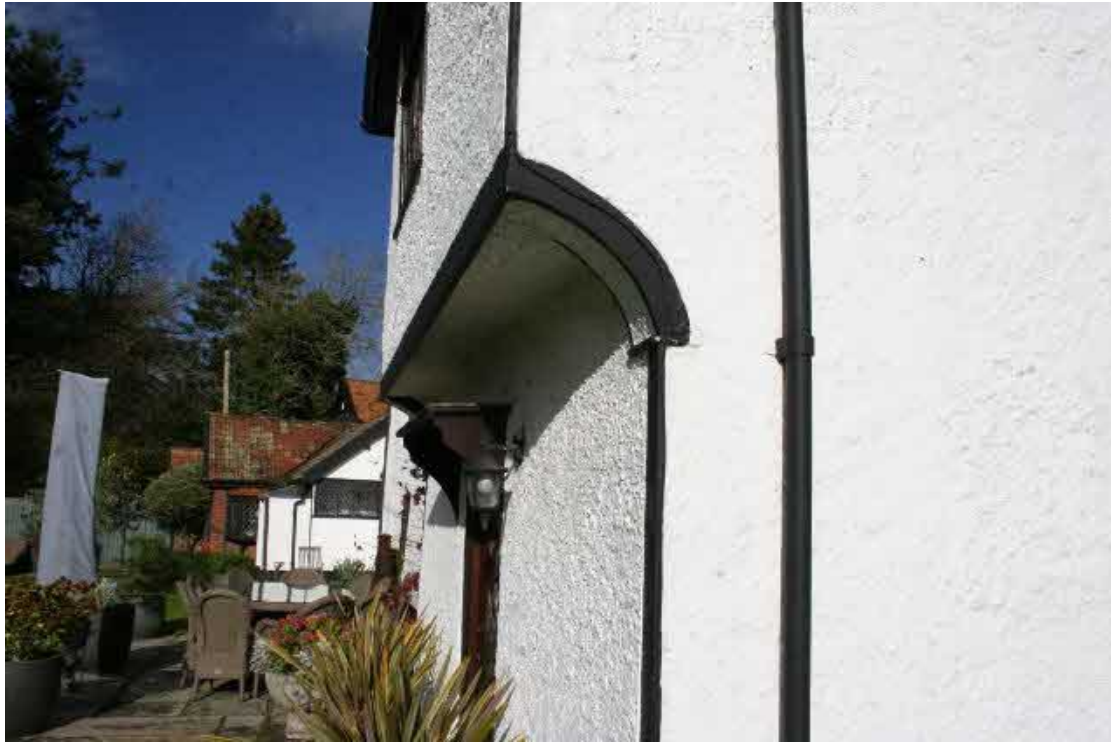
The House is a two storey timber-framed building clad with hard cement roughcast on EML or MC20th laths (seen in the cross-wing). The roof is clad with clay peg tiles and there is a C20th three shafted chimney for a firestack set between the southern cross-wing and the main range. The cross-wing is jetted on both the west and east sides and the roof is hipped on both sides and contains remnants of a clasped side purlin roof with tapered rafters.

Detail of the render and the jetty brackets.

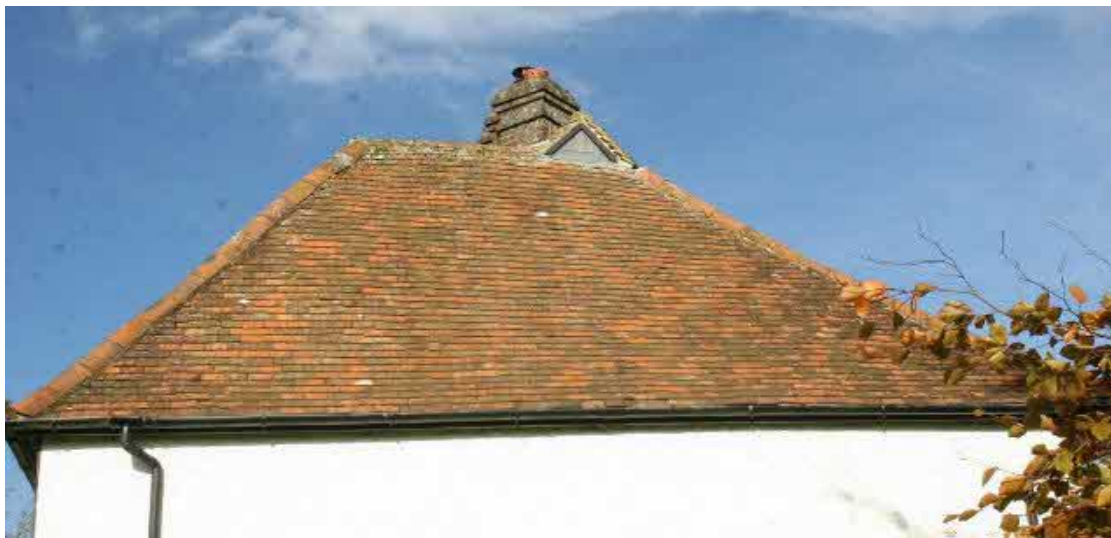
Detail of the roofline above the cross-wing.

The south elevation displays both jetties. The roof is fully hipped and this is normally a later intervention when the collar purlin roof has racked over and the roof needs to be reinforced. The ridgeline of the main range is off-centre and higher than the cross-wing roof which is an early indicator that the main range was an open hall house that has been raised up to form two storeys.

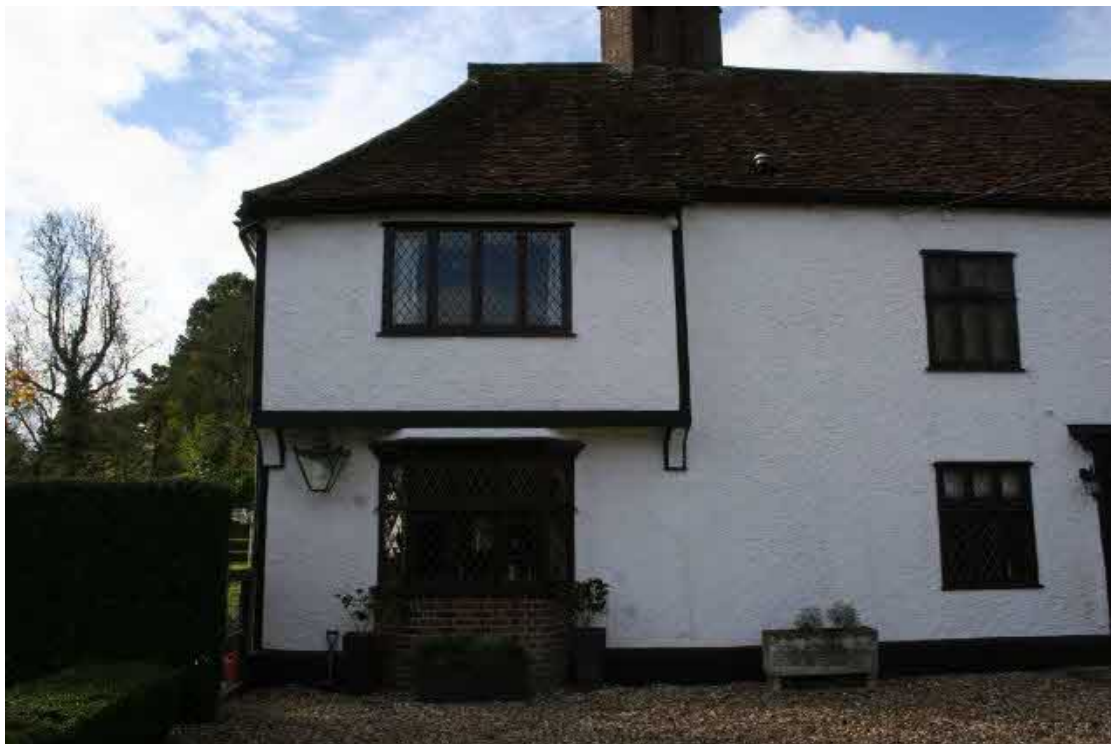
The south cross-wing has an inserted C20th bay window.

The eastern elevation is currently the front of the House. Ordinarily the cross-wings project forward of the main range but here the roof runs straight across and only the jetty is forward. Again, all the windows are LC20th oak casements with leaded lights. A LC20th canted bay window has been added under the jetty.
