Cheynes Farm, Warren Lane, Cottered, Herts. SG9 9QD.
Historic building recording and analysis of the buildings. Recorded 09 11 2022.

This report describes and analyses the historic fabric and records of the buildings under study. This report adheres to Historic England Level 3 as outlined in Historic England. Understanding Historic Buildings – A guide to good recording practice. 2017. Page 25.

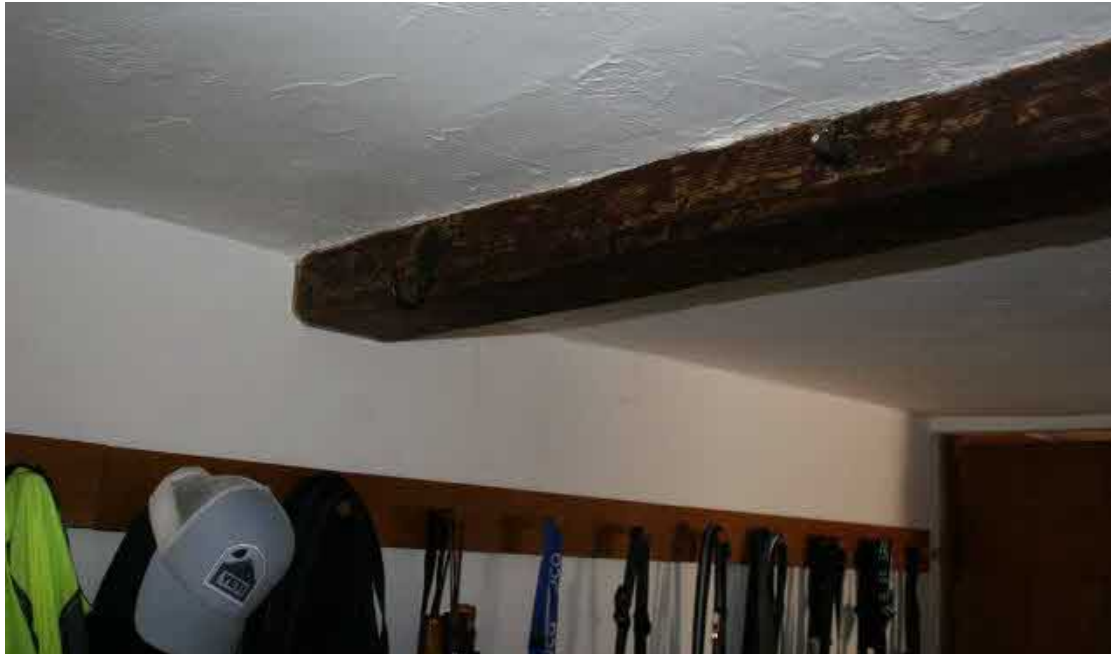
The House is entered from the Kitchen Hall into a large single bay room currently used to store the coats and boots. Of interest is the exposed axial joist in the ceiling which is lodged in the brickwork of a now redundant firestack. Seen outside, it has EC19th brickwork and design.

Detail of the axial joist.

While lacking in visible historic fabric it can be seen elsewhere in the House that this bay is EC19th – c.1800. The axial joist is much older and has been reused.

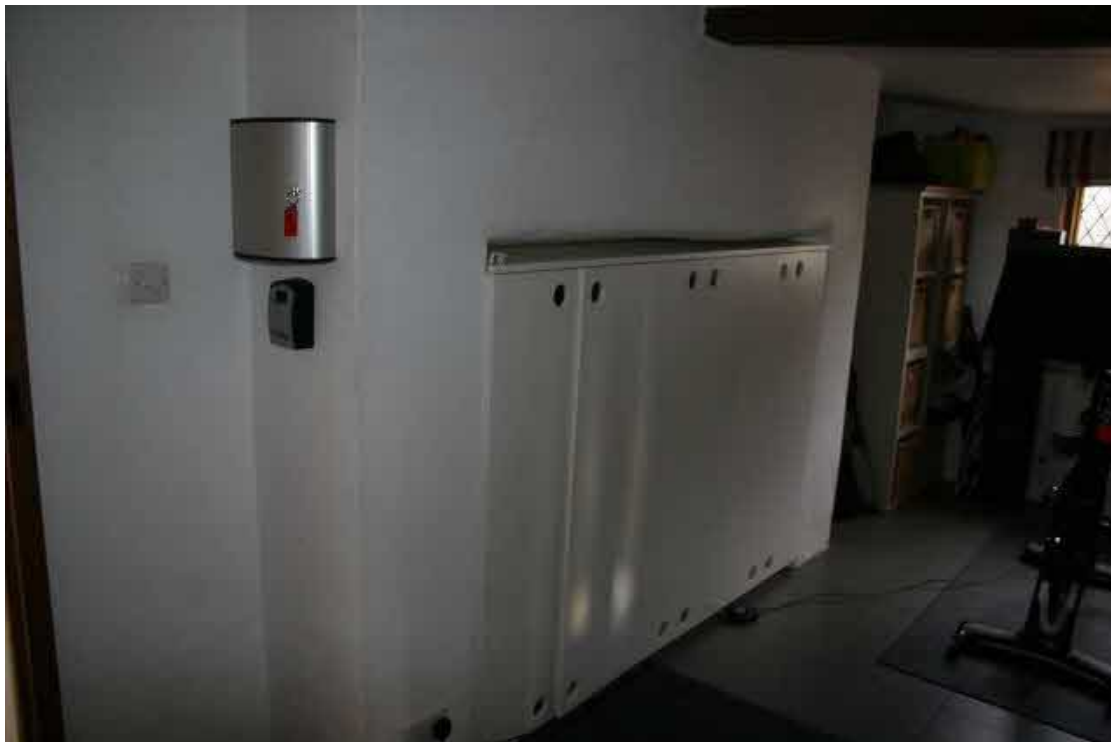
Detail of the fireplace - now converted to closets.

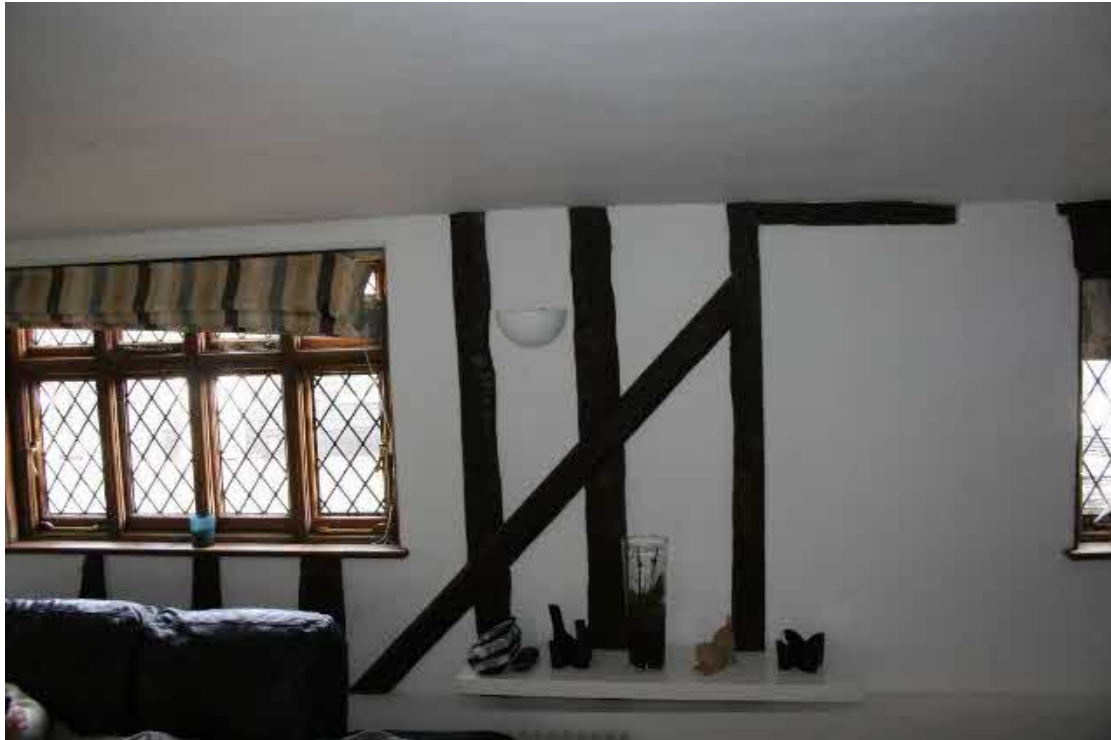
The Living Room has nailed, interrupted scantling studwork wall frames cut on a 3in module – a common size of c.1800 and later. Half of the eastern wall is a LC20th interpretation of a similar frame made with bandsawn softwood.

Fake LC20th frame in the east wall and earlier doorframe.

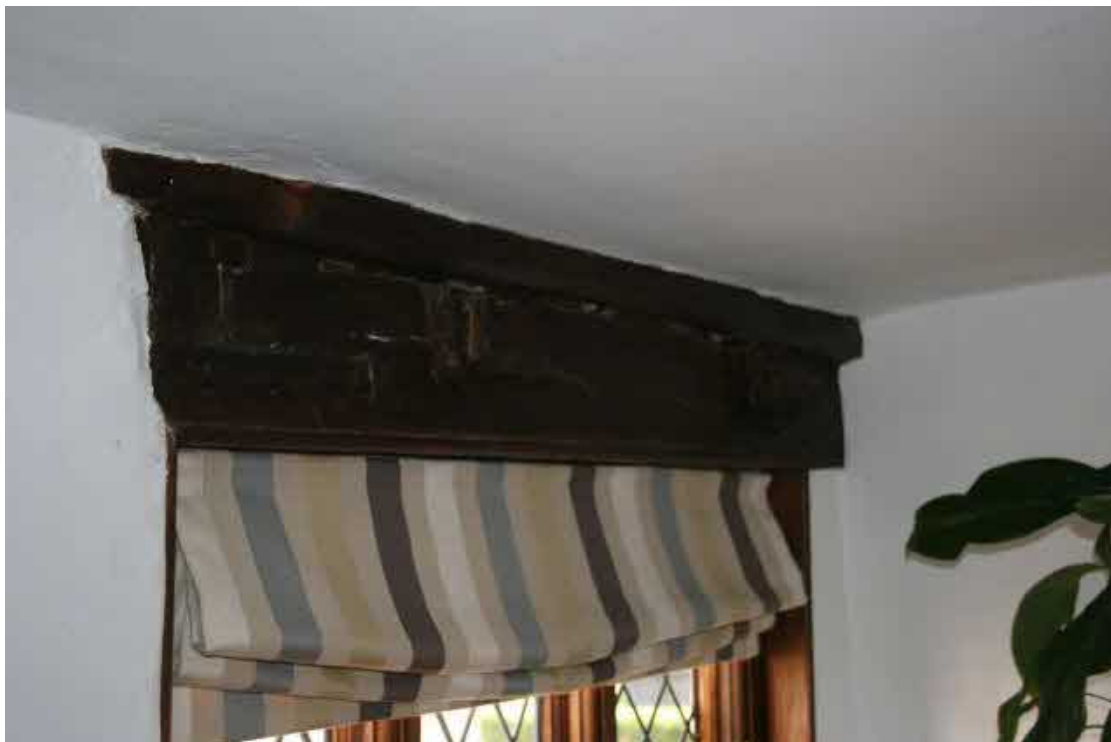
Two large metal staples are fixed to the frame over the window.

There are two large staples fixed to the midrail in the east wall over a window opening. There are two matching staples in the partition wall and it is apparent a large fixture was suspended from them. Given the position it is likely there was a range stove installed here.

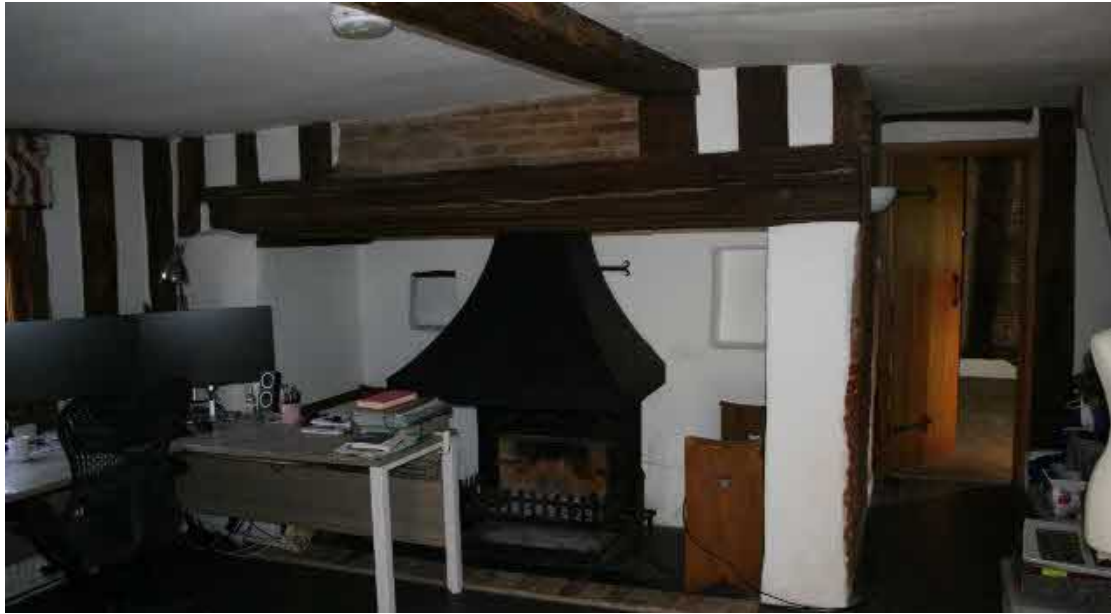
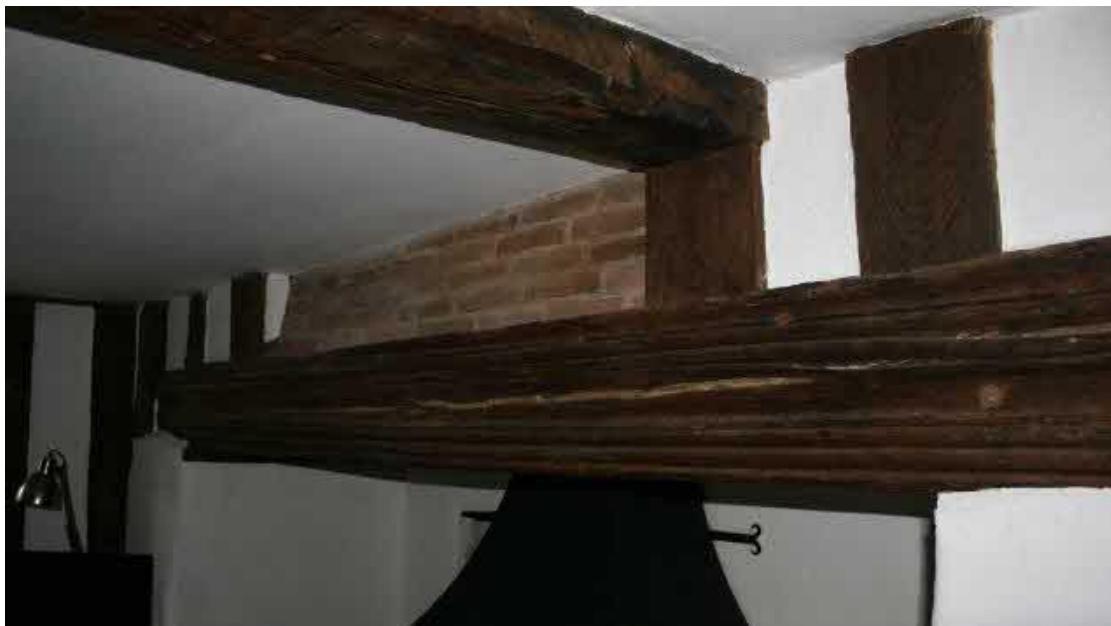
Inglenook fireplace in the Entrance Hall.

Detail of the roll moulded bressummer in the fireplace.

The Entrance Hall contains an impressive inglenook fireplace with a roll moulded 10ft 8in long x 12in x 10in bressummer made from a resited main e-beam from a much grander building. There is one small taper burn which may be an apotropaic mark. The fireplace is 8 x 5ft 7in x 3ft deep with niches and a cabinet and is plastered over as it would have been originally. The visible bricks are 50x110x230-240mm with creased faces, so arrises and thick lime mortar beds. The bressummer supports a 10in wide axial joist, hacked back for plasterwork but retaining a chamfer and cyma stops.

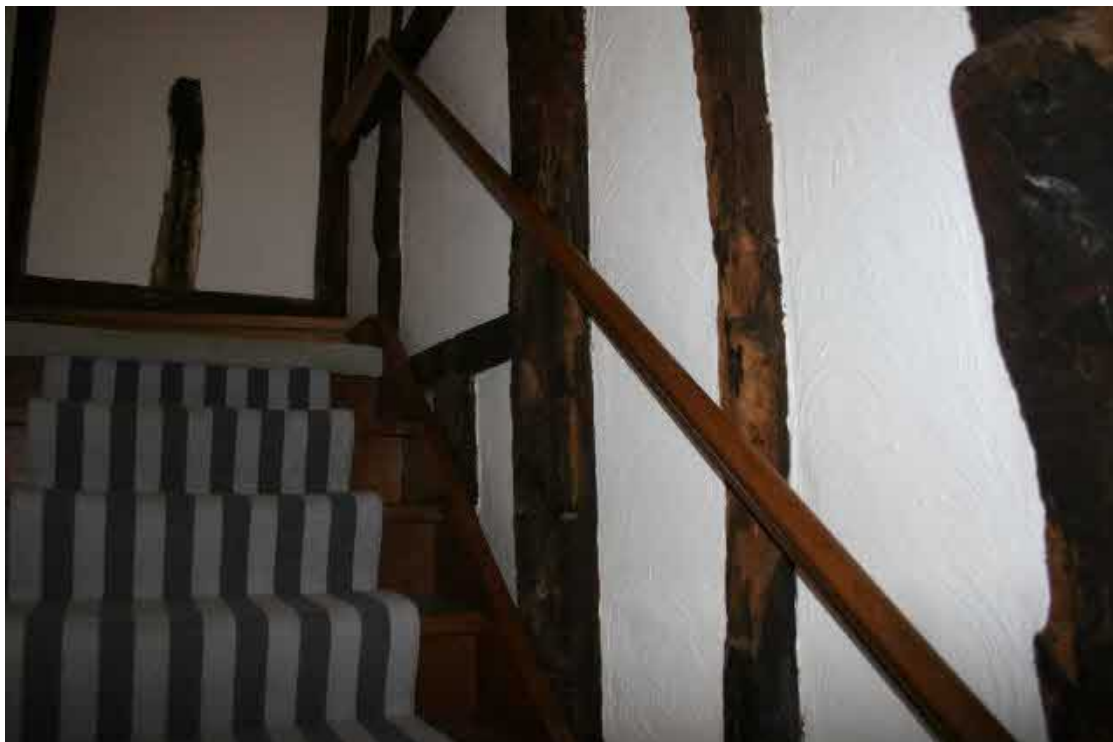
The frame exposed in the stairwell in the west wall.

The frame changes character in the west wall where the full height studs are all reused smoke blackened timbers of varying thickness from 6in. to 10in.. The wall is also framed for a window or door opening and the current LC20th cuts across it.

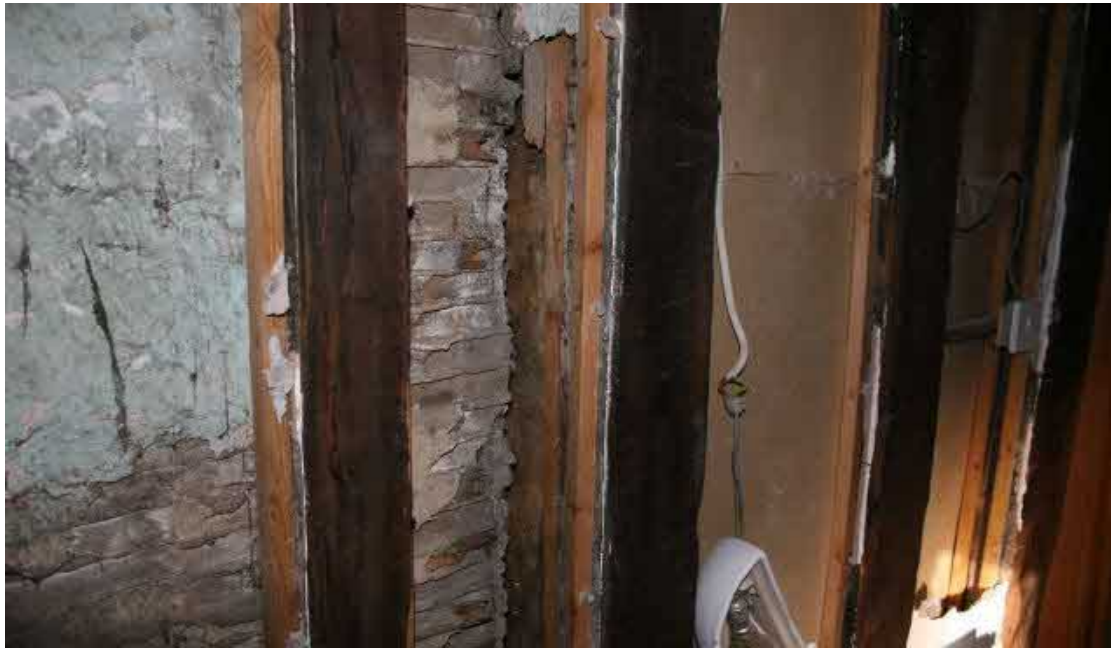
Detail of the lath and daub and LC20th plasterboard.

Originally, the panels would have been finished flush with wa le and daub. When this failed it was replaced with lath and daub and a section diamond pa ern scratch coat remains in the east wall. This would have then been floated over with lime plaster. This would have le a very thin wall and would be a very cold room so it must have been ba ened out and lath and plastered over on the inside. This is indicated by a few widely spaced nail holes. In the LC20th this was removed and the panels side battened and packed with insulation and plasterboard. There must have been a lobby for the front door in the west wall.

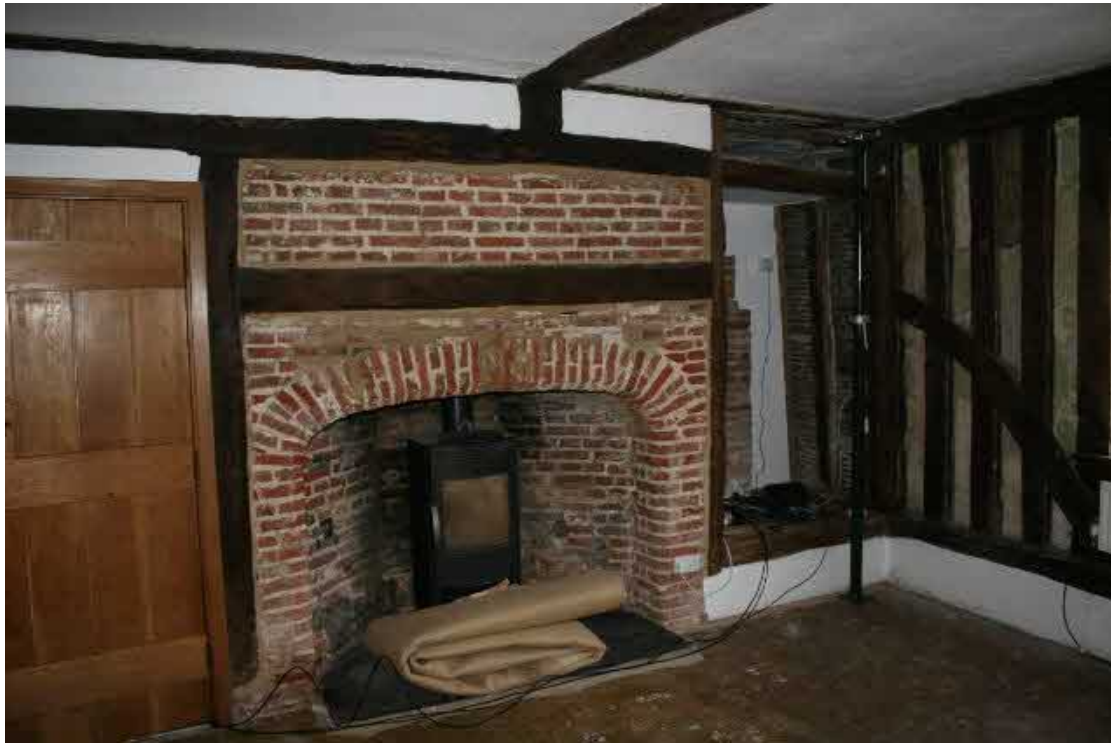
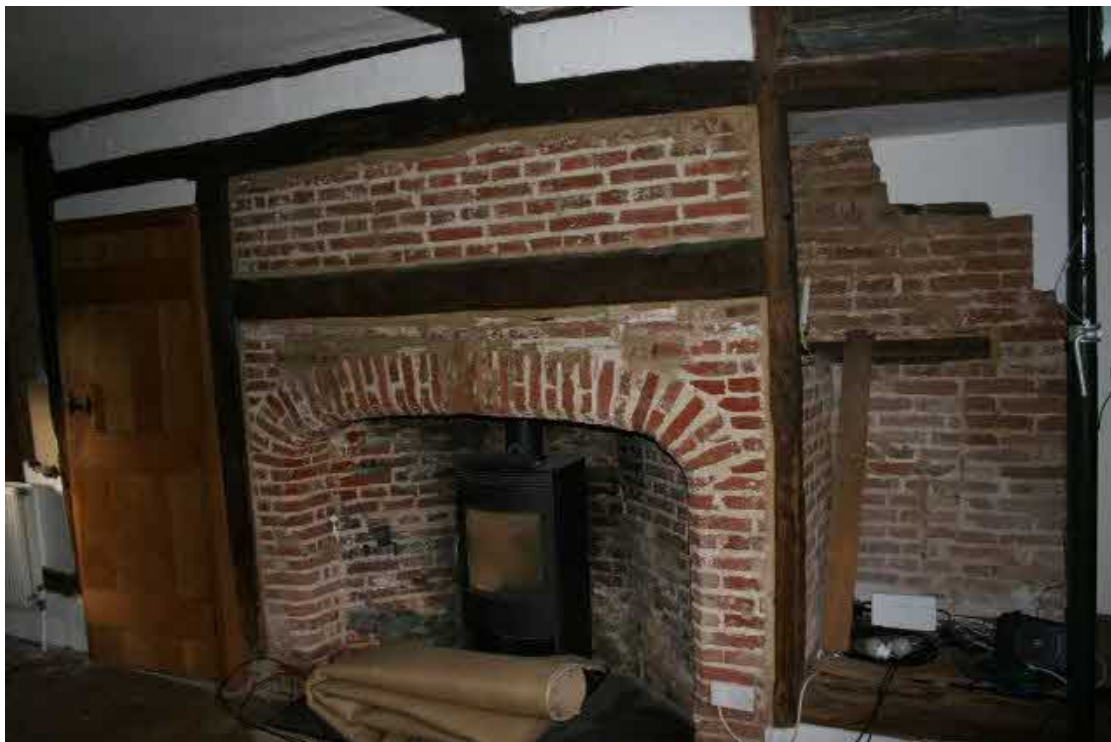
The fireplace in the north wall. Looking NE.

The fireplace is backed onto the inglenook fireplace.

There is a 7' wide brick fireplace with a segmental Tudor arch made from 50x110x230-240 red bricks set in thick lime mortar beds. The opening is 5ft4in wide and 4ft high and the back has been canted to insert a cast iron insert.

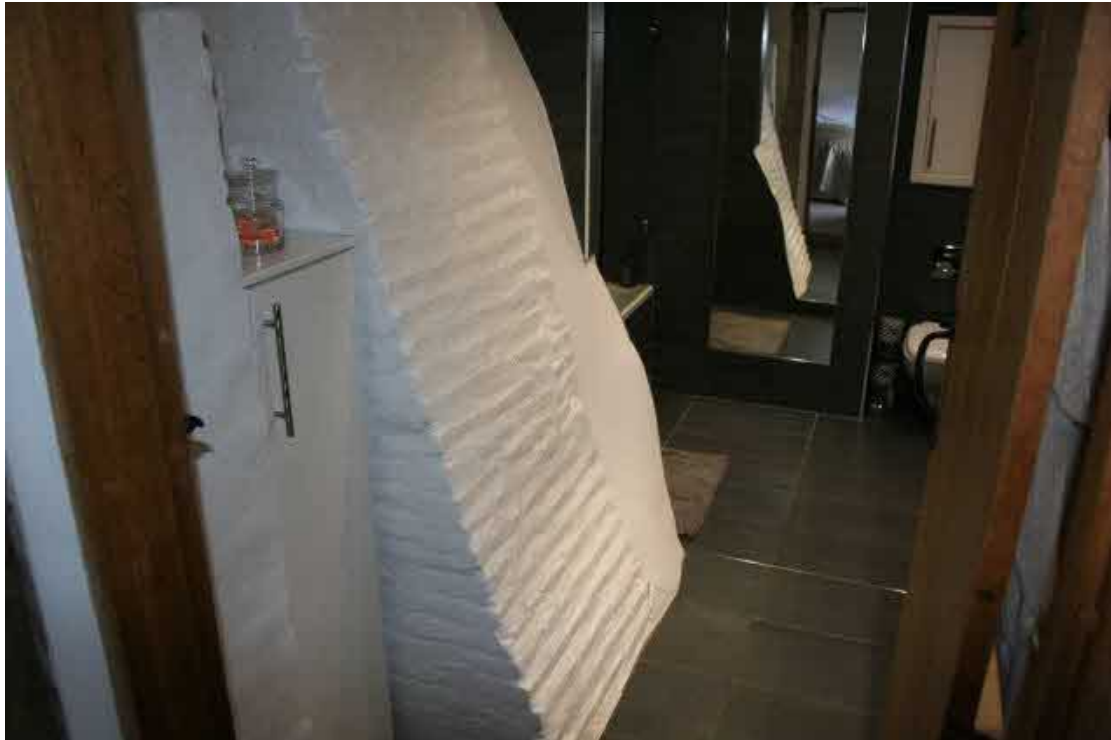
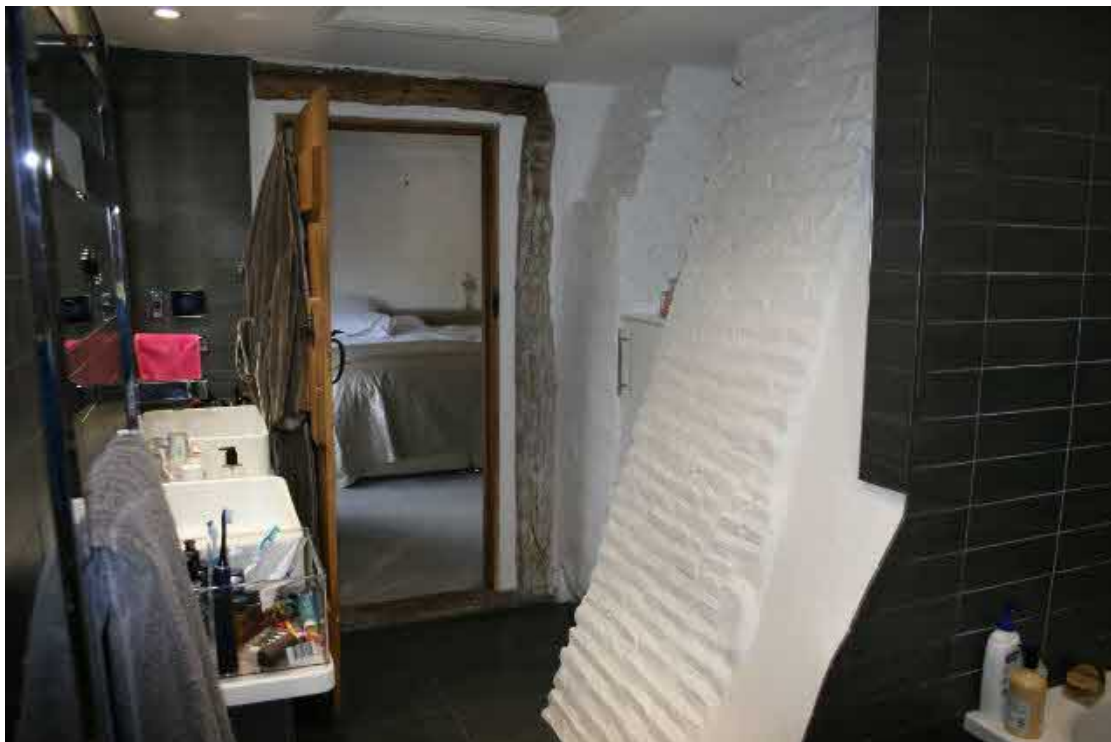
The flank of the firestack seen in the en-suite to Bedroom 1. Looking N.

Looking S in the en-suite to Bedroom 1. The firestack is in two parts.

In the en-suite to Bedroom 1 it can be seen that the firestack is built in two phases with a large gap between the flues. The bathroom itself has been recently out-fitted.

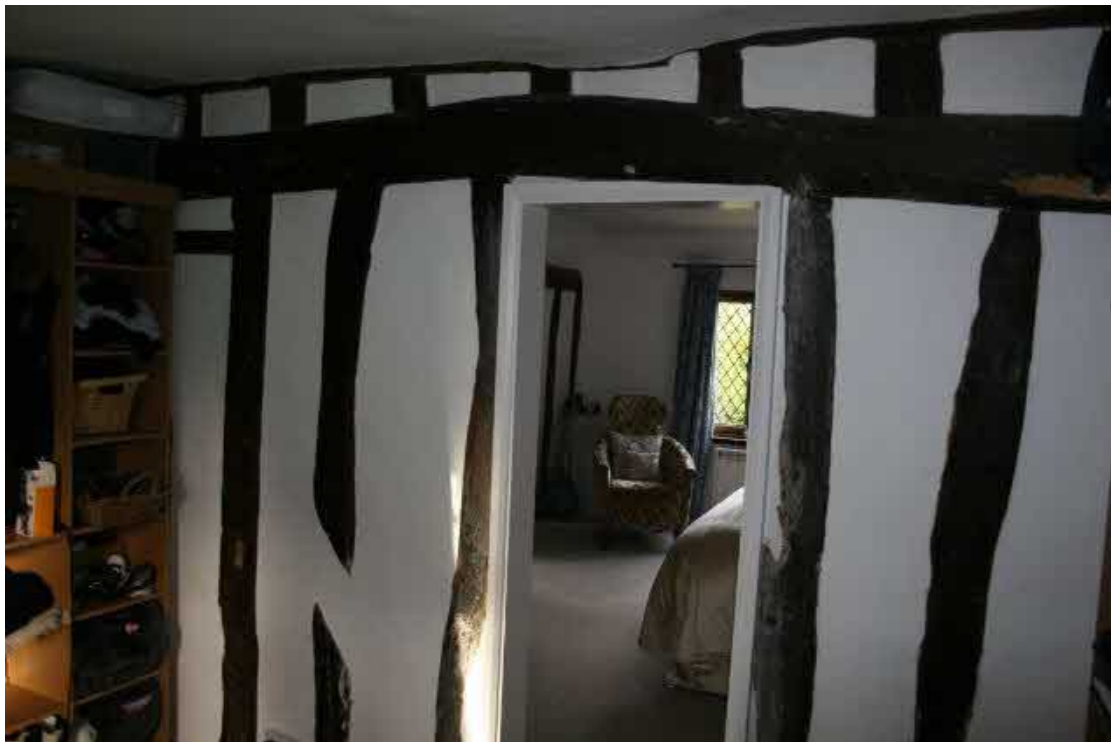
The partition frame in the Cross-wing. Looking E.

In the Dressing Room of the Cross-wing the partition wall retains some of the original studwork. There was a doorway at the north end that has been closed up and a modern central doorway added. The wall has fixture holes for shelves and trenches for curved braces.

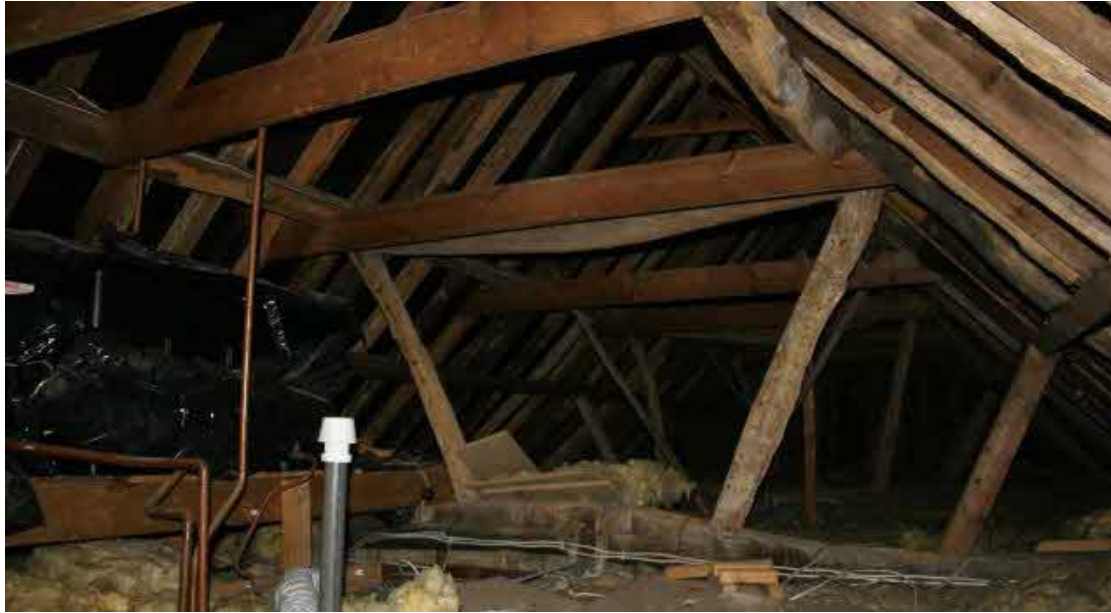
Looking N over the main range from the firestack.

The roof over the main range retains a tie-beam from a crown post roof, cambered and morticed in the middle. The remaining roof is EC19th structure and design and is a simple clasped side purlin roof with plank collars and birdsmouthed struts. It has been extensively repaired in the LC20th with machined softwood timbers, retaining the C19th rafters and also a phase of EC20th machined softwood rafters. There is a fresh asphalt membrane which may have been a like for like repair in 1994 as in general these were only installed between 1965 and 1985 before breathable membranes became supplanted.

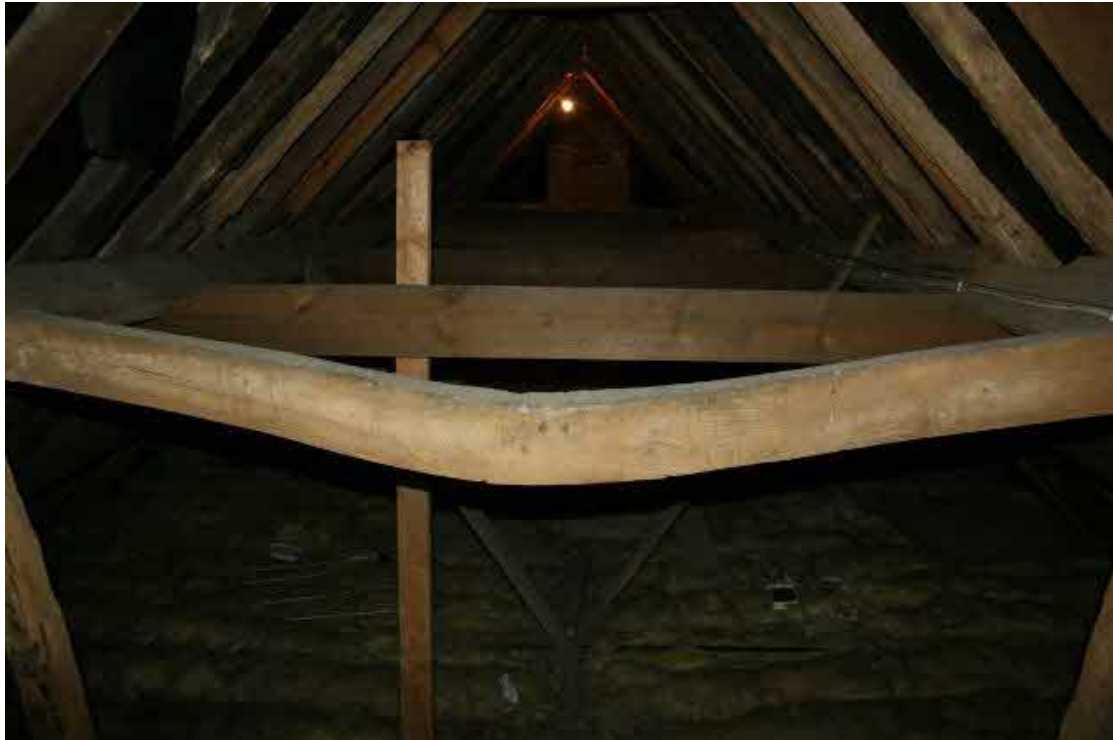
Looking N over the main range at the inverted collar.

Some of the C19th members have bracking marks and one of the purlins is marked Thames with a race knife. One of the collars is inverted.

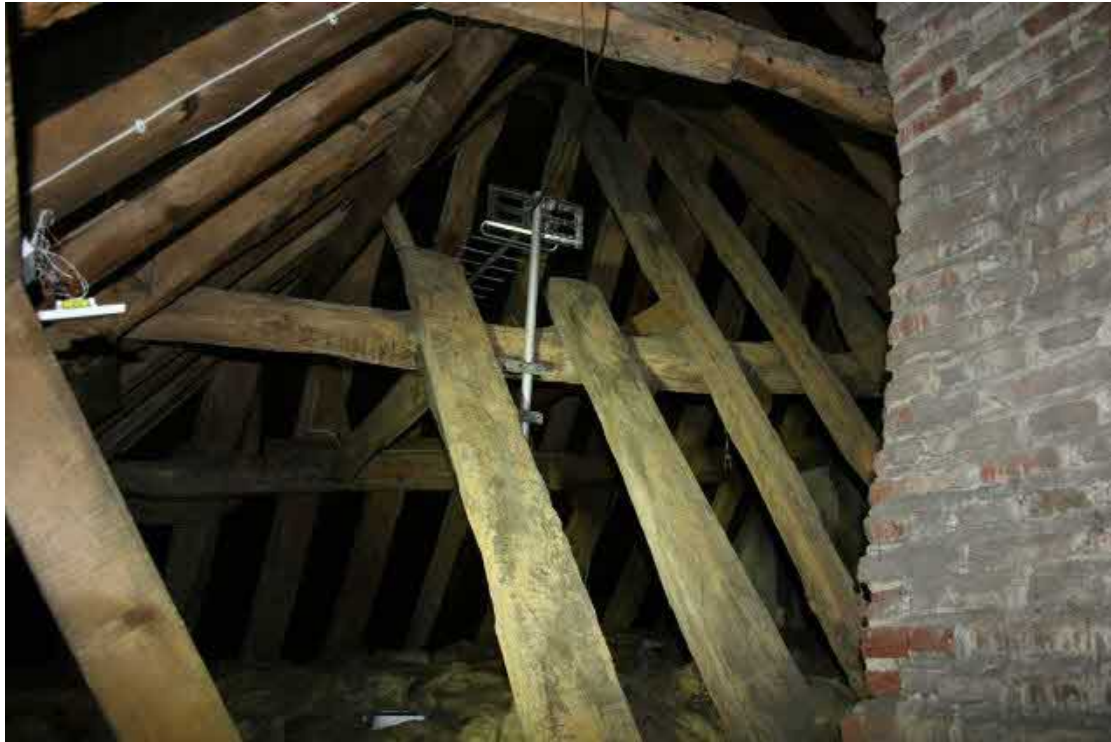
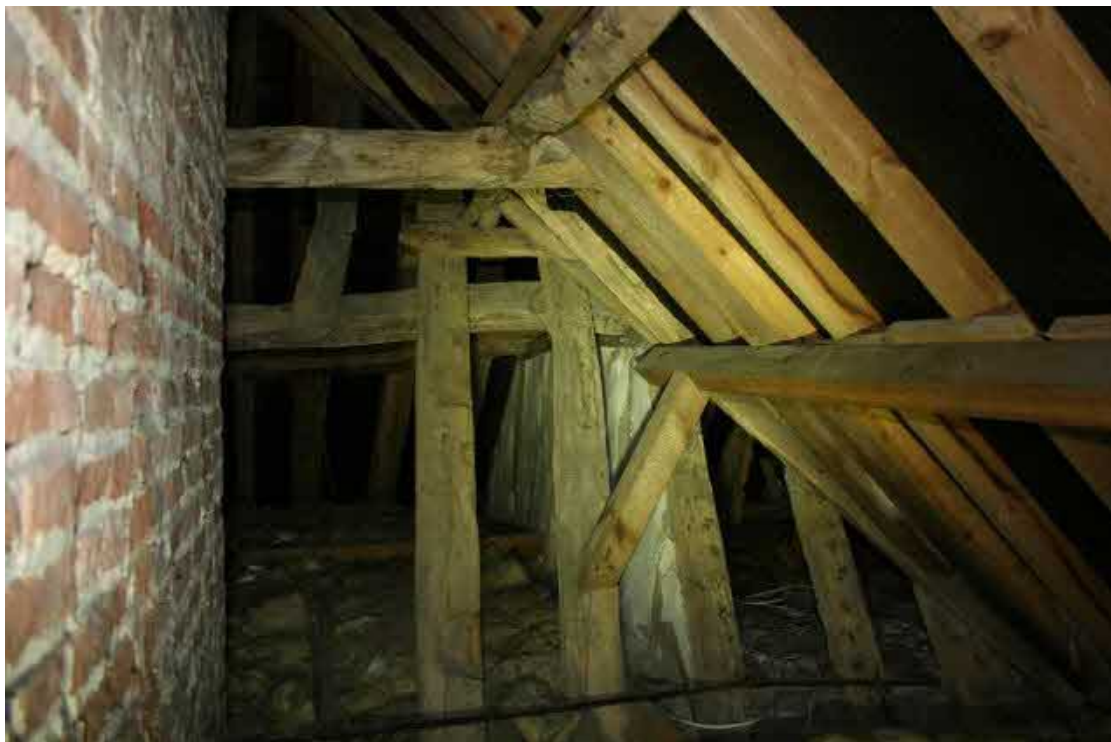
Looking S at the roof over the Cross-wing. West side.

Looking S at the roof over the Cross-wing. East side.

The roof over the cross-wing retains a set of tapered paired rafters from a collar purlin roof which has been rebuilt as a clasped side purlin roof. The partition wall seen in Bedroom 1 is made from scantling studs with wattle and daub panels and most likely EC19th.
