CONDITION SURVEY

**1-4 Church Close,
Sproughton,
Suffolk,
IP8 3BD**

**Church Close
Properties Ltd**

Ref: 23002-CS rev 1

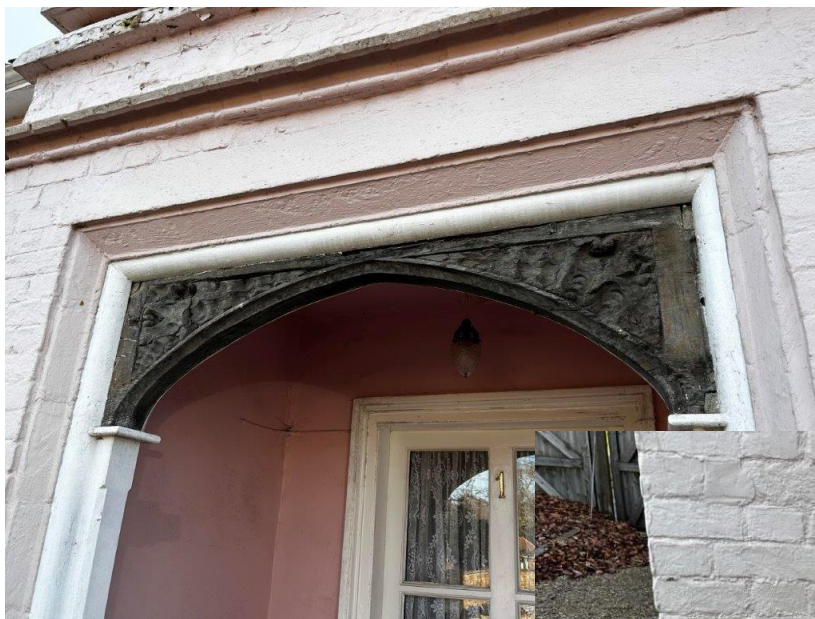
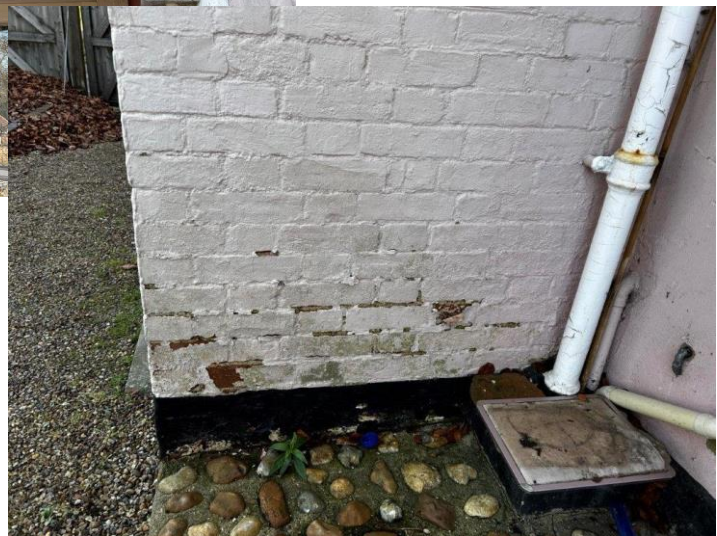
Evidence of rising damp is present on both sides of the porch.

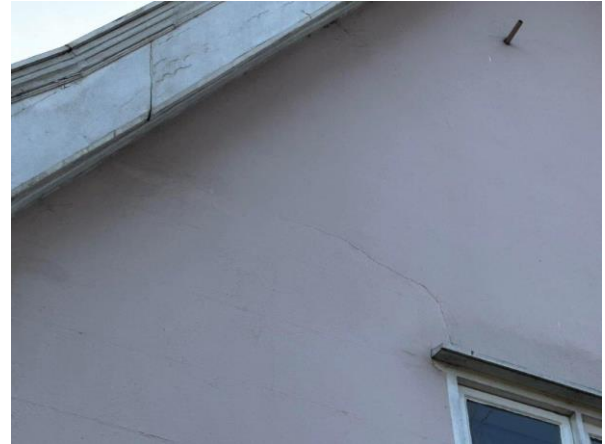
Several hairline cracks are visible to the rendered surface of the gable. These run vertically and horizontally and generally emanate from the window reveals.

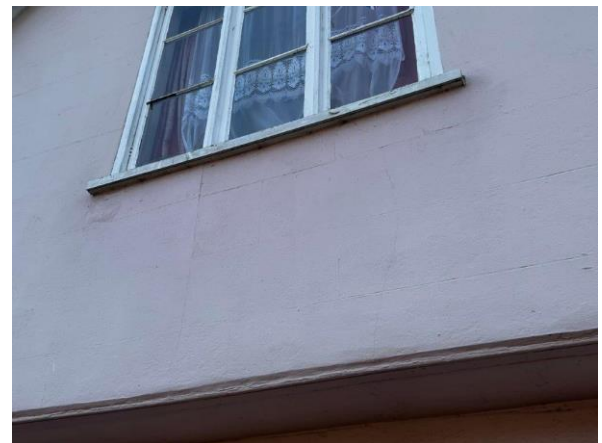
A small section of render has also blown at the LH end of the first floor window cill.

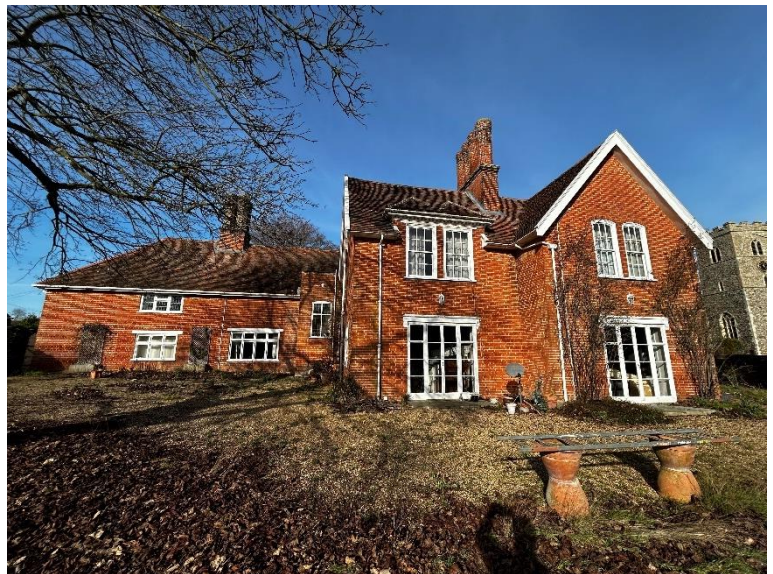
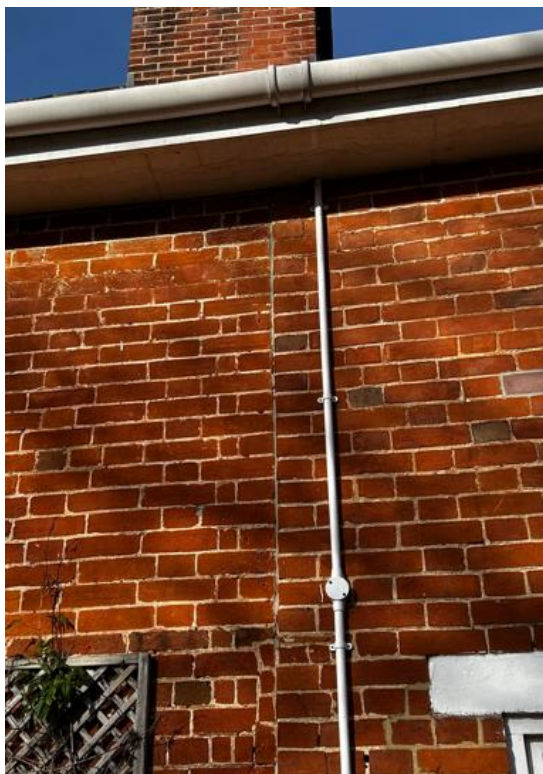
The brickwork is generally in a fair condition with signs of previously infilled openings and repairs.

Stone heads are present over a number of windows and arched brick courses are also present in various locations. Where the building has been extended, the brick coursing has not been toothed in and the mortar joints therefore do not run continuously. However, there is no sign of recent movement in this location.

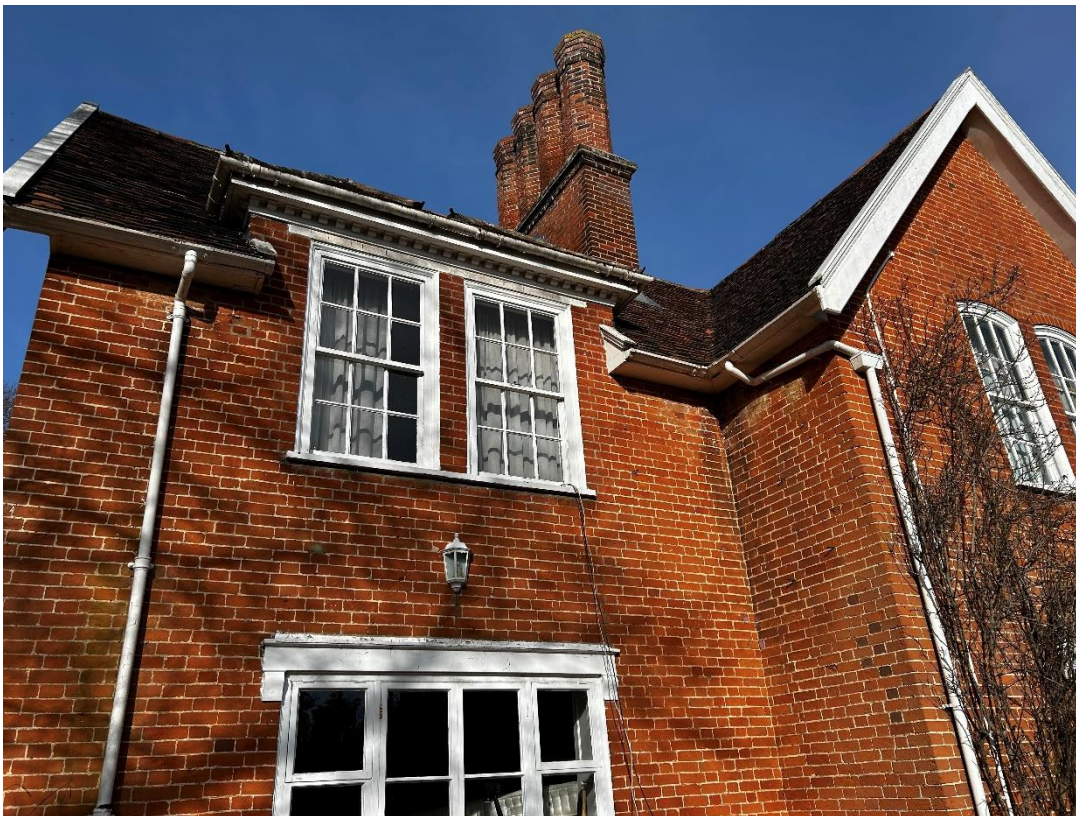
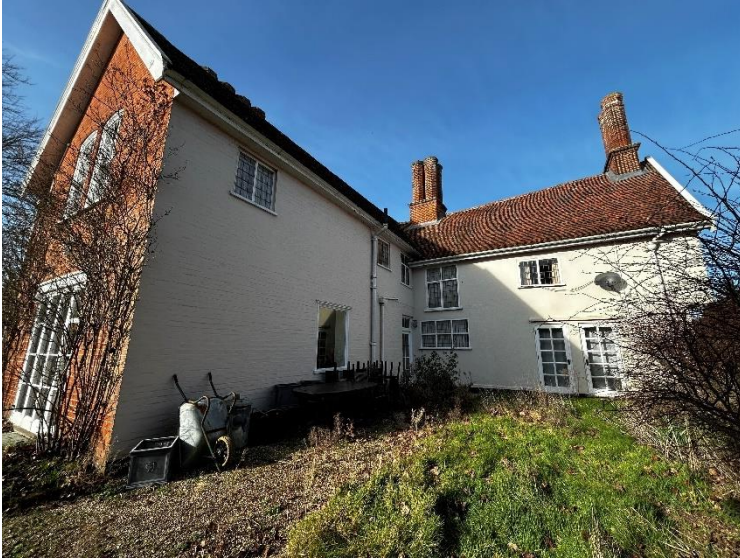
A dormer window with a double hipped roof (and central valley) is located on the rear elevation serving the first floor. The condition of the roof appears to be in keeping with the main roof.

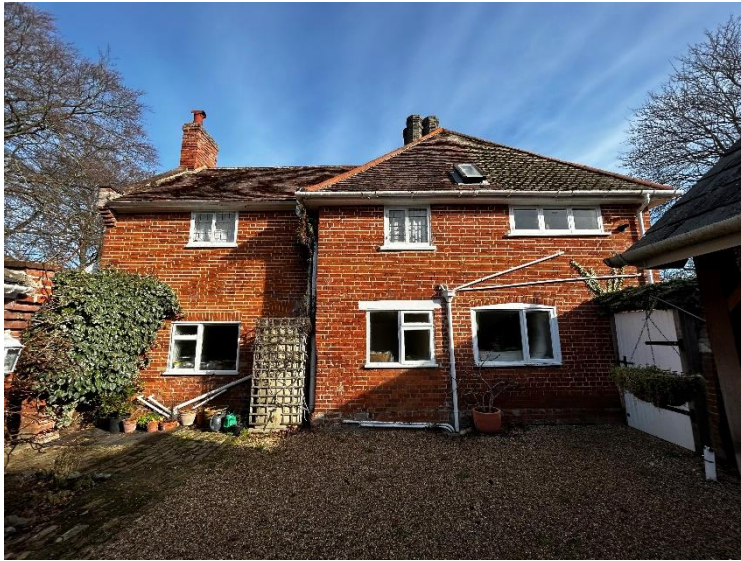
The side elevation to the right-hand end of the main house is comprised of facing brickwork. Vegetation is evident at high level around the rainwater guttering and downpipe at high level.

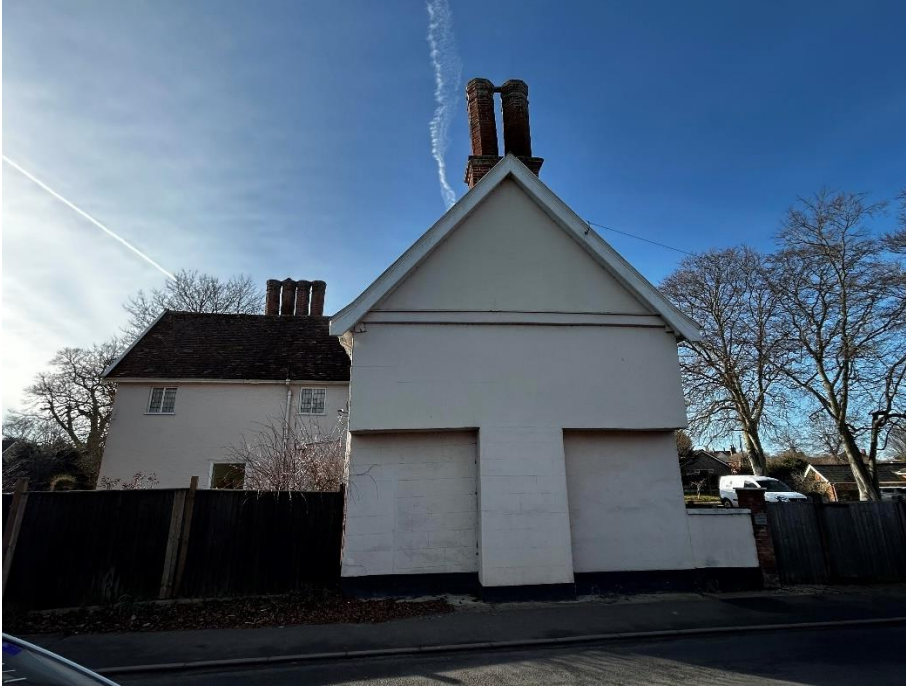
A series of horizontal and vertical cracks are evident across the whole of the elevation. These do not appear to be recent cracks and are assumed to be historic.

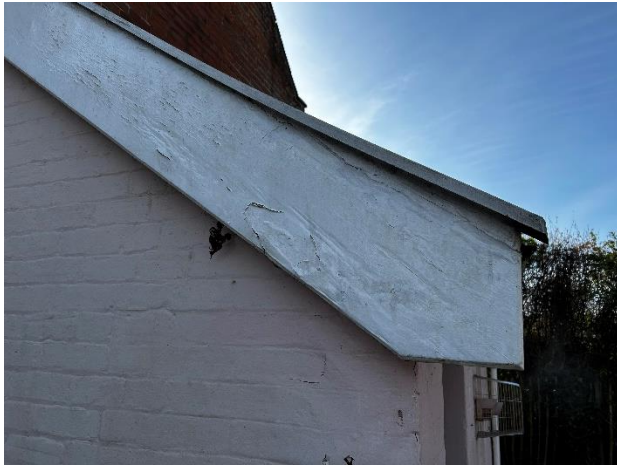
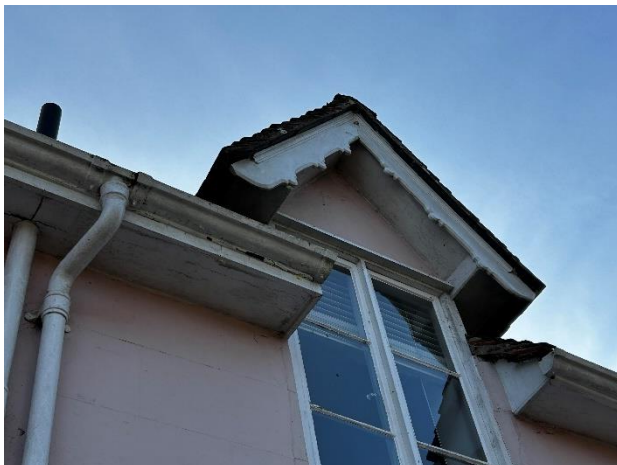
The fascia's and soffits to the perimeter of the main house are generally in a poor condition and are showing signs of rot throughout.

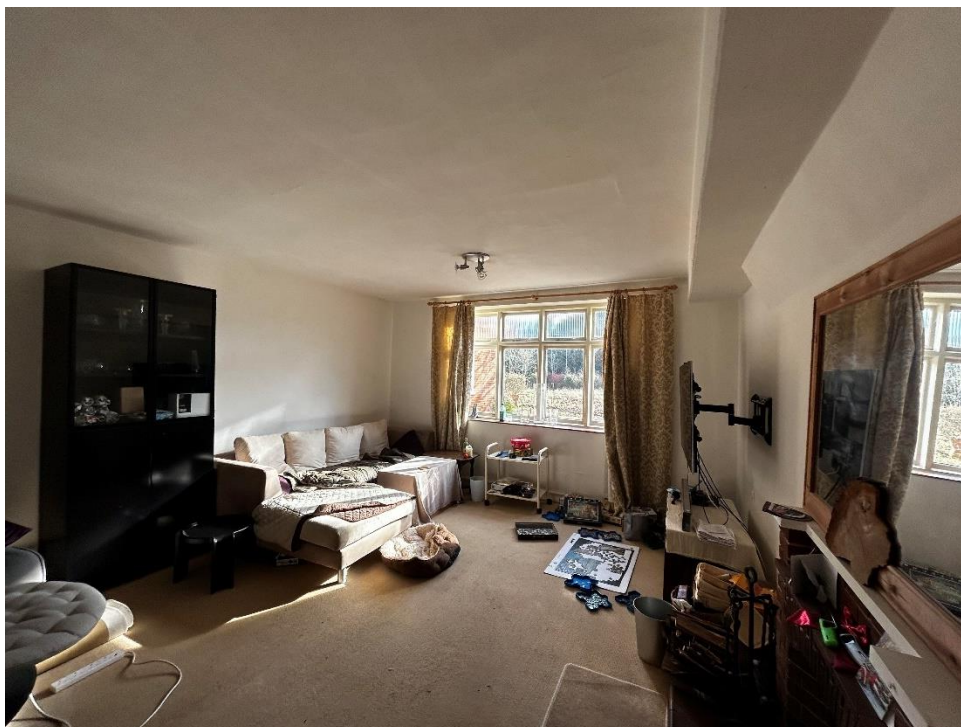
The ceilings show signs of historic cracks that have subsequently been repaired.

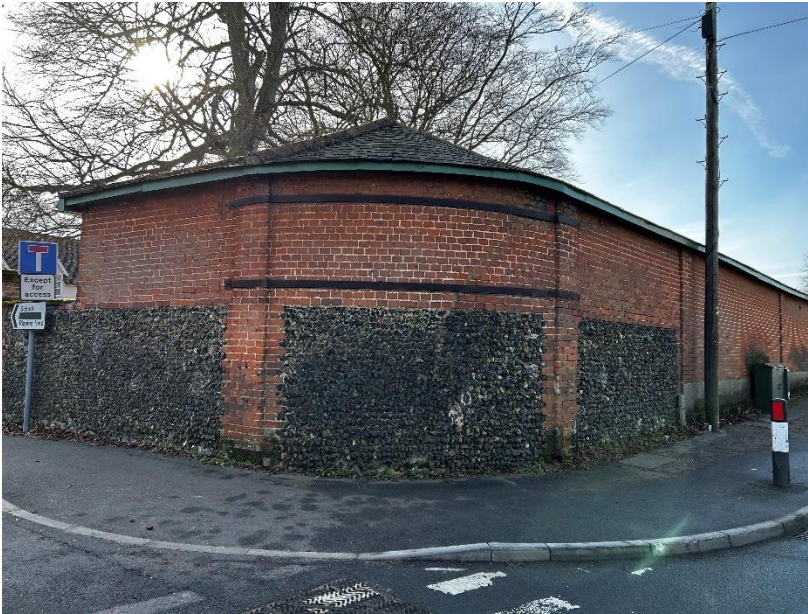
The garage/ store building is single storey with a combination of solid brickwork and flint stone walling.

The building has a pitched slate roof with gable ends and a curved section on the corner of the road junction.

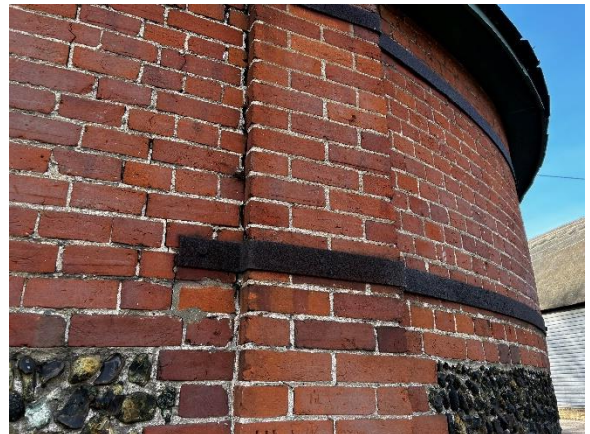
Vertical cracking is evident in the corner between the facing brickwork and the brick pier to the LH end of the curved wall.

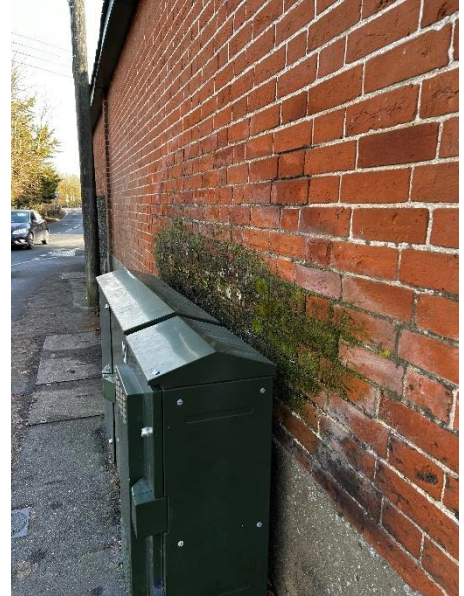
Generally, the wall has suffered from the transfer of water from the highway along with general traffic. As a result, the mortar joints and a number of bricks are worn. A render plinth has been installed at low level.
