# TREE REPORT

**PRE-DEVELOPMENT  
BS5837 TREE SURVEY  
PART TWO**

**Site:** Elms Farm  
Elms Road  
Govilon

**Date:** May 2008

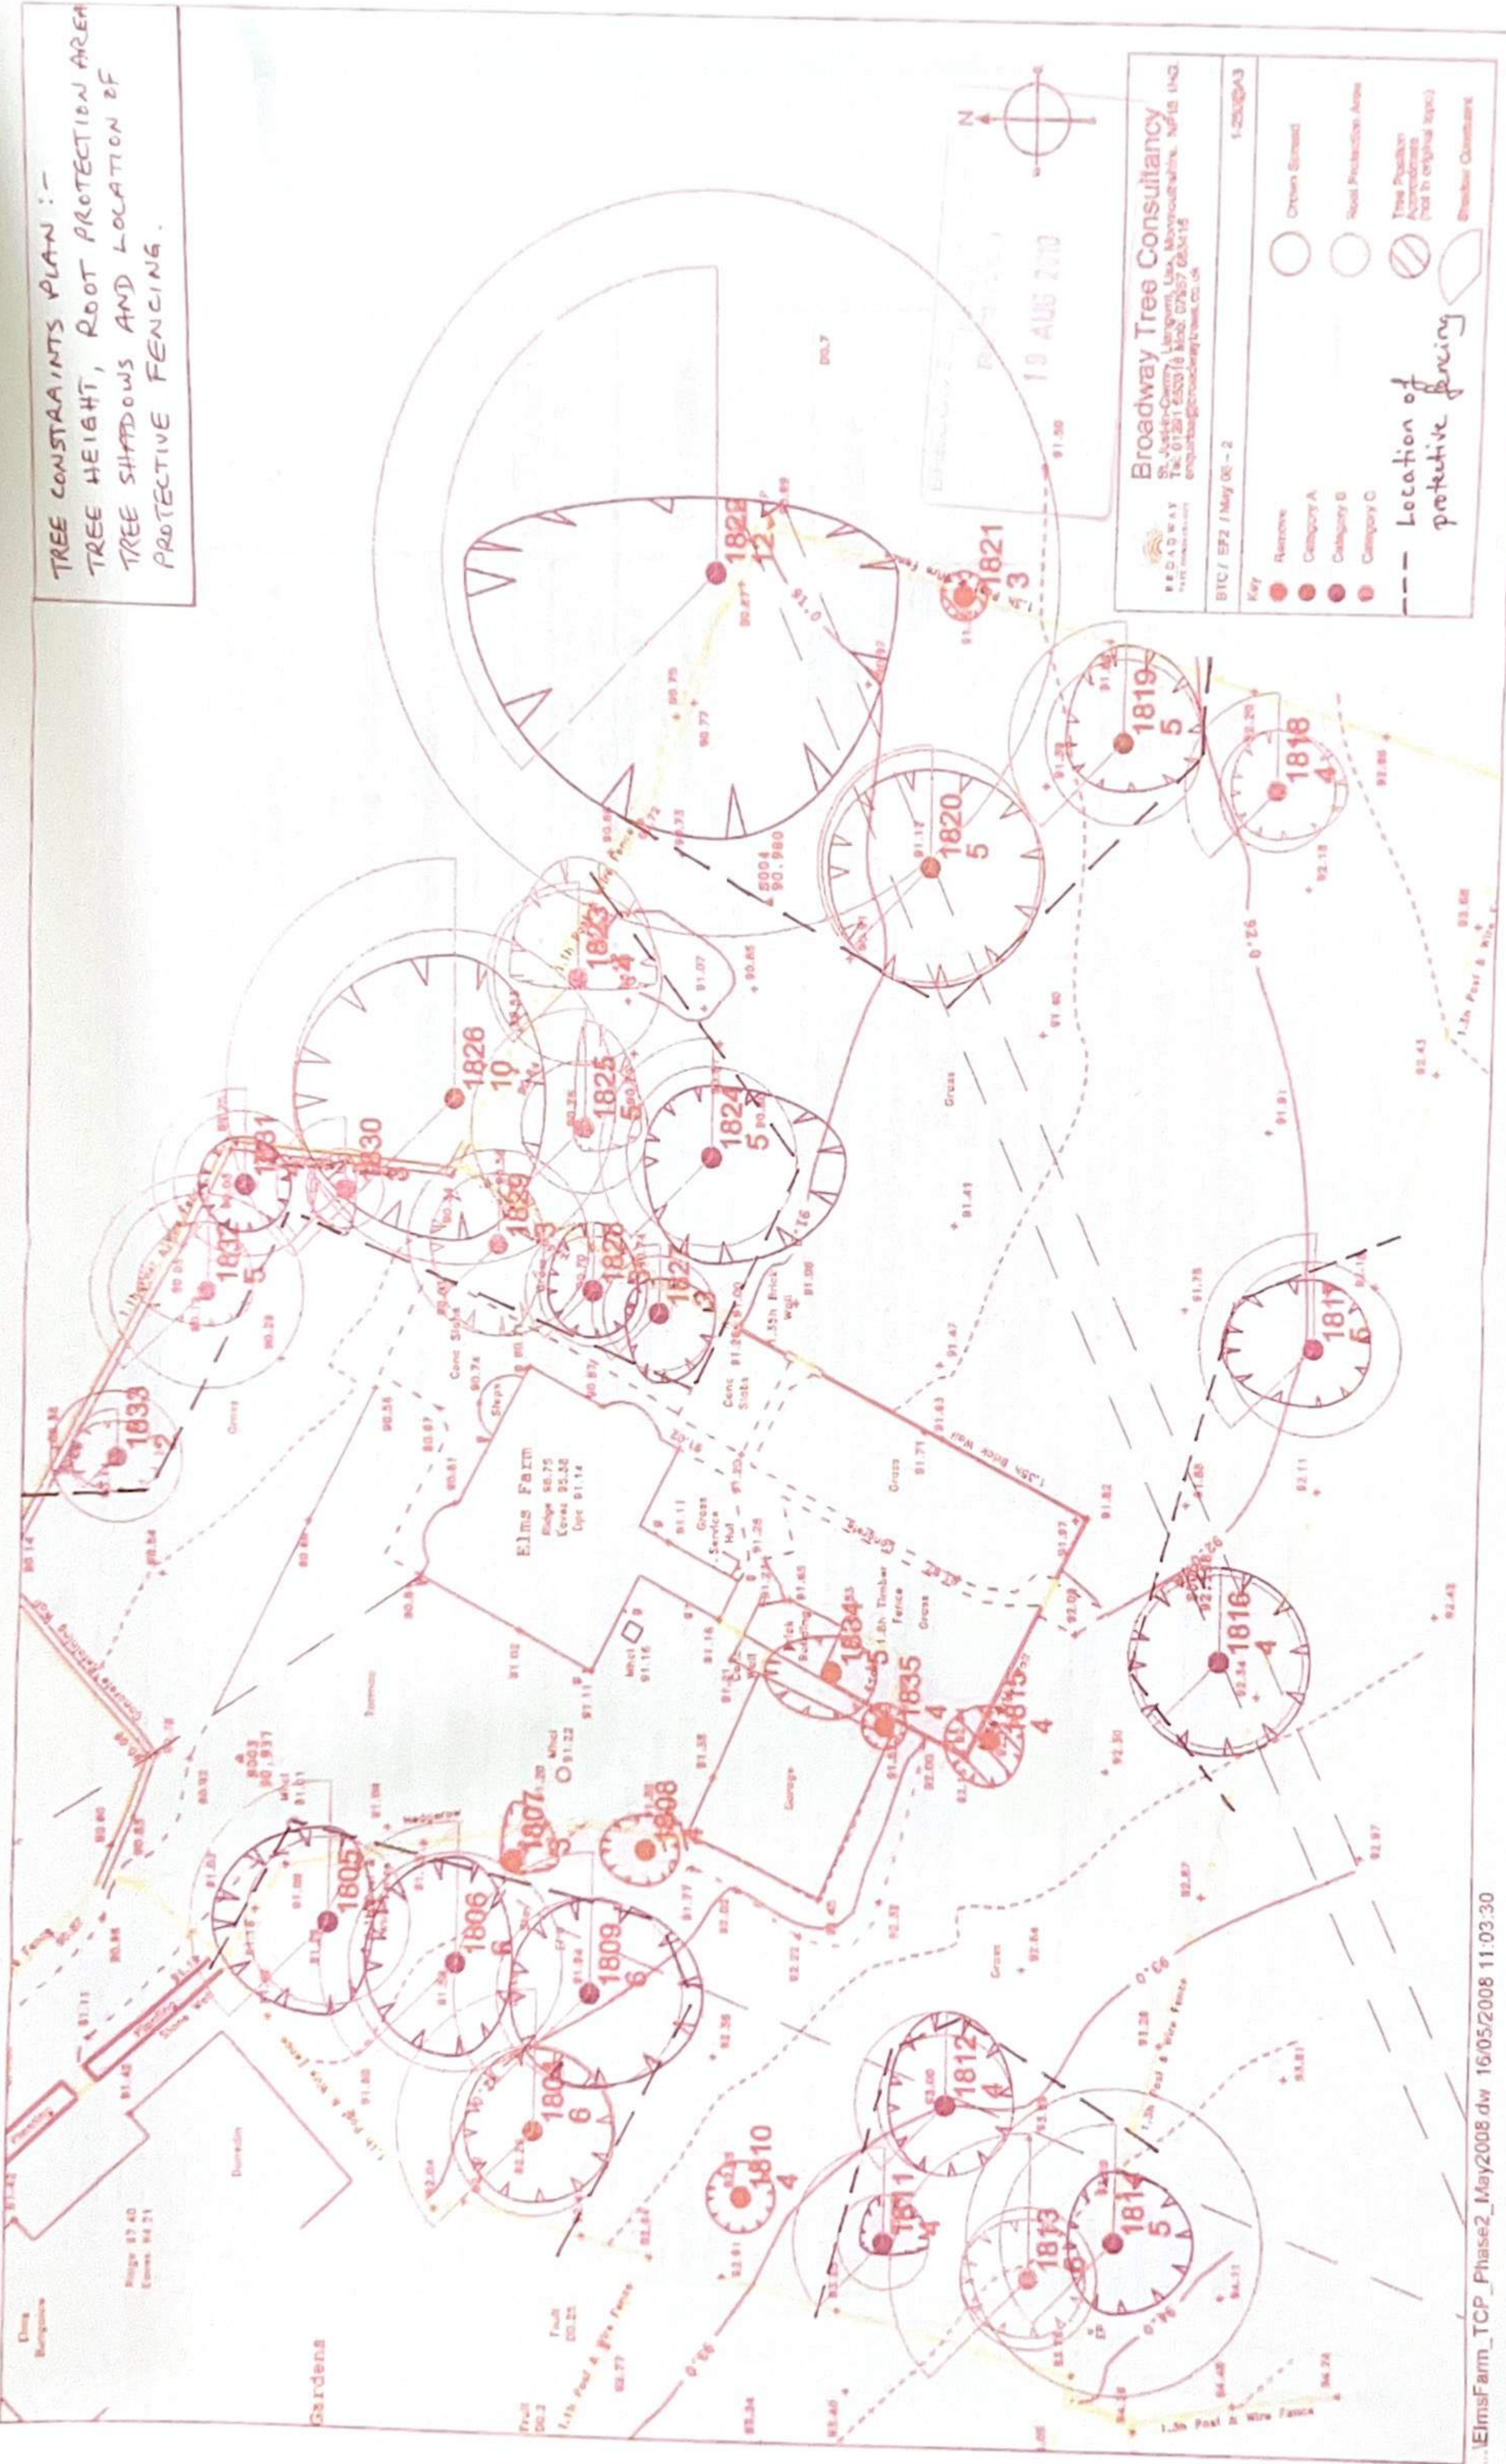
BTC / EP2 / May 08 - 2  
 1-2302043

TREE CONSTRAINTS PLAN :-  
 TREE HEIGHT, ROOT PROTECTION AREA  
 TREE SHADOWS AND LOCATION OF  
 PROTECTIVE FENCING.
