CCTV REPORT FOR: 54 VICARS HILL
LONDON
SE13 7JL

Insured: Ms Quartano & Mr Bailey
Reference: DLG-SN-22-004841

Site Visit: 05-Oct-22
Report Date: 30-Nov-22

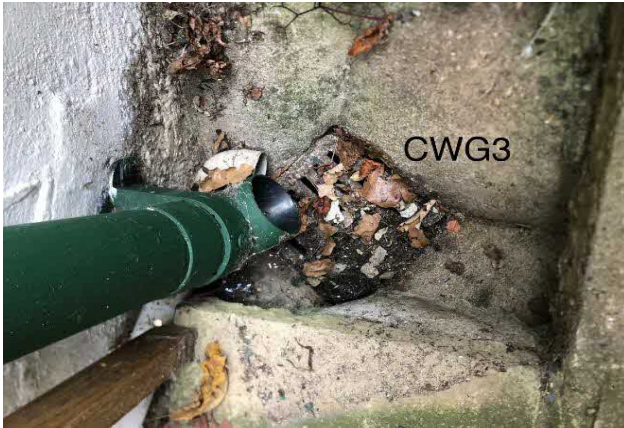
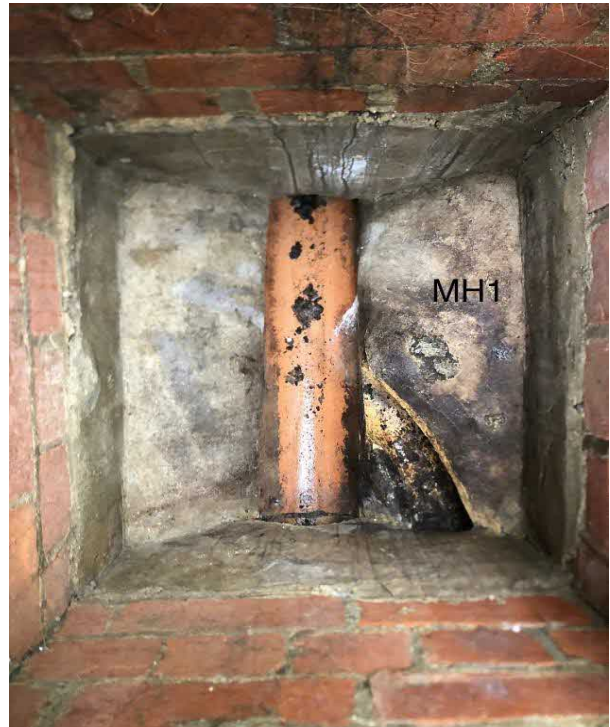
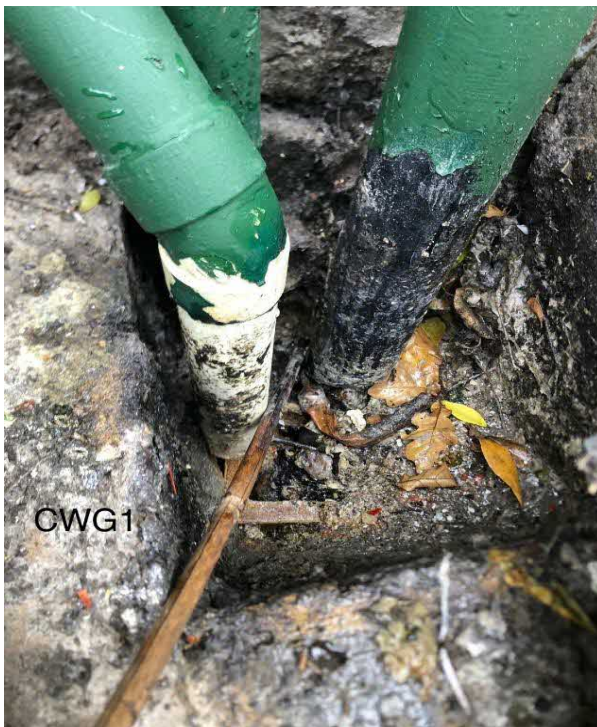
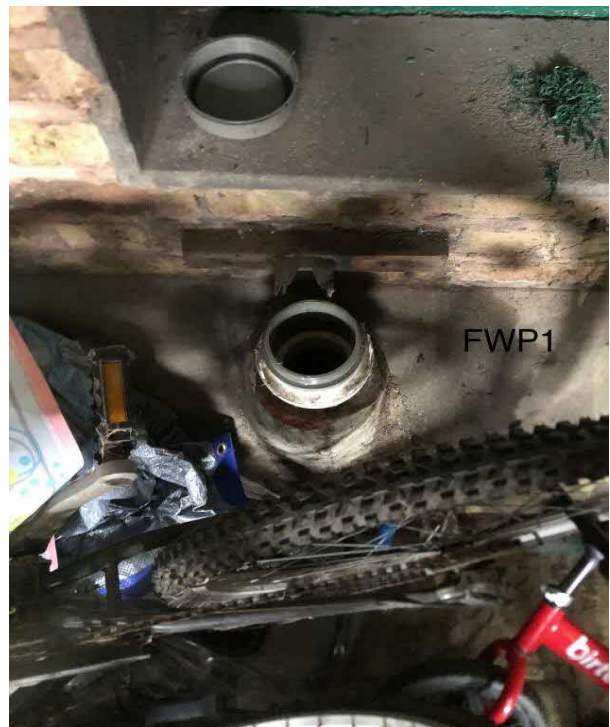
Run 1 - Combined Foul/Storm - Private:
Cracks and displacements.

Run 2 - Foul - Private:
Cracks and displacements.

- Excavate and replace CWG
- Excavate and replace up to 1.0m of pipework downstream
- Excavate and replace junction at 0.6m
- Carry out high pressure water jetting
- Install a structural liner from I/C1 for 4m
- Backfill excavation, reinstate surface, remove spoil from site

- Carry out excavation to gullies
- Break into pipe underground
- Carry out further CCTV to report on condition and end point of pipe
- Backfill excavation, reinstate surface, remove spoil from site
