ARBORICULTURAL IMPACT ASSESSMENT REPORT  
BS 5837:2012 'Trees in relation to design, demolition and construction. Recommendations'

Debden Village Hall, Mill Rd, Saffron Walden CB11 3LE

**DATE: 7 October 2019**

**OUR REF: SHA 944**

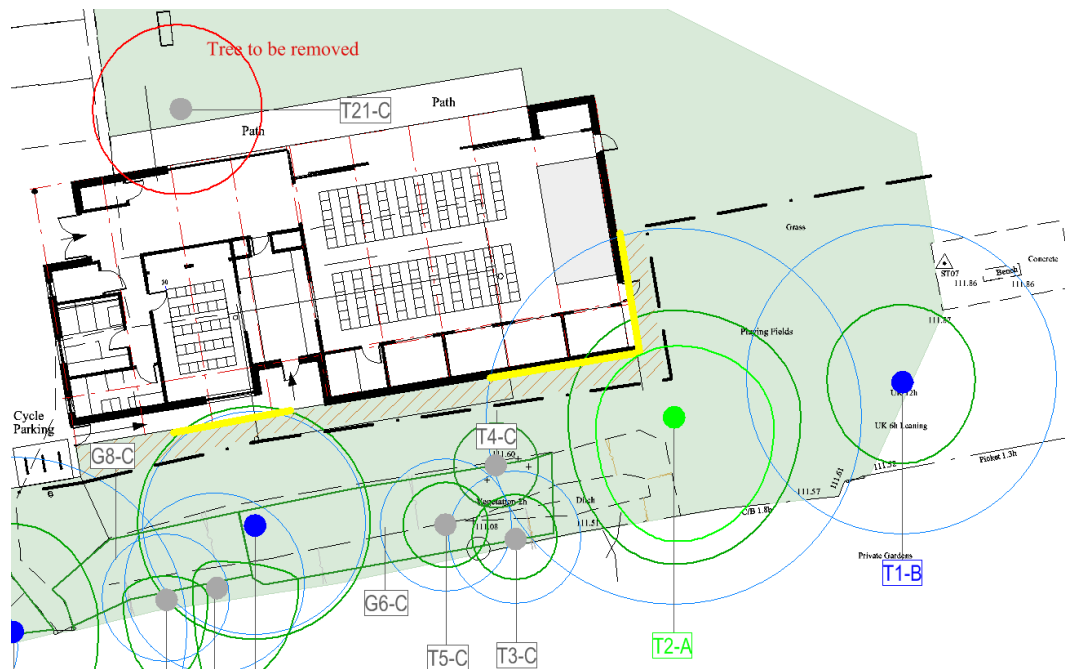
The building is within 11% of the root protection area of T1, and 4m at its closest point. The actual rooting area will be explored under arboricultural supervision to establish the depth, extent and size of any roots in the proposed footprint of the building. This will be done by a hand dug trial trench. The results of this will be reported to the Landscape Officer at Uttlesford District Council and be used to inform foundation design. It will also assist in calculating the amount of pruning required to compensate for any root pruning. Ideally some roots will continue under the building. The down pipes will be directed towards the tree and there will be no excavations for new services along the southern boundary. A draft method statement for the installation of the foundation is found at appendix 6, and the area to which this applies is shown by a thick yellow line (see plan 1 extract below).

*Plan 1 – extract from SHA 944 TPP. Black dashed line – tree protection fencing. Brown hatching – ground protection. Blue circles – root protection area. Green inner circle of T2 – pruned outline (approximately). Yellow line – area where arboricultural method statement applies.*

At the time of writing it is presumed that the tree will be pruned approximately 2m (a crown reduction), as detailed in the tree surgery schedule at appendix 4.

The trees will be protected by tree protection fencing and ground protection to a specification at appendix 5 and at a location on the tree protection plan *SHA 944 TPP* at appendix 3.
