quinquennial inspection
church of st. peter and st paul • osbournby

pcc of south lafford • diocese of lincoln

date of inspection: 23 june 2022

PETER ROGAN
+ ASSOCIATES LIMITED
ARCHITECTS +
HISTORIC
BUILDINGS •
CONSULTANTS
46 • ST. MARY'S GATE
NOTTINGHAM

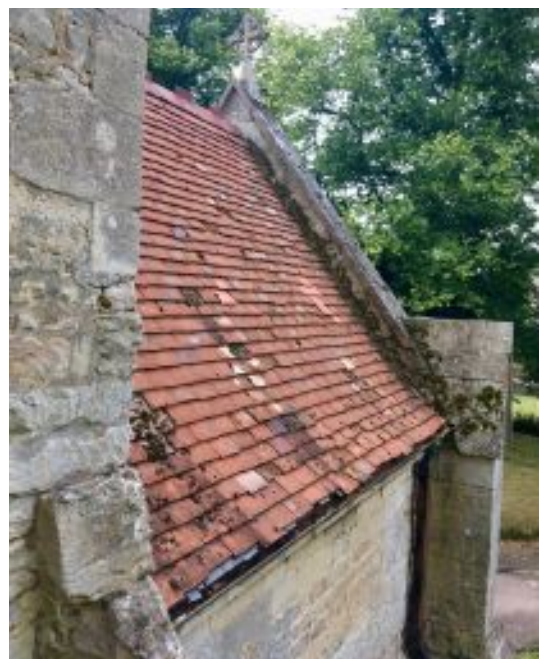
Above: General view of the church from the south. Below: View of the tower roof seen from a drone. Second below: Tower roof concrete gutter. Bottom: South porch west roof pitch.

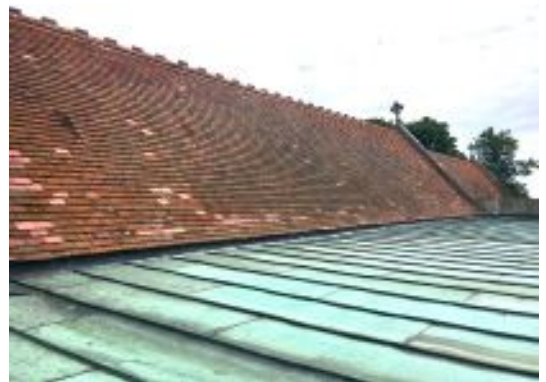
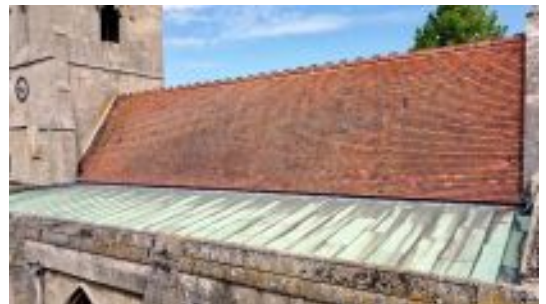
Above: View of the church roofs seen from the drone. Below: Nave south roof pitch looking east. Second below: View of the nave south roof pitch. Third below: Nave north roof pitch. Bottom: Nave north roof pitch seen from the north aisle roof.

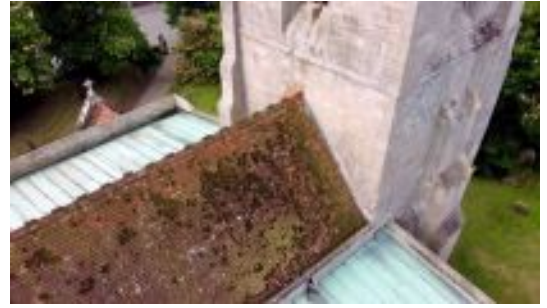
Some replacement tiles but fewer in number than on the south side. Damaged tiles towards the bottom southern south eastern corner, which might be sufficient to allow some water ingress but also a number of tiles to the roof, which are starting to break up or delaminate – not yet significant but a developing problem, which could indicate the roof covering is becoming tired.

Above: View of the nave north roof slope and abutment with the tower. Below and second below: Chancel south roof pitch seen from the drone. Bottom: Chancel north roof pitch and eastern parapet wall and finial.

[B] Replace damaged tiles pending possible full re-tiling in 10 - 15 years.

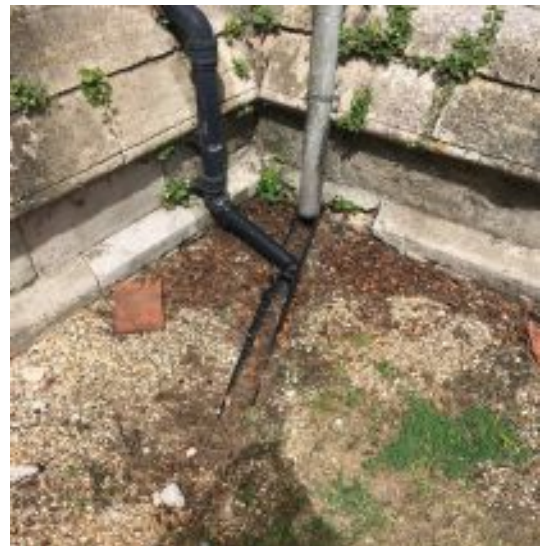
Above: RWP1 - south porch west side. Below: Base of RWP2 and RWP3 with plastic branch pipes.

[B] *Install below ground drainage and gully.*

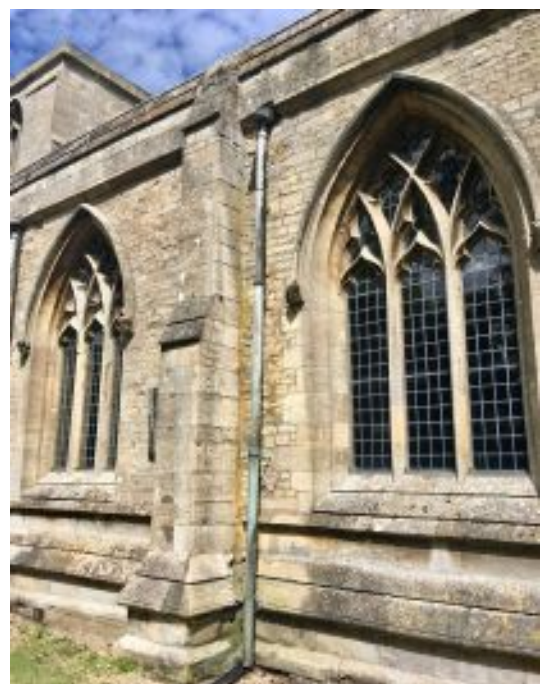
RWP5 Description

South aisle, south side, east end: Circular asbestos cement downpipe discharging straight on the ground causing erosion of soil and adjoining stonework to the church wall but plastic gutter installed to try and direct water away from the wall base.

One of the joints to the downpipe is fracturing and signs of overflow from the top of the pipe. The top of the pipe has a lead drop pipe from a lead chute. Downpipe should be replaced by cast iron or cast aluminium and below ground

drainage installed.

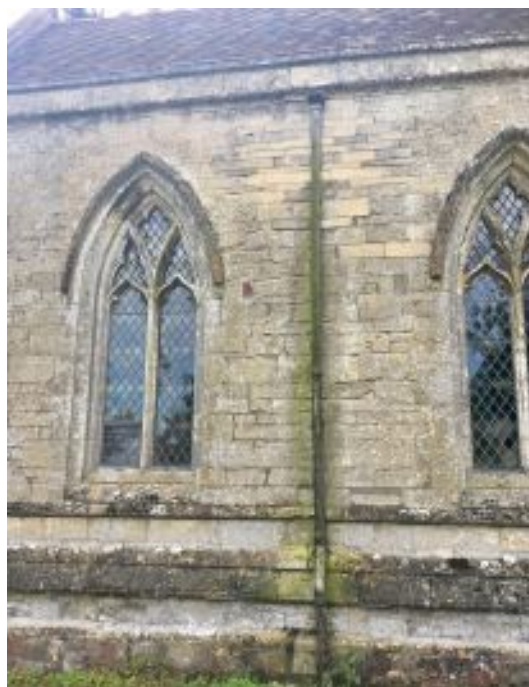
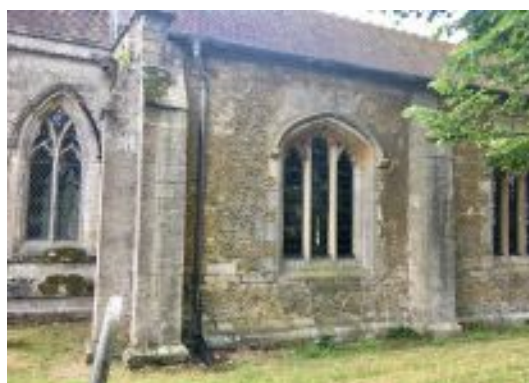
Above: RWP6 - chancel south elevation. Below: RWP7 - chancel north elevation. Bottom: RWP8 - north aisle, north elevation, east end.

The downpipe should be replaced with cast iron or cast aluminium with ground level gulley and below ground drainage provided.

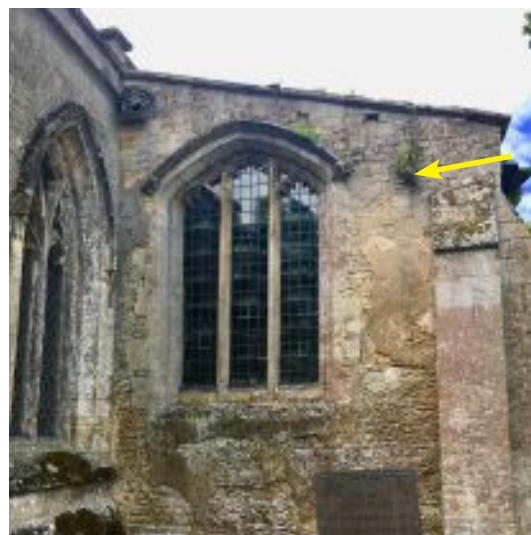
Behind the downpipe at the east end, where there has been overflow in the past. The pointing is looking fairly hungry and consolidation and re-rendering is desirable. Elsewhere on the elevation re-rendering with lime render is recommended. Above the north door there are areas of open joints in the stonework, again all small pieces of random rubble and consolidation and re-rendering is desirable. The buttress stonework generally looks in good order, the significant outward lean of the wall generally looks to be historic and probably pre-dates the Victorian restoration work. The window stonework is described in the windows section. To the top of the wall the overhang eaves generally looks in a good condition but asbestos cement guttering should be replaced with cast iron or cast aluminium. Behind the downpipe at each end where there is no proper gully or managed below ground drainage the wall is becoming very wet and voids in pockets are forming in the stonework, particularly at the west end. There is some debris and need for cleaning out of the guttering but

Above: North aisle east elevation with some weed growth to the stonework. Below: View of the north aisle north elevation. Bottom: North aisle north elevation eastern end.

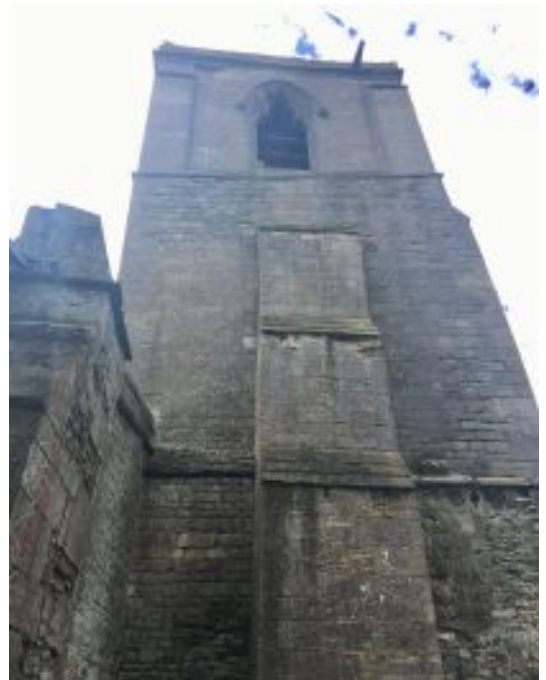
Above: North aisle north elevation, western end with brick-in north door. Below: North aisle west elevation. Bottom: North elevation of the tower.

The pointing generally looks to be in a reasonable condition, the wall is rather twisted towards the north western corner, which again appears to be historic. To the top belfry stage of the tower above the window the wall is missing its window and inner tracery, which has been long-standing and there has been some distortion around the arch head of the belfry window. Possible old crack in the main stonework to the east side of the window, which has been pointed up with cement mortar and has not reopened. Shallow buttresses to each corner and offset to the base of the belfry stage. Moulded stringcourse/overhang detail to the base of the very shallow parapet stonework where most of the upper parapet stonework is now missing. Long lead chute to the northwest corner of the parapet. The high level pointing still looks in reasonable condition although cementitious - remains as noted in 2017.

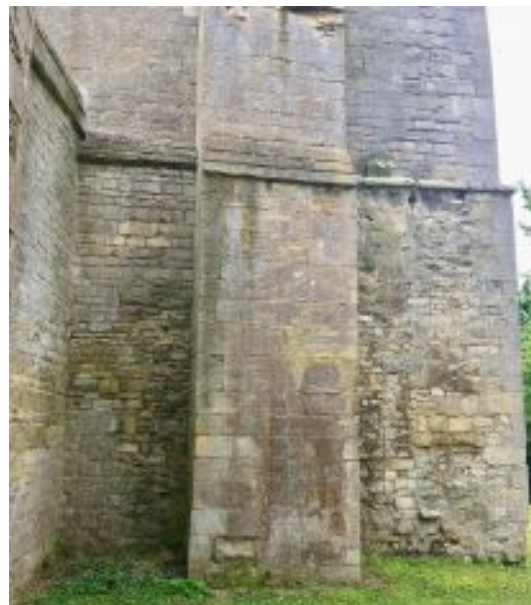
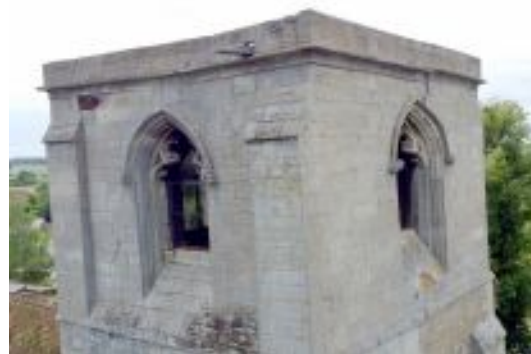
There is evidence of some cracking through the northern buttress, partially disguised by the render but running vertically through the middle of the buttress. The window stonework is as described in the window

Above: Tower north elevation lower stage. Below: View of the tower north and west elevation at belfry level seen from the drone. Bottom: Tower west elevation lower stage.

section but with some cracking evident running in the stonework, which looks somewhat fresh and running through cement pointing leading from the base of the window corner on the north side down through the stonework below, almost running down to ground level. Above the window some cracking from the window arch running through the plinth into the base of the tower stage above through the ashlar work, possibly in part caused by some poor bonding of stonework. The crack then seems to peter out. The southern buttress contains some old weathered stones but the stonework has generally been pointed up in a cementitious mortar and appears to be satisfactory for the moment. The old ferramenta to the window would benefit from repainting and has caused damage to the lintel stonework but the damage now is probably less significant than the interest value in the old ferramenta. To the second stage the stonework around the slit window to the stair would benefit from pointing up and one or two stones above the lintel are rather weathered and might benefit from consolidation or replacement. To the northern buttress some of the face stones have been masked with a mortar fill abutting old render but not blending well with it and a couple of the corner stones on the southern aris, 2 courses up from the stringcourse to the base of the lowermost stage, have spalled leaving a gap. The stringcourse stonework to the top of the lowermost stage is cracked and split in places with some missing sections, notably to all the corners of the buttresses and through the southern half of the main walling area. To the southern buttress on the second stage some open joints, which would benefit from pointing up in lime mortar and a little bit of damage to the top offset. To the belfry stage there is some old distortion around the head of the window, fairly significant and displacement of tracery. Running up into the stonework above there is some distinct misalignment of the stringcourse detail to the base of the old parapet. The parapet itself has been truncated and capped with a lead covering. All movement in the tower is very significant but appears to be historic and it appears as if the northern side of the tower has slumped and distorted in the past. At present however, the top stage of the tower looks to be in a satisfactory condition and all movement historic – note that birds are entering through the mesh in the window. The tower underwent major repairs in the 1960s when much of the renewed masonry visible on the west face is presumed to have been installed - all generally remains as recorded in 2017.

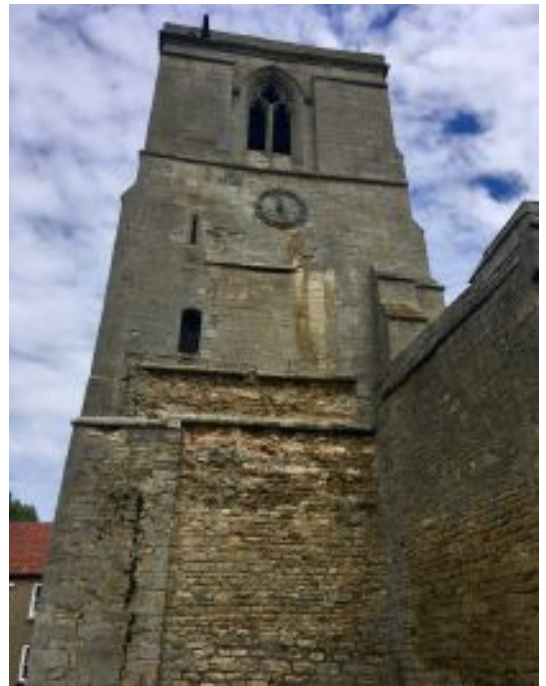
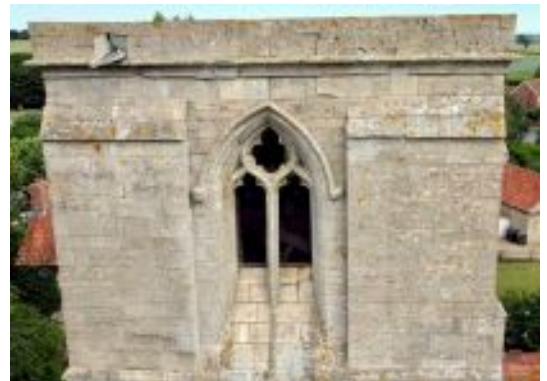
Above:View of the tower south elevation. Below: Tower south elevation top level seen from the drone.

[C] Patch pointing of open joints recommended.

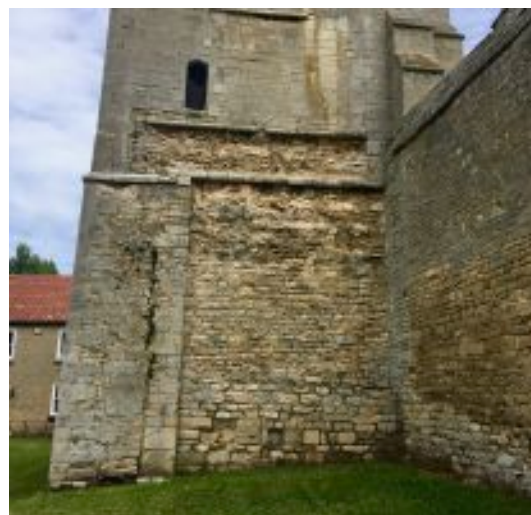
Below: Tower south elevation lower stage.

The mullion and inner tracery to the window to the belfry is now missing. Weathering to the stringcourse to the base of the parapet, the parapet has been taken down with only 2 courses remaining and capped by a leather weathering. Some distortion in the parapet evident but is all old and long standing. All stonework to this face of the tower generally seems satisfactory, past pointing in a possibly cement based mortar but all sound for the moment - all remains as noted in 2017.

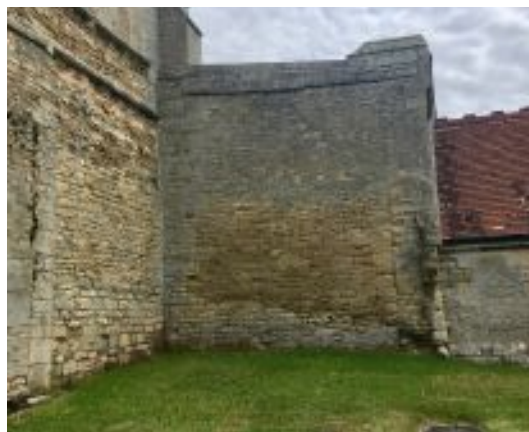
End base stone to the parapet is a bit out of alignment and the joint underneath is open and would benefit from pointing up. Roll top coping stone is fracture to its western corner and some of the adjoining coping stones are also fractured horizontally through the stone and require pinning or replacement. The lower stonework above the porch roof is generally ashlar work, a few bits of pointing up required. To the side of the porch evidence of where the aisle originally continued westward. To the east of the porch behind the downpipes there is some erosion of stone and proper drainage needs to be provided. The airbricks require repainting and some consolidation and filling of gaps and voids in the plinth stonework is desirable. The stringcourse generally looks to remain in a reasonable condition with a couple of sections of minor damage to bricks etc but nothing of significance. To the parapet some evidence of horizontal fractures in some of the upper coping stones, mainly towards the western end but also potentially elsewhere, partially disguised by moss growth. Evidence of some distortion in the parapet, which appears to be historic and some of the base corbel stones have been replaced in the past. Stringcourse/overhang to the edge of the porch roof has some curvature/distortion, which is old and this is all basically satisfactory. A few pockets and voids are just starting to form in the stonework and when further pointing is carried out this should be in lime mortar - all generally remains as seen in 2017.

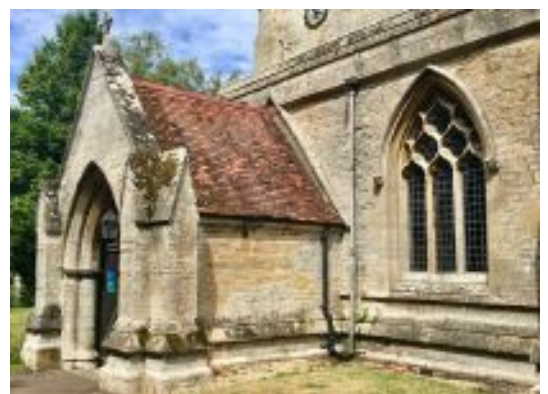
Water from the downpipe discharges onto the wall leaving open joints at the wall base. Some old evidence of leakage from the joints from the gutter, which is laid level on a corbel stone to the top of the wall. The wall has some patch pointing in cement and also lime pointing, a few bits are working loose but nothing significant at present. The guttering has been re-bedded onto cement to create a slightly better fall. Some weed growth at the back of the parapet to the southern end of the gutter need to be controlled and removed and may be being sustained by some of the moss growth in this area, which might need clearing back to prevent opportunity for regrowth.

[M] Remove weed/plant growth to parapet.

[E] Patch point in lime mortar where cement mortar is failing.

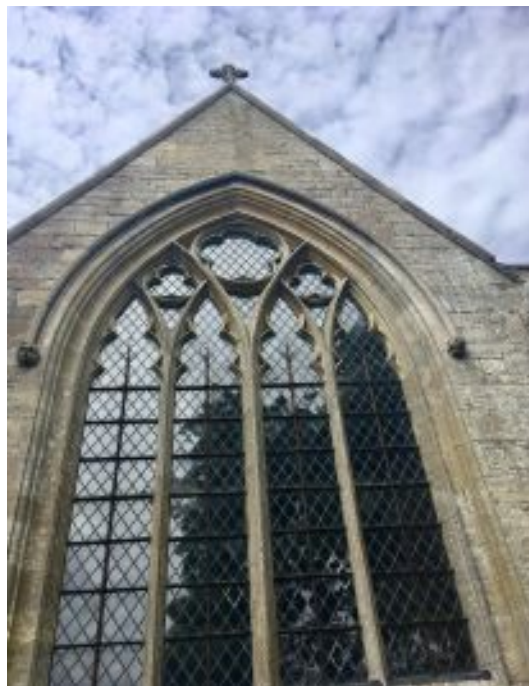
Above:View of W1 - chancel east window.

The window stonework generally remains in a good condition and probably renewed or repaired in the 19th century. Rust to the ferramenta, which ideally would be removed and tipped with stainless steel and reinstated and should be painted to control the rate of rusting, which in time will damage the stonework. The window leading looks to be in generally good condition with a bit of distortion to the base of the 2nd panel from north and some evidence that some quarries may have been replaced also to the 2nd window from south. Stonework is in a good condition, lead weatherings to the bases of all main panels. To the upper tracery there is some distortion and cracking to the very top of the main panel, 3rd from south, from old movement and filling of the open gap would be beneficial. There is also evidence of a bit of movement in the arch on the south side and a wider or displaced joint to the south side of the keystone at the top of the arch. The hood mould is generally in a good condition with foliate detail to the stop ends. There is a small amount of loose pointing to the cill but nothing significant at present. Some opening of joints to the base of the circular window at the top of the window and the stone may be becoming displaced and should be checked.

[E] Tip external ferramenta in stainless steel and point open joints in cill.

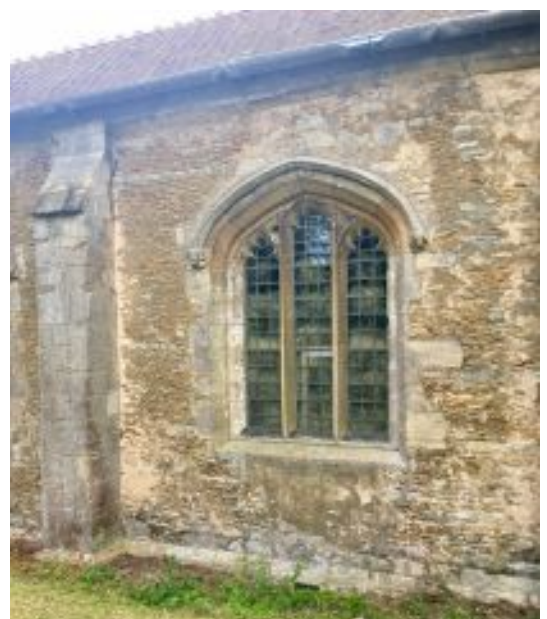
Bottom:W8 - north aisle north elevation western window.

Some dirt and algal build-up on the inside, which is trapped by the internal structure of the vestry. A few patches of lichen growth on the stonework, which is not significant. All window stonework is generally satisfactory and an open joint to the top of the arch, inner and outer, which would benefit from pointing up.

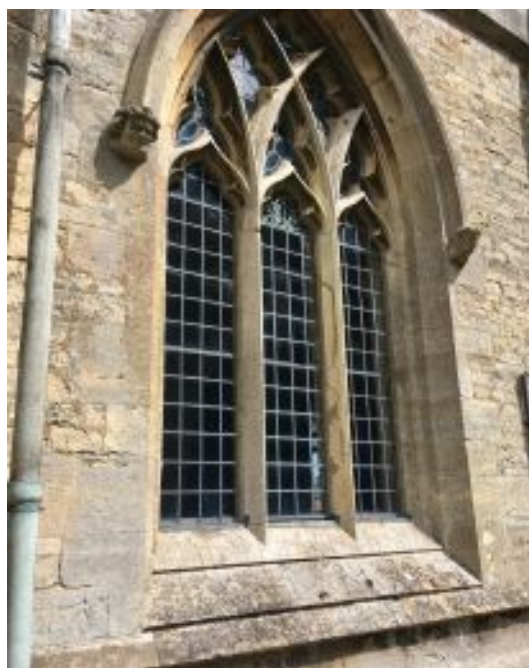
The leading is slightly distorted around some of the quarries and joints halfway up in the middle panel, lead aprons to the base of all windows. Mullions have had past repairs with a piecing-in or indent repair to the top of the western mullion and some patching to a split in the eastern mullion but carried out crudely and further repairs are recommended, either micro-pinning and consolidation by a stone conservator, now more likely sections of replacement mullion required in due course.

[C] *Repairs to window stonework by a stone conservator desirable.*

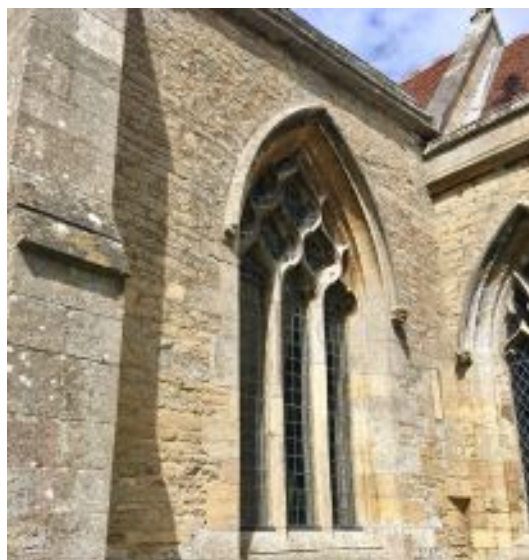
A hood mould is missing its stop end on the south side, the decorative hood mould stop end on the north side remains. Arch stonework remains generally in a reasonable condition, small signs of displacement of the tracery above the middle of the top of the main panel, which appears historic. The cill stonework and jambs generally satisfactory. The metal work, where exposed, would benefit from ideally removal and tipping with stainless steel, or else at least painting to control the rate of rusting. The top of the southern mullion has moved out and has been re-set in the past due to the rusting of the ironwork but is not very well aligned and generally both mullions have had past repairs and indent repairs and have a rather wayward in and out formation as they rise up the height of the window, although no obvious evidence of any current instability. The main panel has been re-leaded with a rectangular clear leaded glass, the upper panels have also been re-leaded with a few inclusions of old mediaeval glass and some new bulls eyes.

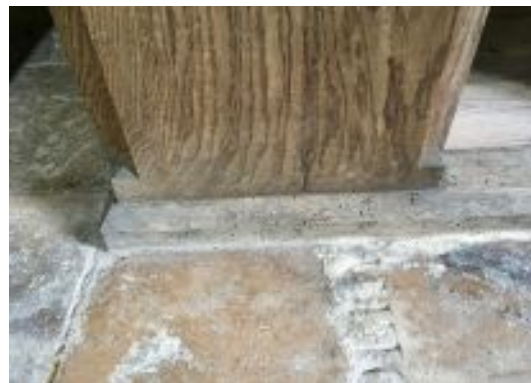
but generally the floor is in a satisfactory condition bar one or two very slight trip hazards where the coir matting has started to ruck slightly or is stuck down with duct tape. To the pew platforms in places there are areas of woodworm in the floor and death watch in the edge kerb, which may well be live and where the increased damp levels in the floor may be creating a suitable environment. Therefore there is a possibility that joists beneath are also decaying; only limited scope for ventilation to the under floor voids, which again may allow beetle activity and potentially rot to occur. Ground level drainage around the church needs to be improved to try and allow the floor to dry out but also it may be necessary to try and improve ventilation by introducing vents underneath some of the pews to allow further air movement underground and the area underneath the pews to dry and local repairs where woodworm in softwood boarding is significant. To the edge oak kerbs the death watch appears to be not confined to just sapwood, again indicating that moisture levels in the timber are relatively high. This is a concern because the death watch could spread to the historic oak pew ends. It may be worth seeking grant aid to help support a more thorough inspection of church timbers by a timber decay specialist, eg. Hutton & Rostrum or Ridouts.

To the second pew from rear on the south side one of the floor boards is deflecting, possibly due to decay of the supporting structure under the floorboard itself and there are boards in the same area that show clear evidence of woodworm activity. All remains as recommended in 2017.

[B] Closer inspection of timber floors including lifting boards.

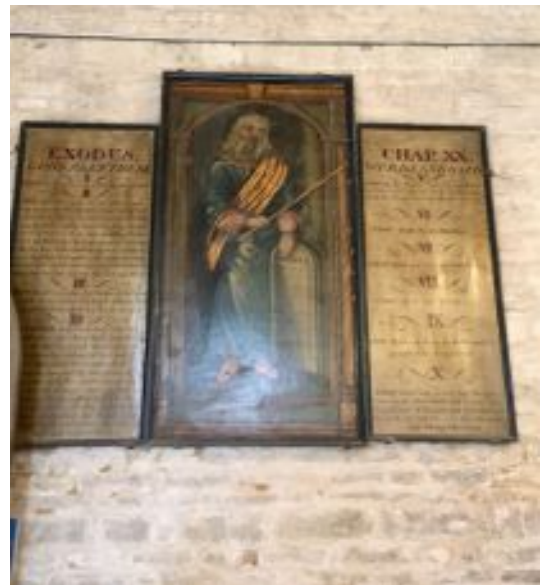
The creed board with painted lettering direct onto timber and a central painted panel on canvas with a timber frame is fraying to the bottom edge of the canvas and there appears to be a repair with a row of rusty nail heads running up the north edge. The panel would benefit from conservation by a specialist and grants may be available from the Church Buildings Council or similar, or an initial conservation report. The panels are boards are held in place by iron cramps, which are lightly rusted. Stonemasonry generally is satisfactory, some of the base foundation stonework is visible at low level and some of the surface is slightly crumbling. The wall has been pointed with a strap pointing at lower level, which is light coloured and therefore reasonably disguised but is starting to work loose and fall out and so in due course perhaps some patch pointing within the next 5 years might be desirable, or even more widespread removal of the failing surface pointing and repointing to the wall complete - all remains as noted in 2017.

Above: South aisle looking west. Below: Creed boards on the south aisle west wall.

[E] Conservation of creed board.

[E] Patch or full repointing in lime mortar.

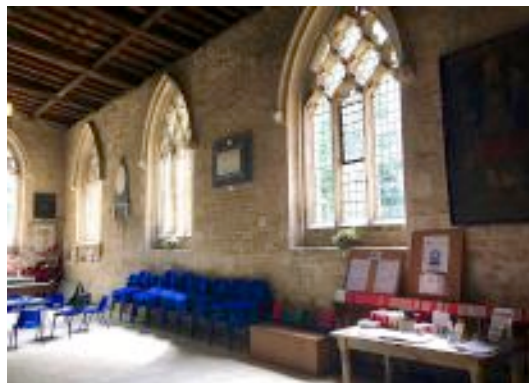
Window stonework seen internally generally looks to be in a good condition, although there are some fractures, particularly to mullions, which have been patched and repaired in the past. The surrounding stonework is coursed rubble, generally pointed with a light coloured strap pointing; the wall was probably originally intended to be plastered. The walling generally is in a good condition with no significant cracks or water ingress from high level. Along the base of the wall there is some algal growth to the bottom edge rising slightly towards the east end. Some old water staining from water ingress to the plaques on the wall, which appears to be historic. The pointing to the wall generally is satisfactory, although a few areas are starting to work loose – not as significantly as seen on the west wall but above the south door perhaps more areas of loose pointing and possible slight evidence of movement but not significant at present, although again as referred to elsewhere some drainage improvements recommended to help reduce the risk of significant structural movement caused by poor drainage.

Above: South aisle south wall. Below: South door entrance to the west end of the south aisle south wall. Bottom: South aisle looking east.

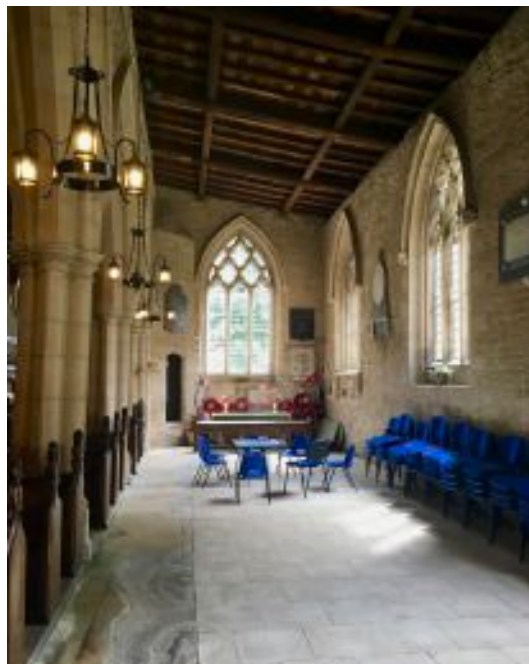
the base of the columns. Arcade stonework generally looks to be in a good condition. The walling above is of narrow bands of squared rubble walling, some old signs of streaking, which is probably historic and then the top wall plate has been replaced with concrete with the main roof beams bearing onto the wall tops and all appears to be satisfactory at present.

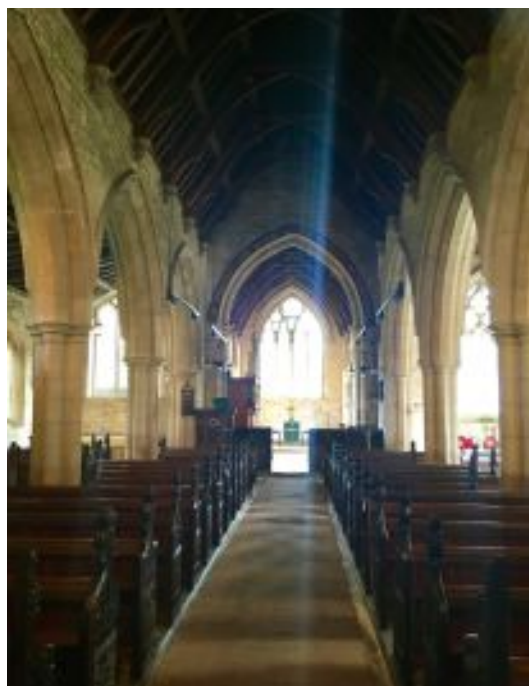
At low level to the eastern respond there is some algal growth on the plinth stonework, rising to a height of about 450mm and some mould bloom above the chancel step. The 3 columns generally have a slight eastward lean, which appears to be historic and some algal growth to the bases but otherwise the stonework appears to be in a good condition to the columns. Some reddish colouration, which may be possibly the remains of a mediaeval colour scheme, which may have been concealed by pews at some stage although it is difficult to be certain. Arch stonework to the arcade is generally in a good condition, the stonework above is generally of narrow courses on rubble of varying thicknesses, pointed up with what may be cementitious or brittle mortar, which is loose in places, particularly towards the west end, although still satisfactory for the moment. To the base of the eastern respond there is an area of patching, which may be cementitious in nature, forming a slightly odd truncation of the lower level stonework but there may have been some adjustment to the floor

Above: Nave looking east and view of the chancel arch and north and south arcade walls. Below: View of the nave south arcade arch at the east end of the south wall.

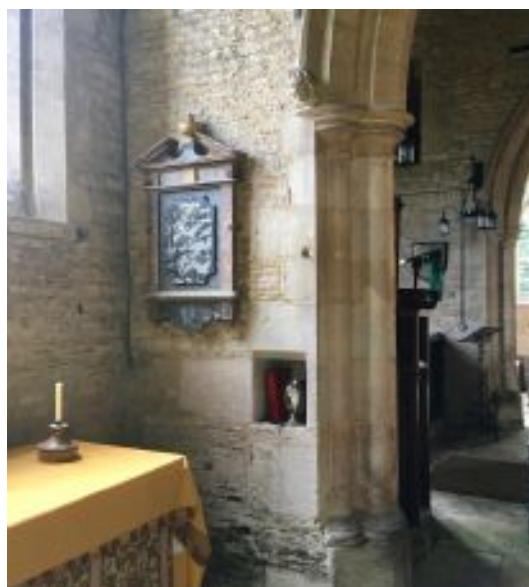
There is a painted stone wall plaque, which is rather fine and unusual but the paint decoration, particularly to the inscription, is failing and there is some physical damage, part caused by iron cramps that fix the backs to the wall – specialist conservation is recommended and grants may be available from the Church Buildings Council. Columns generally have an eastward and northward lean to the arcade, as noted for the nave but otherwise stonework appears to

Above: Nave north arcade wall eastern end. Below: North aisle south arcade wall eastern arch. Bottom: Painted wall plaque at the east end of the north aisle south wall needing conservation.

[E] Specialist report and conservation of monument.

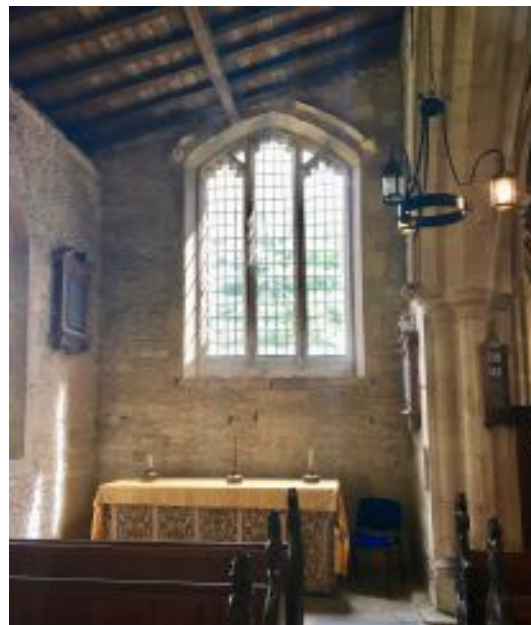
Above: North aisle east wall. Below: View of the north aisle west wall seen above the vestry ceiling.

Some open joints to the cill but otherwise generally in a satisfactory condition. Walling generally of various types of rubble, some larger coursed sections underneath the window and towards the south side at low level but smaller pieces generally at upper level. Algal growth to the bottom section of the wall and failure of pointing, leaving open joints, which need consolidating. The pointing above is generally ribbon pointing, not particularly attractive but being a light colour is not as bad as it might be visually but there are some notable cracks, particularly towards the northern corner extending full height and cracks are currently only 1mm or so but quite numerous in number owing to the small pieces of poorly bonded masonry. The worry here is the poor drainage externally, which could cause or allow further movement to occur and therefore drainage improvements externally and consolidation of the cracks externally are strongly recommended. Further cracks also vertically underneath the window and pointing working loose generally in this area and further repointing recommended - all remains as recorded in 2017.

[D] Consolidation of cracks and monitoring of movement.

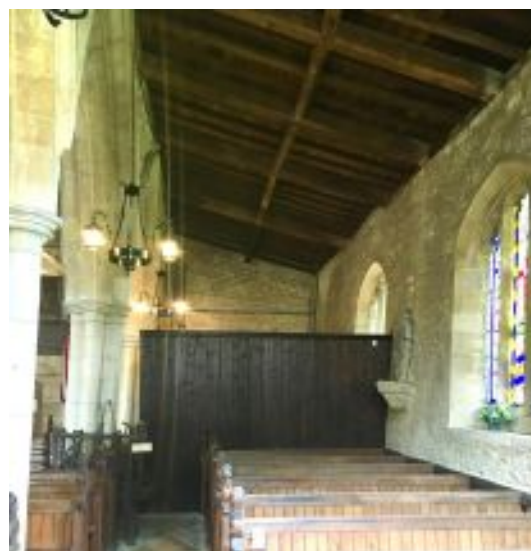
The wall is seen above the vestry roof, the top of the arch is just visible. Walling to the top of the arch is generally small pieces of rubble, probably originally intended to be rendered or plastered over. The top of the 1st window from west is also visible, the stonework so far as can be seen is in a good condition. The joists from the inserted vestry structure have been inserted into pockets in the wall between the window and the door and have been rather crudely infilled with a cement, similarly in the central binder to the ceiling, which is mortared into the west wall. Beyond the vestry area the north aisle wall is revealed full height. Between the central window and the window within the vestry there is a fine early wall monument dated 1720 held in place by iron cramps, which could cause damage in the long term and the top section of the memorial has also become cracked. The bottom of the plaque has a figurative detail, which is partially concealed and set within a carved stone corbel, which looks fairly early in date and appears to be the top of a capital or a respond to an arcade or arch, now reset as a bracket in the wall. Further wall plaques are set between the 2 windows and are again relatively early and dated 1722 and are held in position with rusting iron cramps and set into an older carved bracket. Between the easternmost window and the east wall is one further painted stone wall plaque matching that on the opposite side of the chapel area and again held with iron cramps and with paintwork fading and would benefit from restoration. Along the top of the wall to the final 2 bays there is a recessed cast concrete wall plate, which may be an attempt to help strengthen the wall, although this is sectional and divided by the main roof beams. There is a crack extending from the top of the arch upward to the wall plate

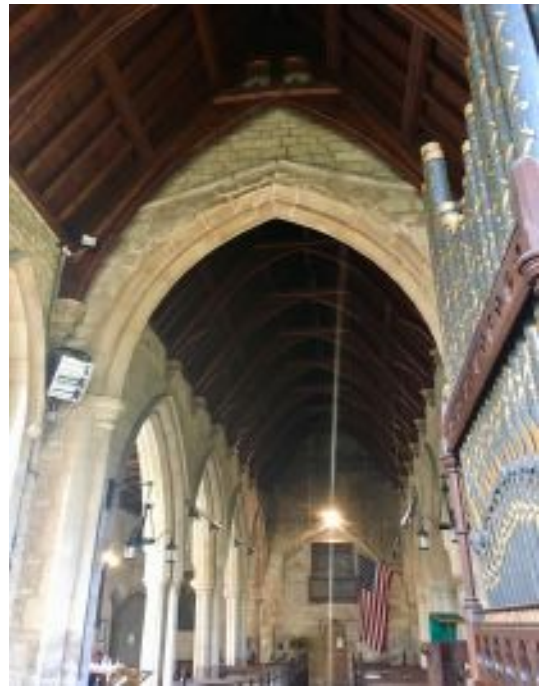
The arch stonework and responds generally satisfactory, possible slight gap to the very top of the outer arch and above the arch there is a weathering/stringcourse detail where an older roof line to the chancel, pre-Victorian, abutted the nave. Above this there is a slight open joint from the top of the arch extending upwards and it is recommended that this be filled and any other open joints in the area be filled, to allow for monitoring of any future movement. There is also slight cracking around the back of the top of the outer arch on the north side, which again ideally should be pointed up to allow future monitoring of movement. To the backs of the responds the stonework has been pointed up rather crudely and scribed, but nevertheless is satisfactory for the moment. On the south side some of the lower level pointing, which is perhaps later in date, is now loose and would benefit from being removed and pointed up again and at very low level there is some missing pointing, perhaps associated with damp on both sides, partially concealed by choir stalls - all as noted in 2017.

Above: Chancel west wall and chancel arch. Below: View of the chancel east wall. Bottom: Lower section of the chancel east wall with past filled cracks.

[B] Point-up cracks to allow monitoring of future movement.

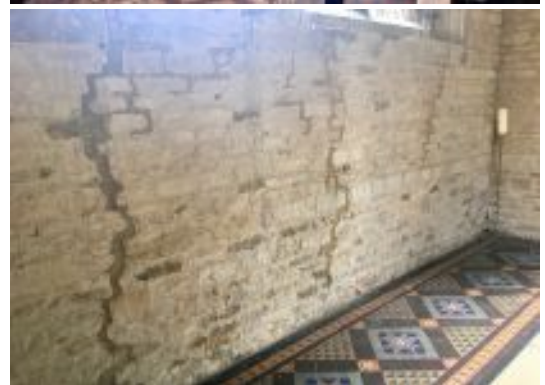
a pale mortar, which is scribed with joints, which would be more unsightly were it not for the pale colour of the mortar, which makes it relatively innocuous although it is technically and visually incorrect. The similar treatment of the stonework continues up to the springing of the window arch and then turns into larger blocks of stone pointed with a darker colour mortar, which so far as can be seen appears to be satisfactory. To the north side of the window there is evidence of a further crack, which has been repointed with a lime mix in the recent past, which does not appear to have reopened and all remains as seen in 2017.

No work required but continue to monitor cracks.

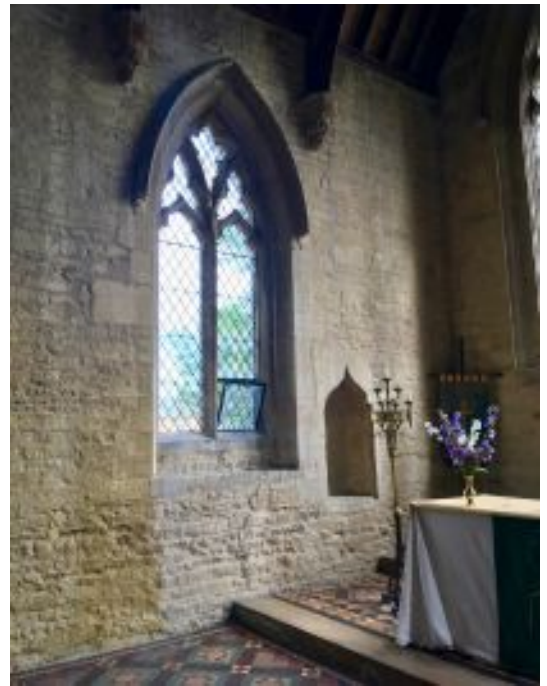
Between the eastern and central window there is a more significant band of staining from water ingress, which is still fairly dark and yellowish in colour although appears dry and as recorded in 2017. For the time being the roof parapet gutters and outlets should be regularly checked by a roofer at least once and ideally twice a year to try and avoid the risk of blockage and resultant water ingress. Along the base of the wall there is a narrow band of algal growth to the edge of the floor tiling and it is possible that the floor construction generally is relatively impervious and therefore will force damp into the base of the walls. There is some damage on the easternmost window to the mouldings of the lower tracery and misalignment of the tracery with the top of the mullion but otherwise stonework is satisfactory, although old streaks from water ingress from above from the parapet gutter. Other window stonework is generally satisfactory but again with slight knocks and damage. Some streaking from the wall top from water ingress when the outlet has been blocked. As part of any future re-roofing it is recommended that the gutter design be amended, ideally with at least 2 outlets of enlarged design as the roof area is quite large and there is a fairly small single central outlet and likely to block from leaves etc fairly regularly - all as noted in 2017.

Above: Chancel north wall. Below: Organ placed along the chancel north wall. Bottom: Chancel north wall western window.

[E] Improve rainwater management as part of future re-roofing.

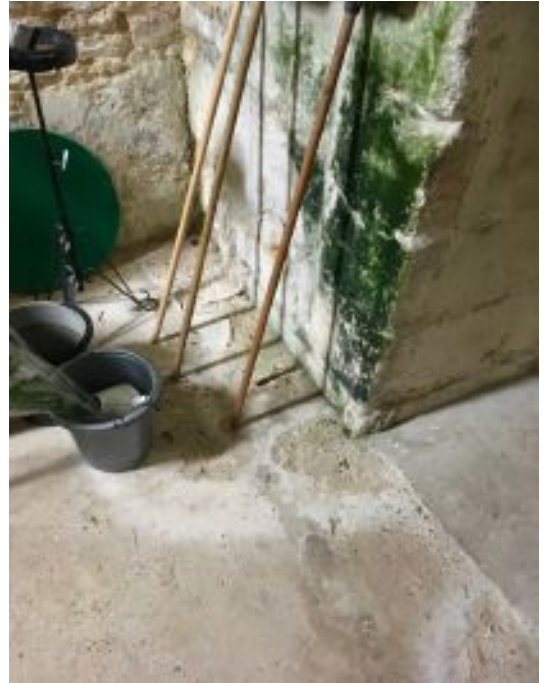
The surface of the concrete or screed has failed and is breaking up somewhat just to the north side of the doorway/ access way into the tower area. The floor itself appears to be relatively dry and evidence of a polythene membrane edge in some places, which does have the potential for promoting damp to the walls - as noted in 2017.

Above: Tower base floor. Below: Tower base ceiling. Bottom: Tower base east wall.

- [C] Some patch repairs to floor screed desirable.
- [B] Timber specialist to check floor beams for decay and structural engineer to check safe loading of bells.
- [C] Point up/stitch cracks and repoint stonework as indicated.

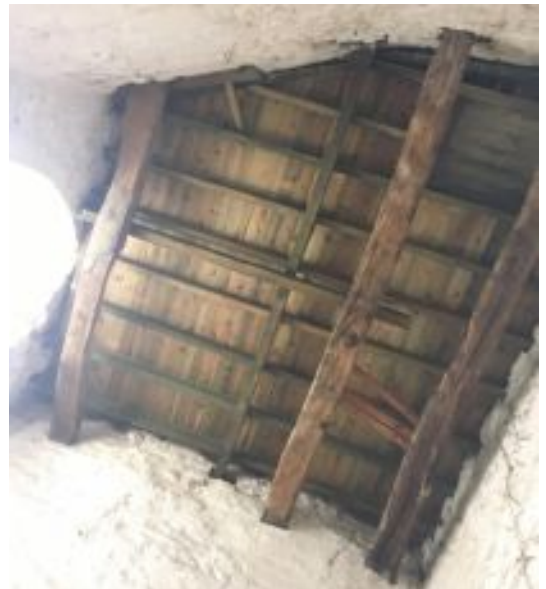
The floor joists appear modern, as does the floor boarding and all appears satisfactory viewed from below, although the older main beams show signs of old decay and beetle activity, which is fairly historic; the easternmost beam in particular, which is clearly circular in profile and has a lot of wane, is probably weakened. Concern that the floor is over-loaded by the weight of the bells.

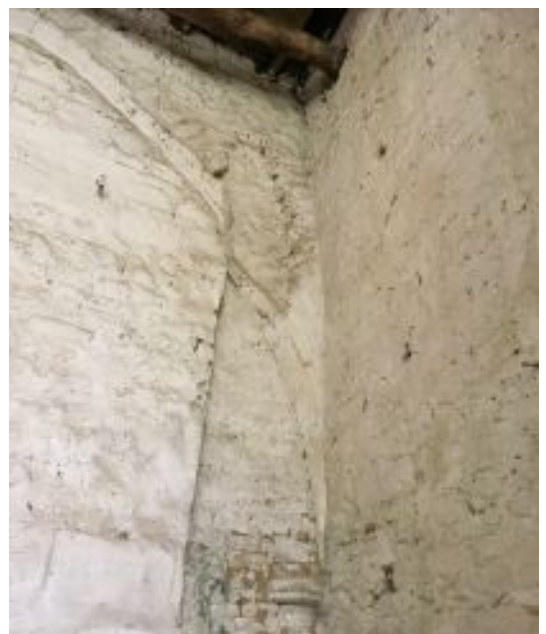
The infill is quite irregular in profile but even more so is the nature of the stonework above the old arch, which includes the recess or cut out and this cuts into some of the arch stonework on the southern edge – reason unknown. There is some evidence of an old relieving arch above the dressed arch stonework and evidence of the deformation of profile as evident from the nave side. The thinner section on the south side of the wall has staining at ground level where the capital to the respond is revealed and is in a slight decayed

state where some of the lime wash has flaked away revealing the pointing. Consolidation in this area is desirable, especially at low level where there are some gaps and voids forming in the stonework. To each side of the door, but particularly to the north side but also on the south side within the actual reveal, there is algal growth from damp penetration. The pattern and formation of the damp is rather odd and does seem to be quite actively damp; it may be caused in part by poor ventilation in the tower area but also the concrete floor, which is suppressing damp may be forcing it into the walls. To have algal growth at this height on an internal wall is somewhat odd, the other reason is for damp to be somehow working its way down the wall core but as this is infill work under the tower arch this seems less likely. The best guess is to somehow associate it with air movement and damp condensation deposits on the stonework associated with the doorway and lack of other ventilation in the tower area. It may be helpful to try and introduce some background ventilation through the tower window by installing a hopper light - as noted in 2017.

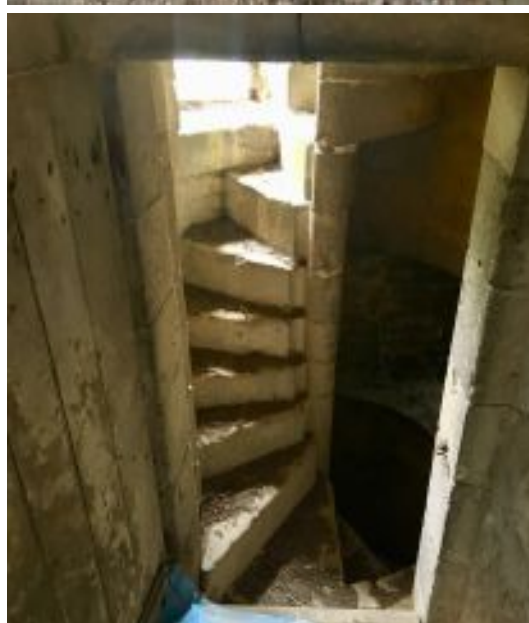
Above: Tower base west window. Below: Bell sat on the belfry / intermediate floor. Bottom: Spiral stair.

rebuilding in brick, particularly around the south western corner. A staircase carries on, reaching to roof level but the upper part of the arch and flanking wall into the belfry area is now missing and the staircase is dangerous at high level - as noted in 2017.

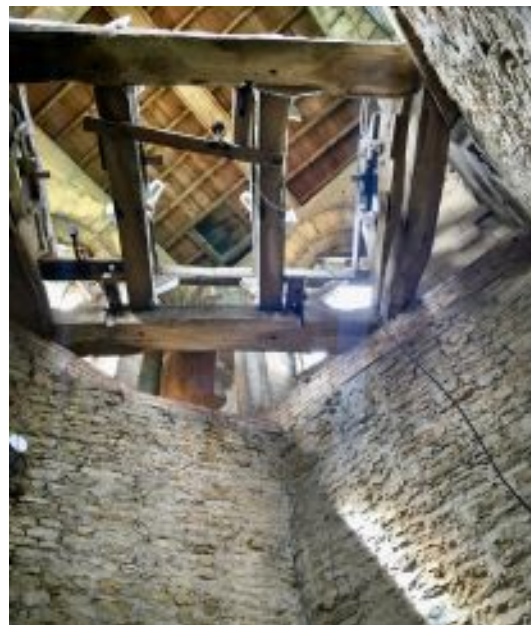
Some possible cracking and open joints in the belfry level stonework, particularly in the south eastern corner, which needs pointing up. A sawn off section of old beam beneath the bell frame in the east wall. The middle and lower stage of the clock chamber with intermediate floors now missing, very rough stonework generally but with a band of ashlar stone in the east half of the south wall and angled flanking stonework to the spiral stair. The older stonework on the west side of the wall is very roughly patched with cementitious mortar but various vertical cracks and poor bonding to the later stonework and consolidation certainly needed. Mesh to the back of the belfry openings supported on timber battens and very hard to access due to the lack of belfry floor but small birds have access to the belfry area with the resultant debris onto the floor at mid-height in the tower, being the only tower floor remaining. Concrete ring beam to the top perimeter of the roof an presumed to be part of the 1960s repair works.

Above: View of the bellframe and the belfry ceiling. Below: Belfry / intermediate chamber walling. Bottom: Belfry opening.

[B] Programme of repairs and consolidation within the tower is required.

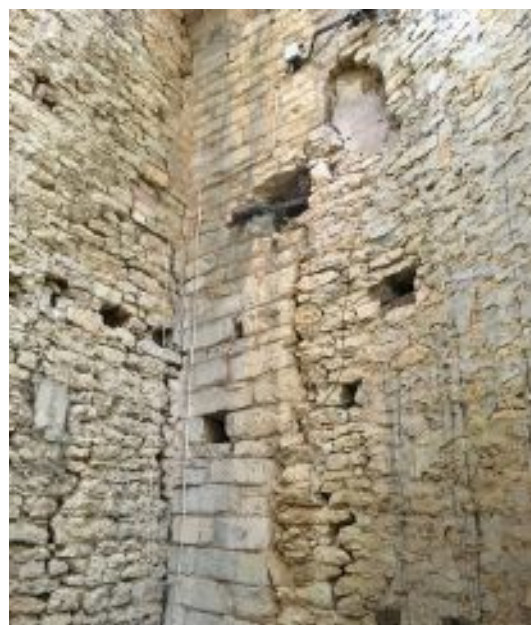
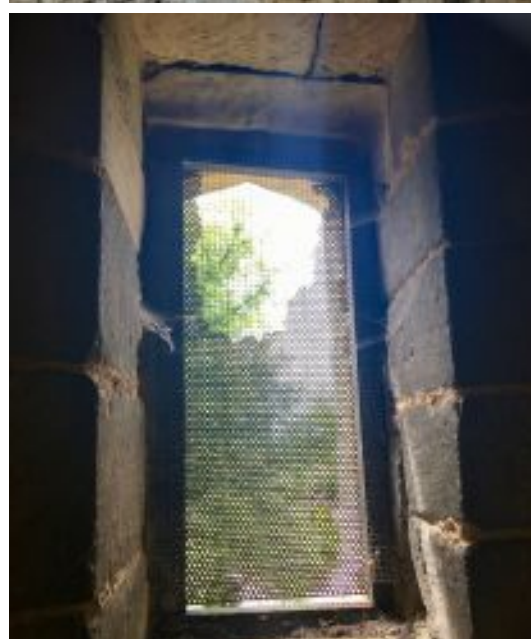
In the south wall there is a central crack, partly caused by poorly bonded masonry but also weaknesses in the wall running full height to the base of the bell frame.

The west wall contains the least cracks and generally is in a reasonable condition, albeit that the pointing is pretty ugly and there are still some cracks discernable, some filled with cement pointing towards the northern corner of the wall and there is a band of brickwork, 5 courses in height, to the top of the rubble walling underneath the bell frame, whereupon the walling changes to ashlar stonework within the belfry area.

The north wall lower section has a very obvious bulge to its middle, sloping outward towards the western corner. In the middle of the wall there is a crack and the wall appears to need urgent consolidation and stitching.

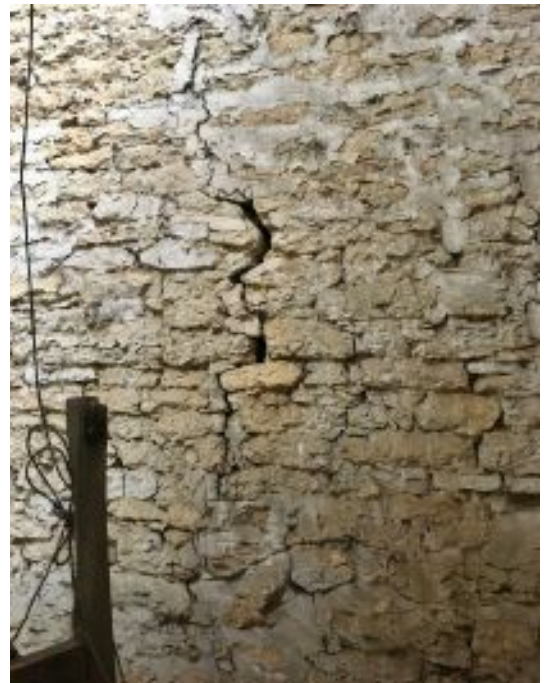
Above: South corner of the belfry/intermediate chamber with larger void visible. Below: Cracking to the belfry/intermediate walling.

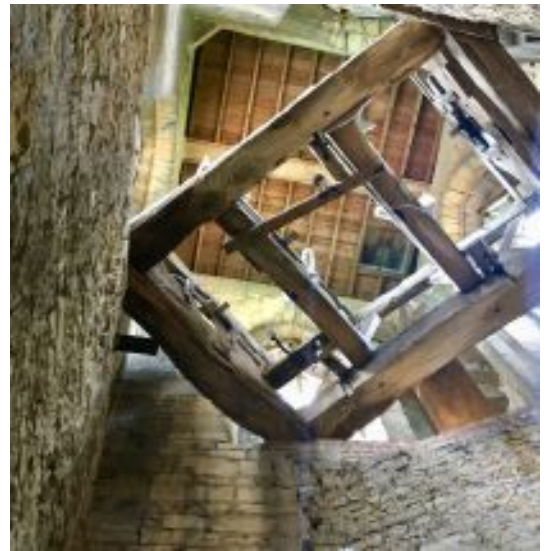
The bellframe is in a poor condition and bells now removed and mounted on the intermediate chamber floor as a temporary measure. Bells still retain headstocks and old bolts to crown staples. Bellframe poorly supported and safe access to the bellframe is impossible due to the lack of a belfry floor. Loud speakers for the bell digital system are mounted onto the old bell frame but access is impossible for anyone but the foolhardy. A belfry floor should be installed, probably of mesh design on metal beams for long term access and safety, as well as the fixed access to the tower roof hatch - as recorded in 2017.

Above: Bellframe. Below: Chancel screen on the chancel steps. Bottom: Vestry screening.

[C] (Subject to above) Mount bells onto beam for chiming to remove weight from the floor.

[C] Install belfry floor and safe access to tower roof, including guarding to openings in spiral stair.

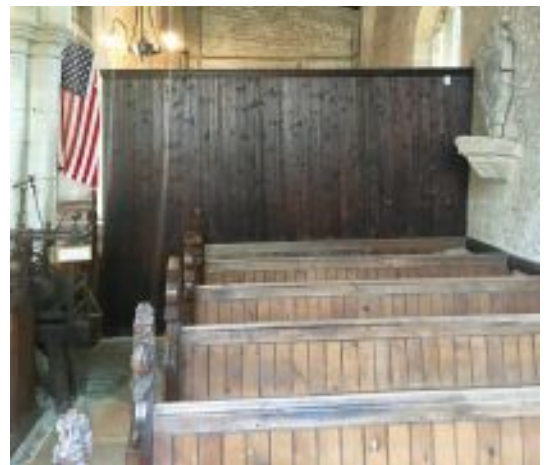
The only other screen inside the church is the tongue and groove panelling, dark stained, around the vestry/meeting room area. The screen appears to be made with either reclaimed or bits of oak and these have within them some death watch ceiling holes.

This generally remains in a serviceable condition and incorporates one pew end against the back wall of the aisle, which is slightly roughly formed and fixed and some of the board joints have shrunk and expose the lighter coloured boarding behind. There are ongoing discussions within the parish about carrying out some decorative improvements to the panelling to try and improve its dark appearance as it is a major feature, as seen from the south entrance door or to replace this area completely with new servery and WC.

[E] Improvements to vestry/meeting room screen desirable.
