quinquennial inspection
church of st. peter and st paul • osbournby

pcc of south lafford • diocese of lincoln

date of inspection: 23 june 2022

PETER ROGAN
+ ASSOCIATES LIMITED
ARCHITECTS +
HISTORIC
BUILDINGS •
CONSULTANTS
46 • ST. MARY'S GATE
NOTTINGHAM

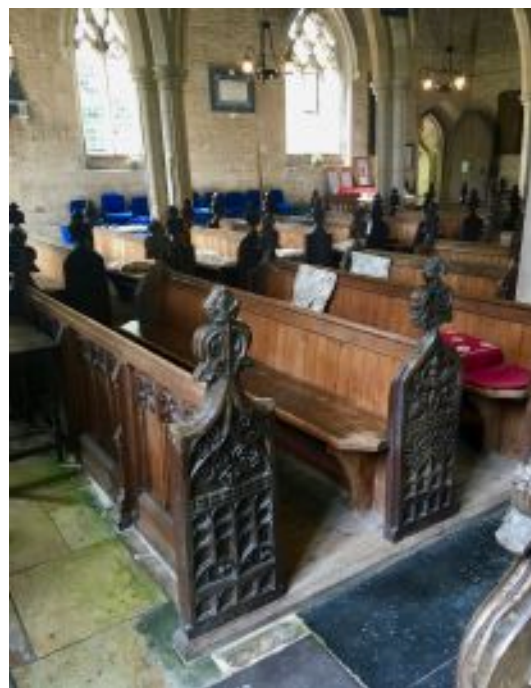
To the central aisleway all bench ends are poppy head type and are historic and generally in a good condition, although isolated pockets and signs of old death watch beetle activity, particularly at lower level. Difficult to judge if any active beetle is present. To the side facing the south aisle the front 2 ends are mediaeval and the remainder are probably

Above: View of the nave pews.

19th century in date. To the edge kerb to this section, which again is probably 19th century in date, there is evidence of fairly extensive death watch beetle activity. There is also activity in some of the bench ends, although probably largely historic, nevertheless activity could transfer from the bench ends. The later bench ends are all in a good condition - all remains generally as recorded in 2017.

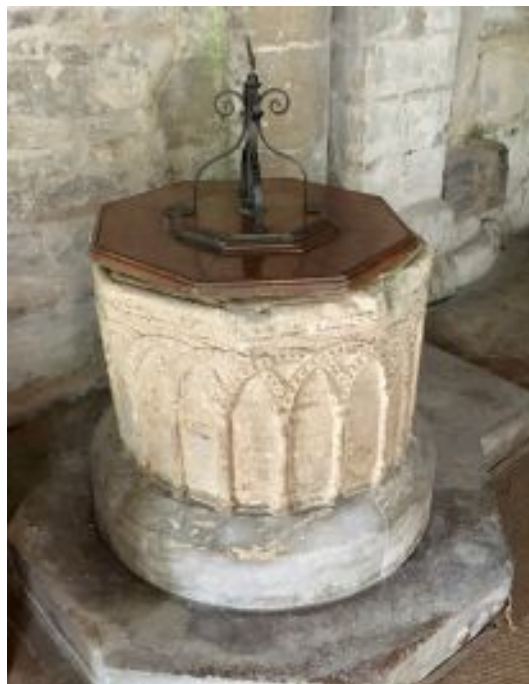
The font is lined with a drain hole to the centre and is an important historic feature of the church and currently remains in a reasonable condition, although is displaying some evidence of its age. In the stone step, particularly on the west side, there is some evidence of salts forming due to rainwater management issues and high ground level externally, as noted in 2017.

Above: The font. Below: The organ.

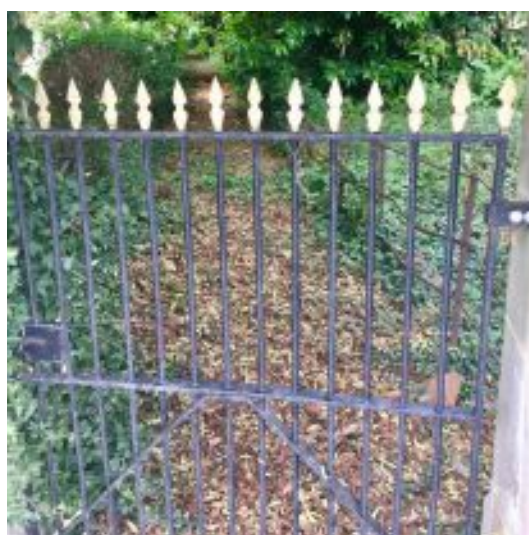
Above: Southern gateway. Below: View of the southern churchyard wall. Bottom: Railings to the west side of the southern entrance gates.

The metal railings in the western corner are in a reasonable condition, although distorted; the railing is distorted and rusted, although still forms an adequate boundary marker and is still reasonably well secured. The responsibility for the railings need to be resolved with the adjoining owner. A few of the sections of railings have rusted to the lower bar ends, meaning that some are somewhat wobbly or loose. Painting the railings to extend their life is desirable but would be the responsibility of either the adjoining owner or the parish council.

[E] *Repairs and refurbishment of boundary railings desirable.*

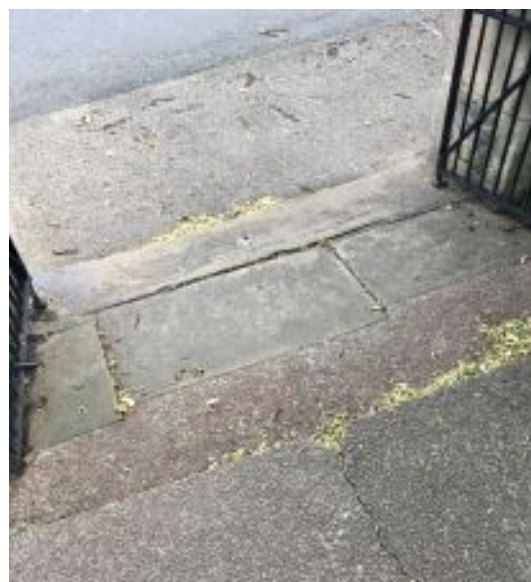
Above: Trees along the southern boundary. Below: Main western pathway in the churchyard. Bottom: Southern gateway entrance with some uneven surfaces.

[C] Remove possible trip hazard to gateway.

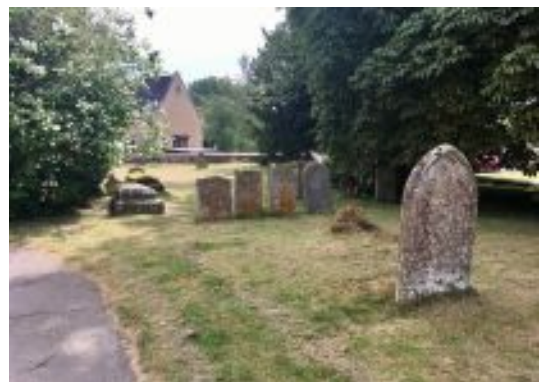
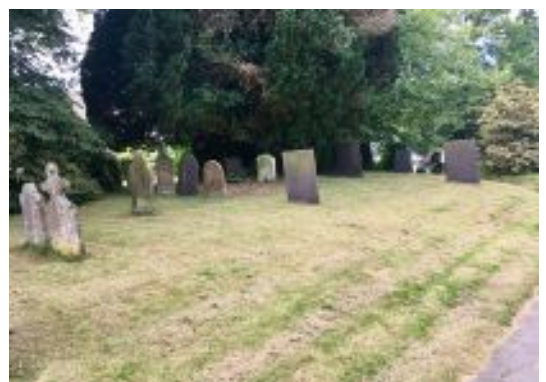
Above: Monuments within the churchyard. Below: Pathway and churchyard to the south of the chancel. Second below and bottom: Grave markers within the churchyard.

inspection and appear to be relatively stable. Generally all headstones and grave markers appear to be 19th century in date. There are a few headstones laid flat to the south of the south porch, which are becoming overgrown with grass and will gradually be concealed and also some headstones laid flat in front of the south aisle, again with grass encroachment likely to conceal them completely in the next few years.

[M] Periodically check headstones for safety and condition.

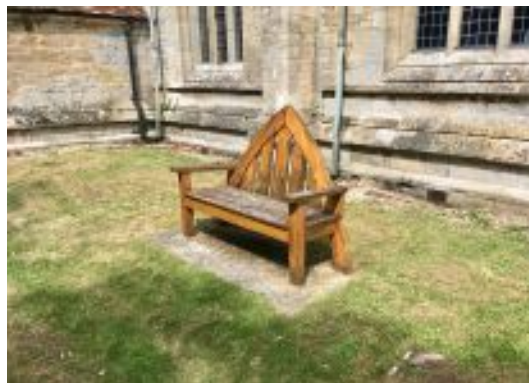
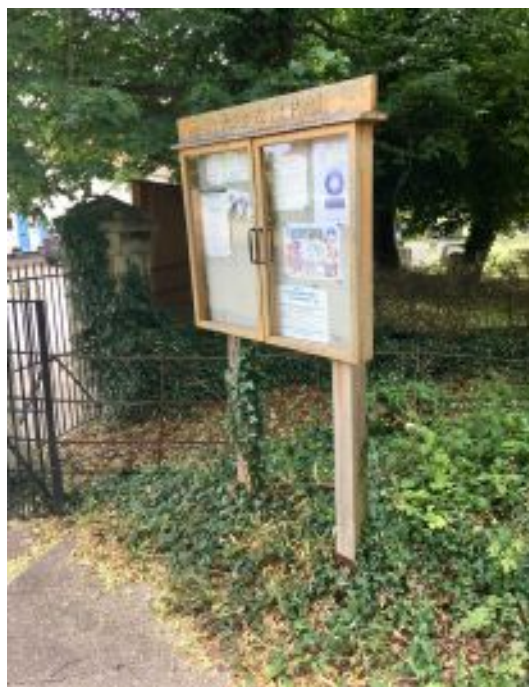
Above: Bench seat. Below: Church noticeboard.

Bench seat and noticeboard need some refurbishment.
