# RETIREMENT VILLAGES

# VISUAL APPRAISAL SURVEY

PENLEE HOUSE,  
ROSELAND COURT, TREGONY  
CORNWALL

JULY 2023 | PROJECT REF: 22323

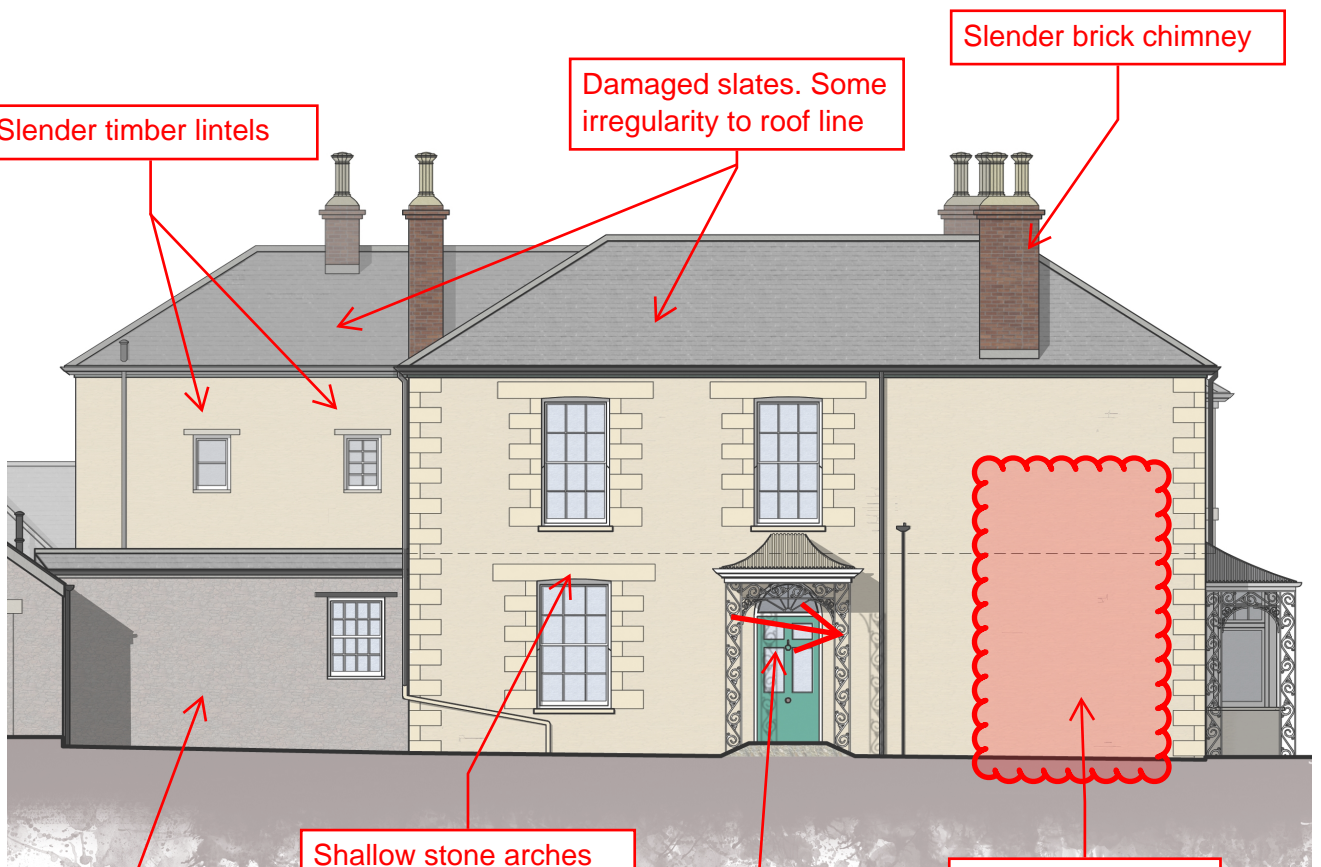
Project		PENLEE HOUSE, TREGONY		Job Ref.		22323	
Section		EXISTING EAST ELEVATION		Sheet no./rev.		SK/PH/30	
Calc. by	Date	Chk'd by	Date	App'd by	Date		
CCO	07/23

Rendered wall

Shallow stone arches to openings

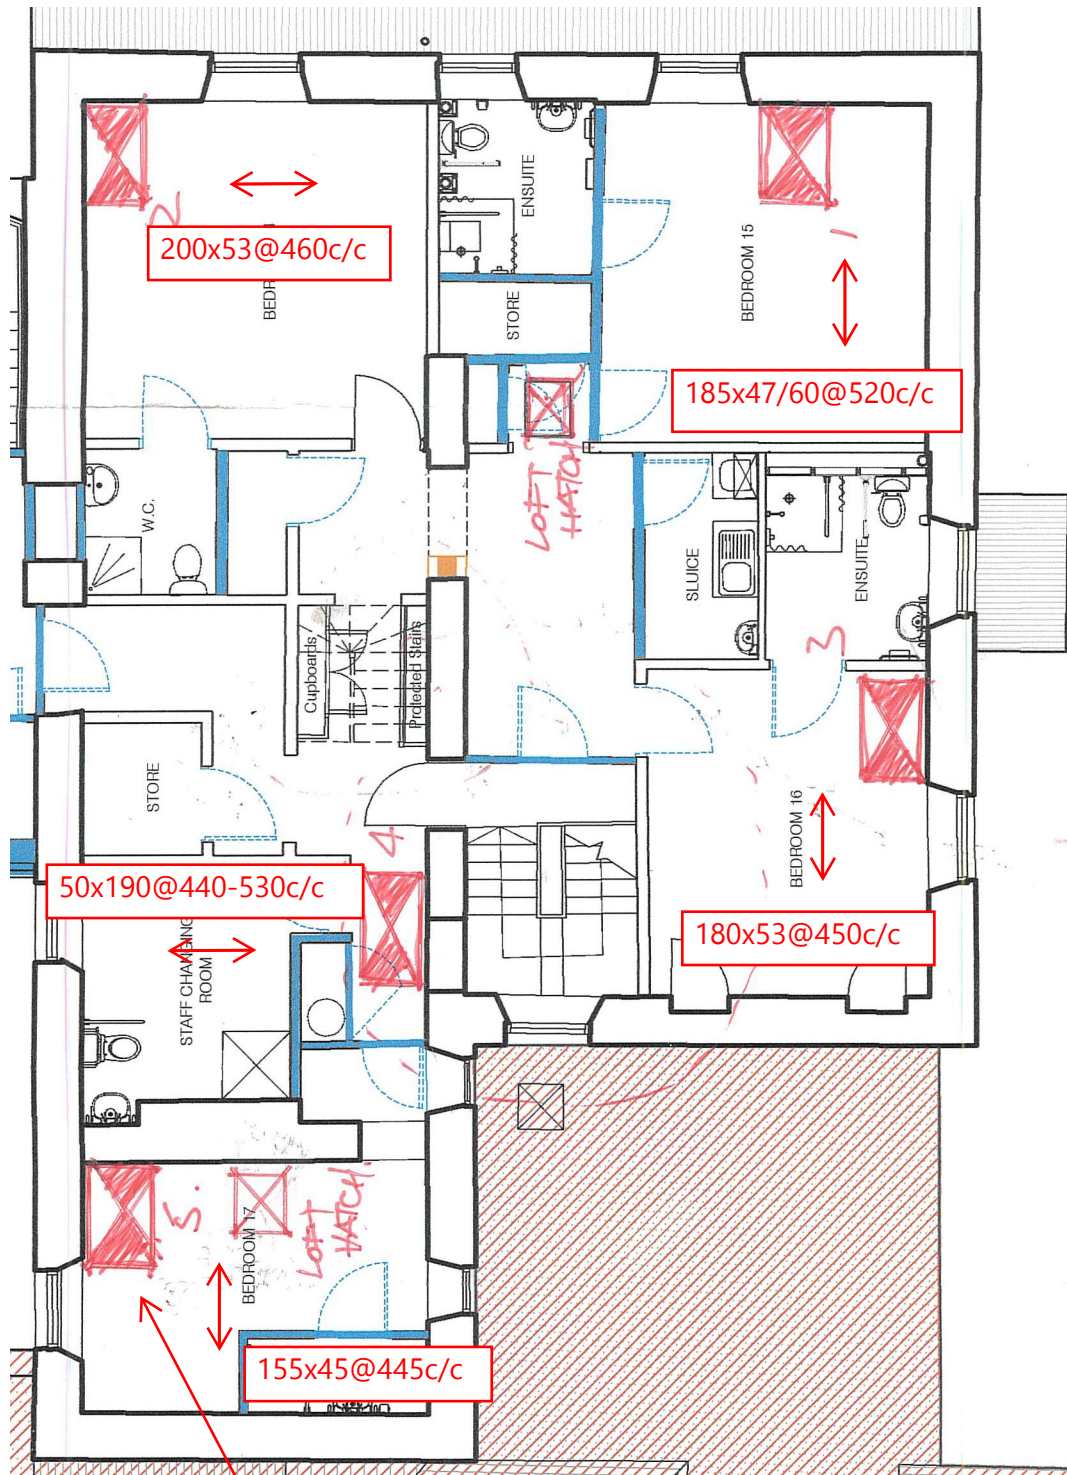
Project <b>PENLEE HOUSE</b>				Job Ref. 22323	
Section <b>FIRST FLOOR OPENING UP</b>				Sheet no./rev. SK/OU/50 REV A	
Calc. by CCO	Date 6/23	Chk'd by	Date	App'd by	Date

In one location (1), the joists have not been repaired and were seen to be totally decayed at the face of the supporting external wall.

There is a significant drop in the floor level around location 4. The joists in this area were found to have been supplemented with new joists. However, these are then trimmed out at the face of the wall and supported back on the original joists (fig 14).

in locations 1-5 marked thus, floorboards and ply covering to be removed to allow inspection of joists. size and spacing of joists required.
