Listed Building App. ref. DC/23/0779 Manston Hall, Whepstead IP29 4TN

SURVEY OF FRAME AND PROPOSED REPAIRS, in accordance with Condition 3 of App. ref. DC/23/0779 Manston Hall, Whepstead IP29 4TN

Assessment of Condition of Extant fabric relative to Sole-Plate Repair

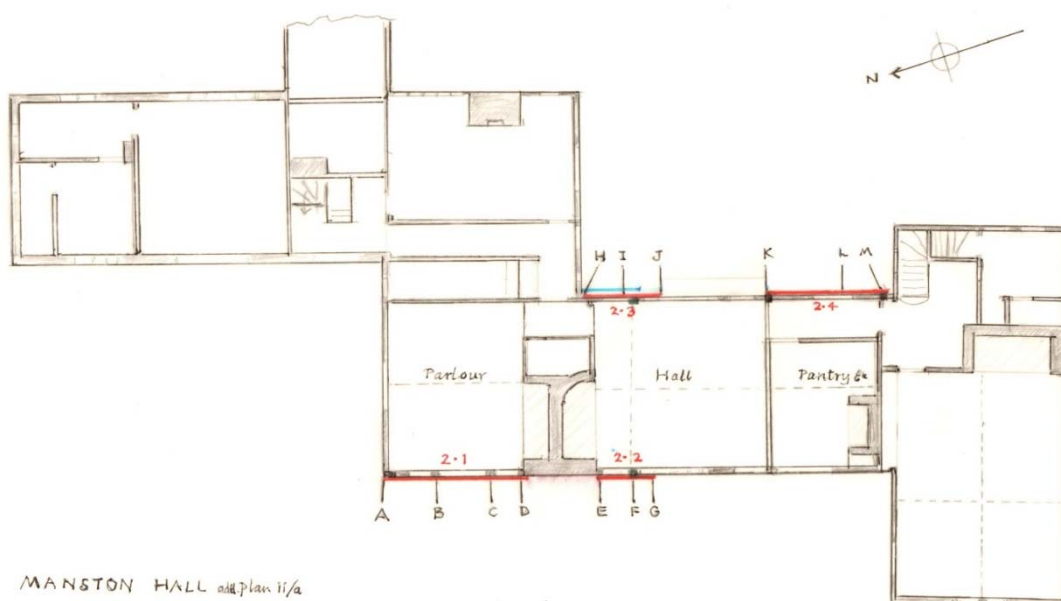
WEST FAÇADE of the 16th century section, Parlour, see sole-plate 2.1

EXTANT FABRIC – Parlour, Sole-plate 2.1 (A to D)

The Parlour sole-plate, which has rotated by about 45° slopes markedly from south to north. From **A** to **B** it disappears behind the wall-like plinth. From **C** to **D** there is a thicker projecting section on the exterior. [see: f-1 plan iia, f-2, f-3, f-4, f-5, f-6]

On the exterior a substantial **repair**, using scarfed-in sections of *green-oak*, is required. [see **F-3, F-4**]. The aim remains, for as much as possible of the **existing fabric**, to be retained depending on its condition and fitness for purpose.

A-D Sole-plate [Original 16th C – *interior measurement*] timber **230 x 150 mm** internal length **4140mm**. Insert *Green Oak repairs* using *Halved Joints*.

A-C Sole-plate [Original 16th C – *exterior evidence*] Will need **major repair** to sections currently below parapet of brick plinth - from timber **230 x 150mm**, length **3400 mm**.

C-D Sole-plate [Original 16th C – *exterior evidence*] Here the **retention** of, all *visible extant timber* is intended but *scarfed in repair* will be needed behind raised brick plinth– nominal original dimensions. **230 x 180 mm** length **1200 mm**

A-D Studs approx. size of original timbers **150 x 100mm** to use for sections needing *scarfed in repairs*, at the base. These repairs will be *proportionate* and use simple **halved joints** fixed with **hidden stainless steel fixings**.

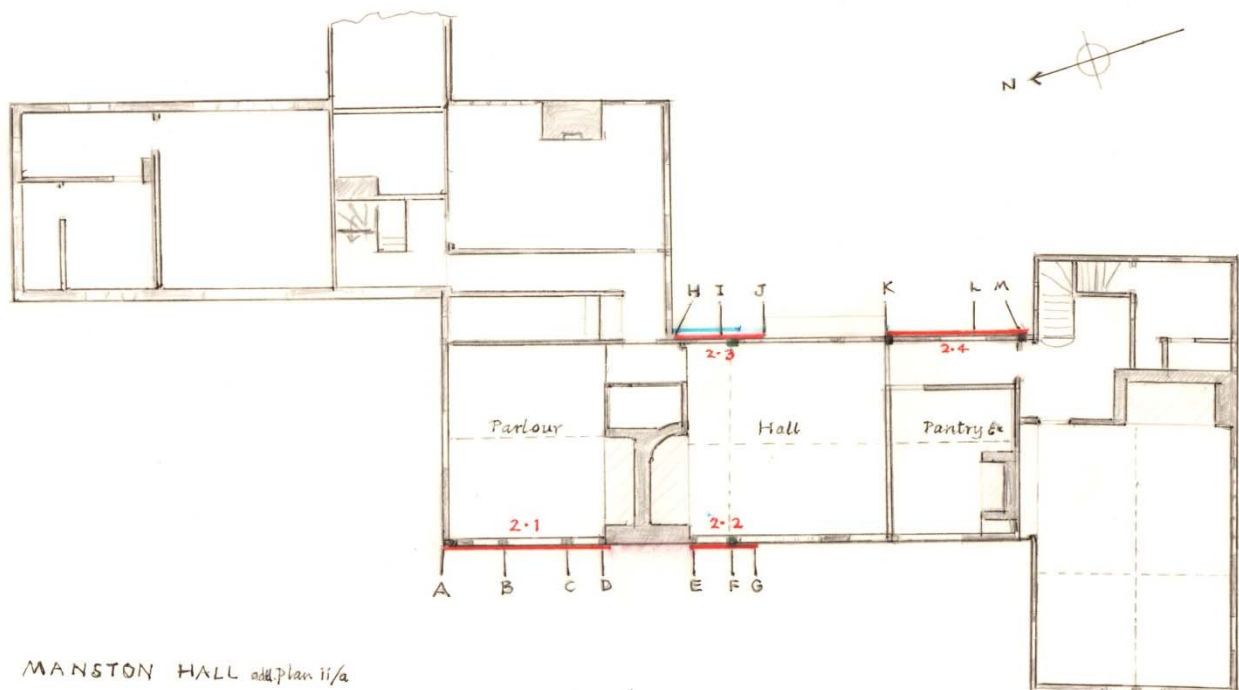
f-1

EXTANT FABRIC – Hall Bay **E-G**, **Sole-plate 2.2**

Interior evidence suggests less rotation of the original sole-plate than in the Parlour. But there is a substantial length from **E-F** which, standing proud of the stud wall, has deteriorated especially at the base. (see: f-2, f-7) This impacts on the **stability** of the *major upright support* for the cross beam in the Hall – at **F**.

Exterior evidence reveals **decay** caused by damp and **voids** suggesting rodent activity. Downward pressure exerted by the weight of *major upright support* – **F** is apparent inside. [see: f-8]

This **sole-plate** carries the *load* of the *major upright support \x/* at **F** and given the condition of the **sole-plate** beneath this, a substantial length needs to be **replaced**.

E-F – Post *Major Upright Support \x/* at **F** – of nominal section **290 x 290mm** will need *scarfed in repair* to base, using *vertical halved joints*; fixing by being *tenoned* to the new **soleplate**. n.b. *retain/recreate* carved detail to front.

E- F - **Studs** - of nominal section **150 x 100mm**. Up to **x 3** need *scarfed in* proportionate *repairs* to base, again using *vertical halved joints*, fixed by *tenons* or *hidden stainless steel fixings*, as appropriate to the new sole-plate.

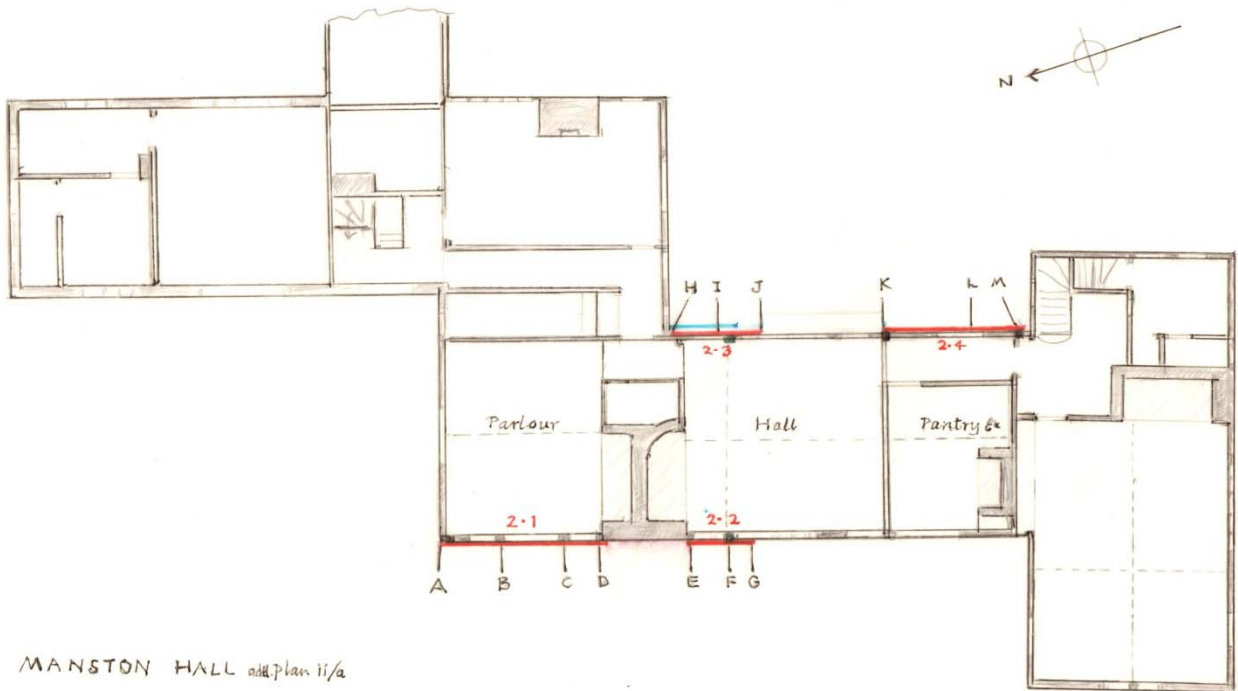
The East Façade is of similar structure to the West side but it has no jetty. The timber frame is exposed both inside and out. Also the Parlour bay and most of the Chimney bay were transformed into internal space following the addition of projecting East wing of 18th/19th century date.

At the North End, H-J both on the **interior** and **exterior**, there are considerable losses and concrete filled holes in the **sole-plate**, particularly from H-I. Here, penetration by water running off the roofs meeting at the angle where the 18th/19thC wing joins [see: f-1 plan iia], and holes in the timber frame (evidently made to support a lean-to structure) explain the *poor/decayed condition* of the extant fabric.

Replacement of the whole **sole-plate H-J** is necessary.

Up to x 4 **Studs** of nominal section **150 x 100mm** will need scarfed-in *repair* to base and all to be joined using *vertical halved joints*, fixed by *tenons* or *hidden stainless steel fixings*, as appropriate, to the new sole-plate. [f-9, f-10, f-11, f-12, f-13].

Major upright support, \x/, between **I** and **J** is of nominal section **230 x 230mm**. This will also need fixing with *hidden stainless steel fixings* to the new sole-plate. [f-11, f-12, f-13].

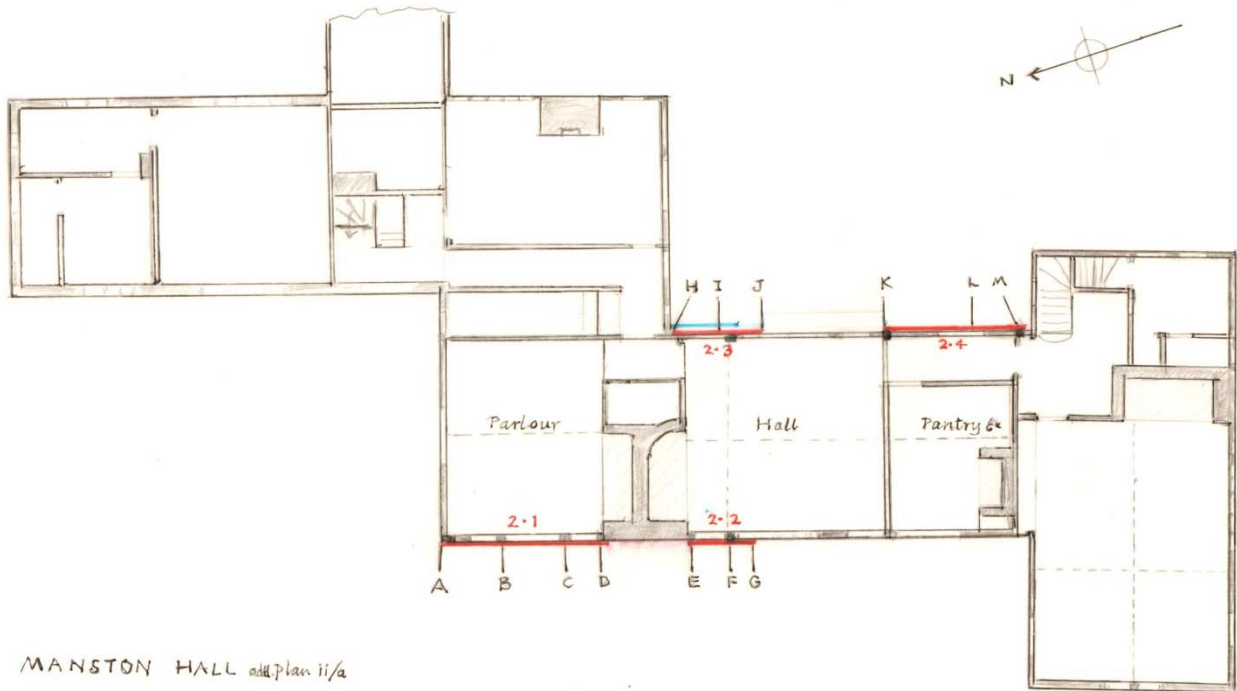
PATCH REPAIRS - East exterior wall of 16th C section

Extant Fabric relevant to - Small patch repairs/insertion plates [see 2.3 on, f-1 plan iia, and H-J on f-9 also f-10, f-12, f-13]
