Subject: Survey Summary
Project: 249 West George Street
Reference: FN 002 REV3
Author: PAH

Report on Condition of Cladding on Main Elevations

249 West George Street

Project Title: 249 West George Street
Client: Carrigmay Glasgow (Jersey) Ltd
Project No: 131138

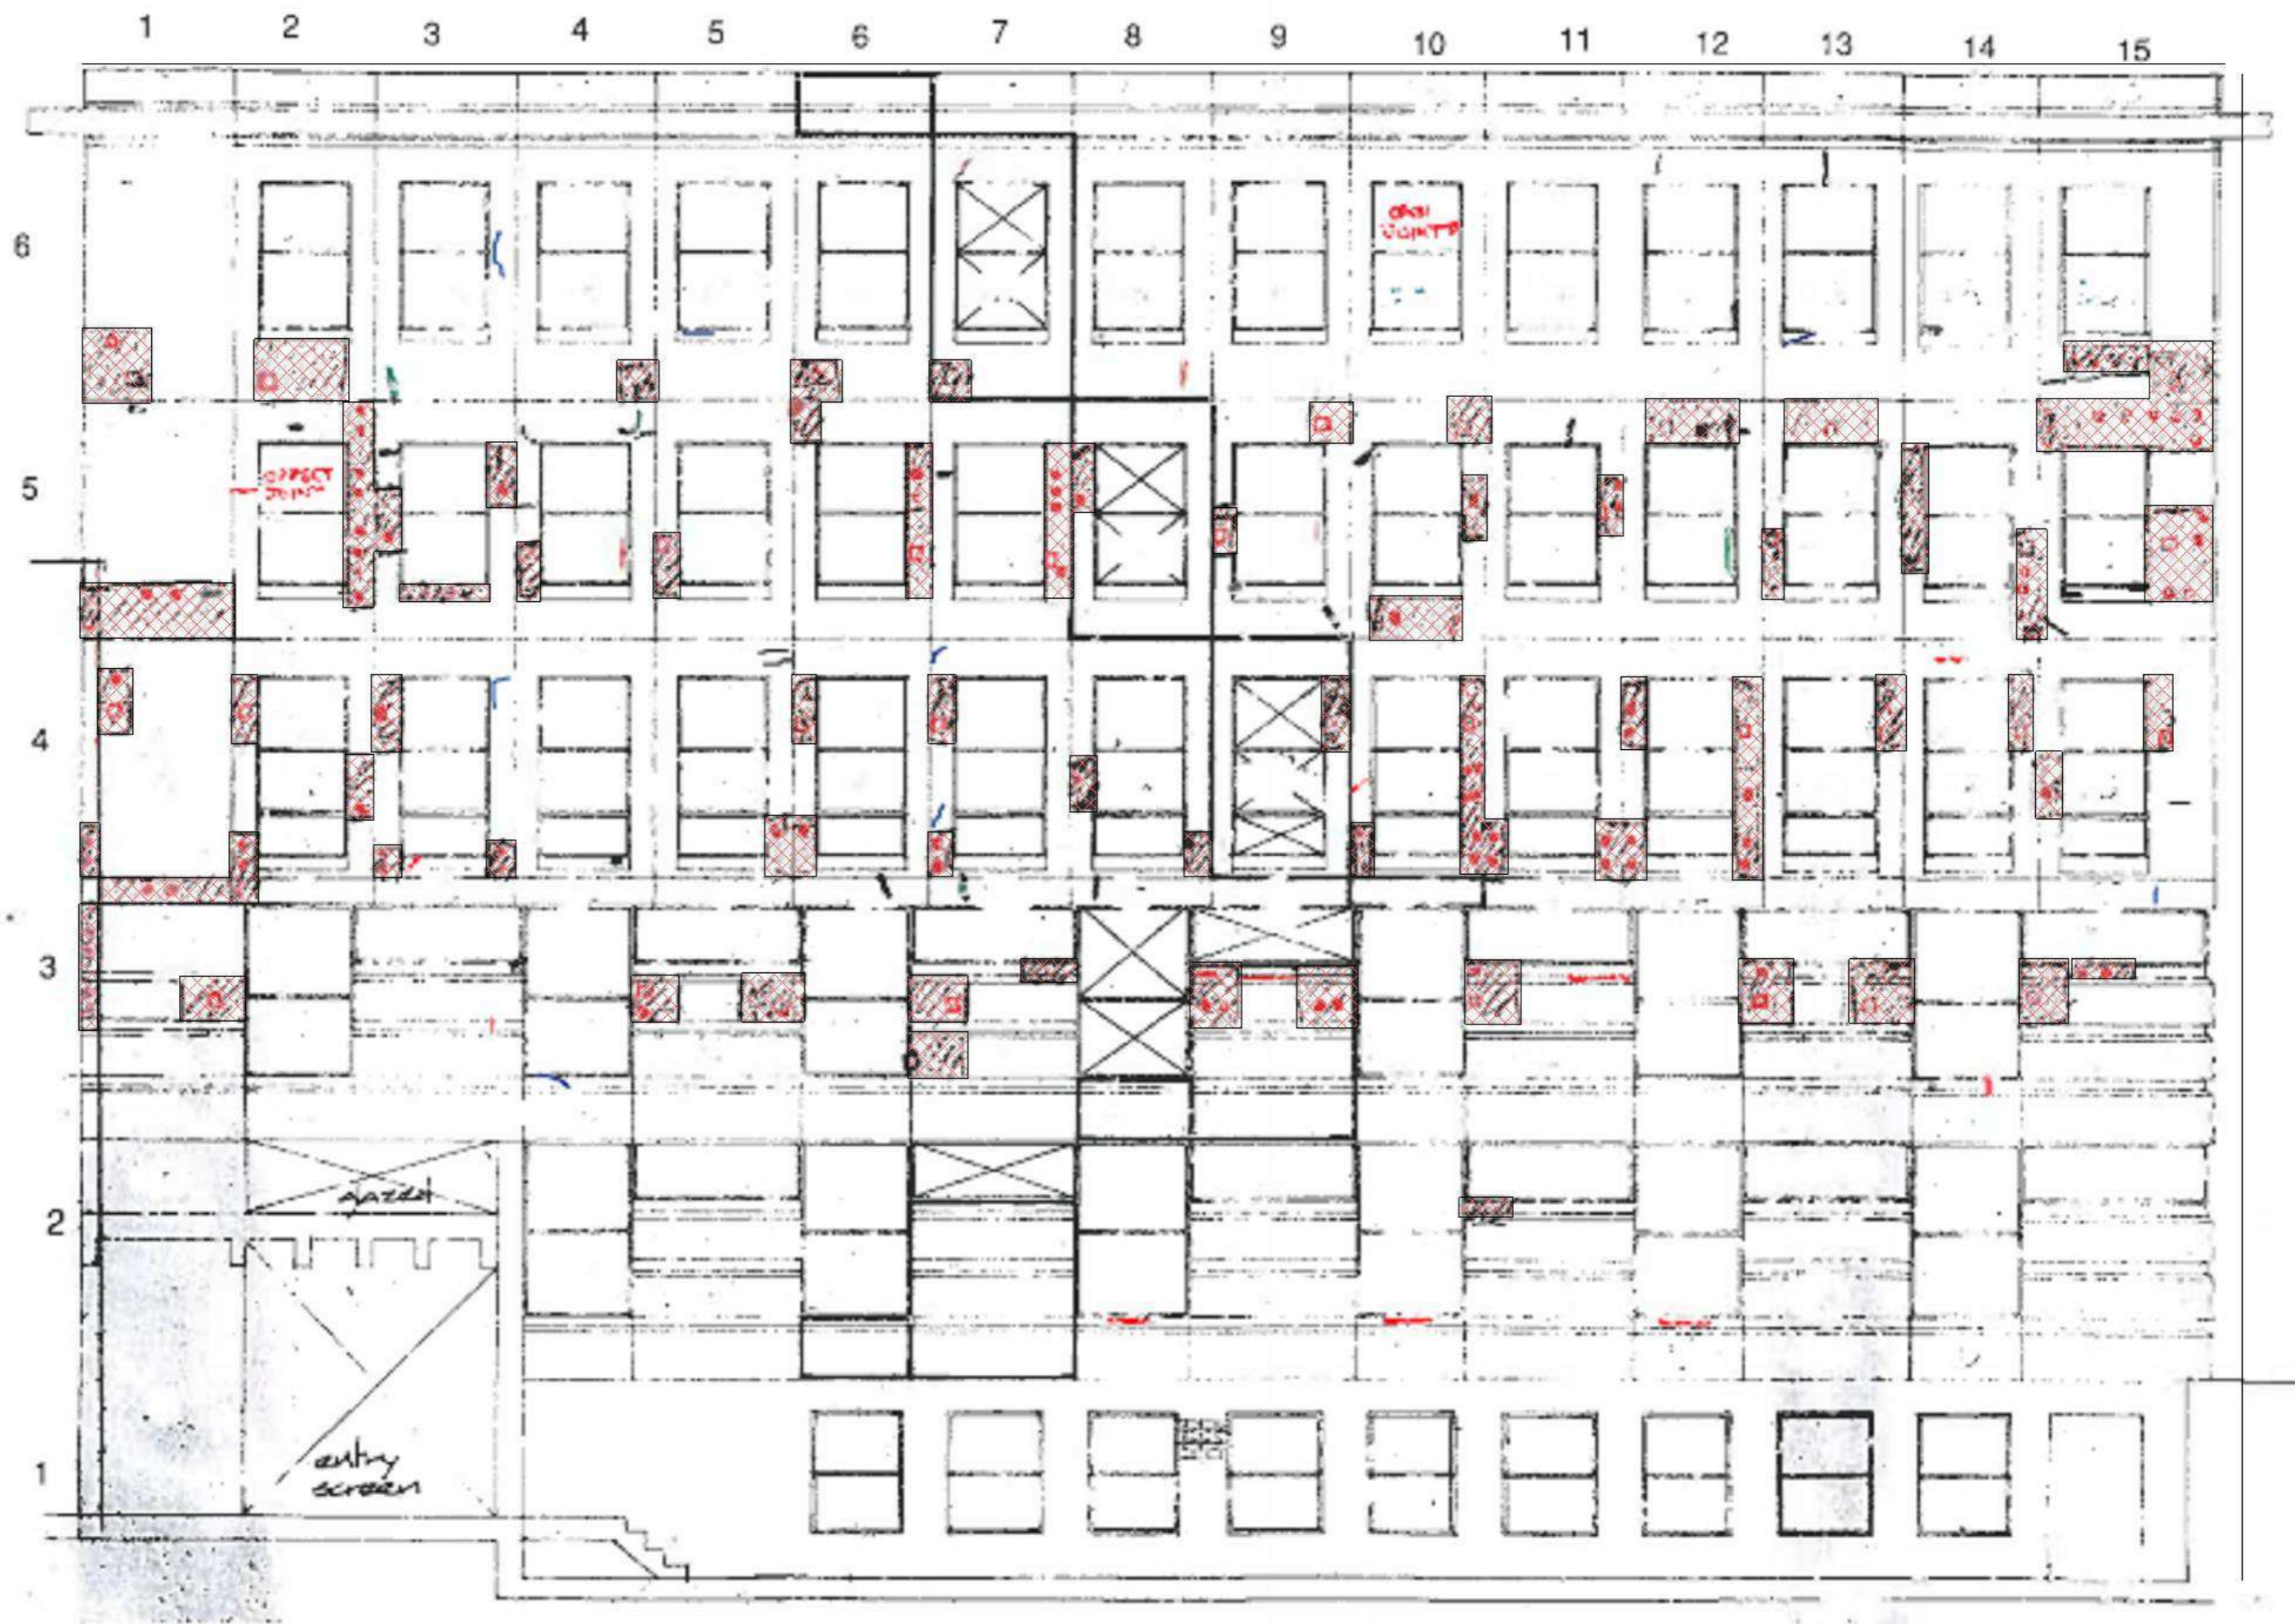
West George Street Elevation - Pinned Area Mark-up

These numbers were obtained by extrapolating the timings identified during the site investigation works. Also, the pinned areas were determined using the mark-ups produced during a previous inspection carried out on the 13th of March and 3rd of April 2016. Mark-ups of these can be found attached at the end of this document.

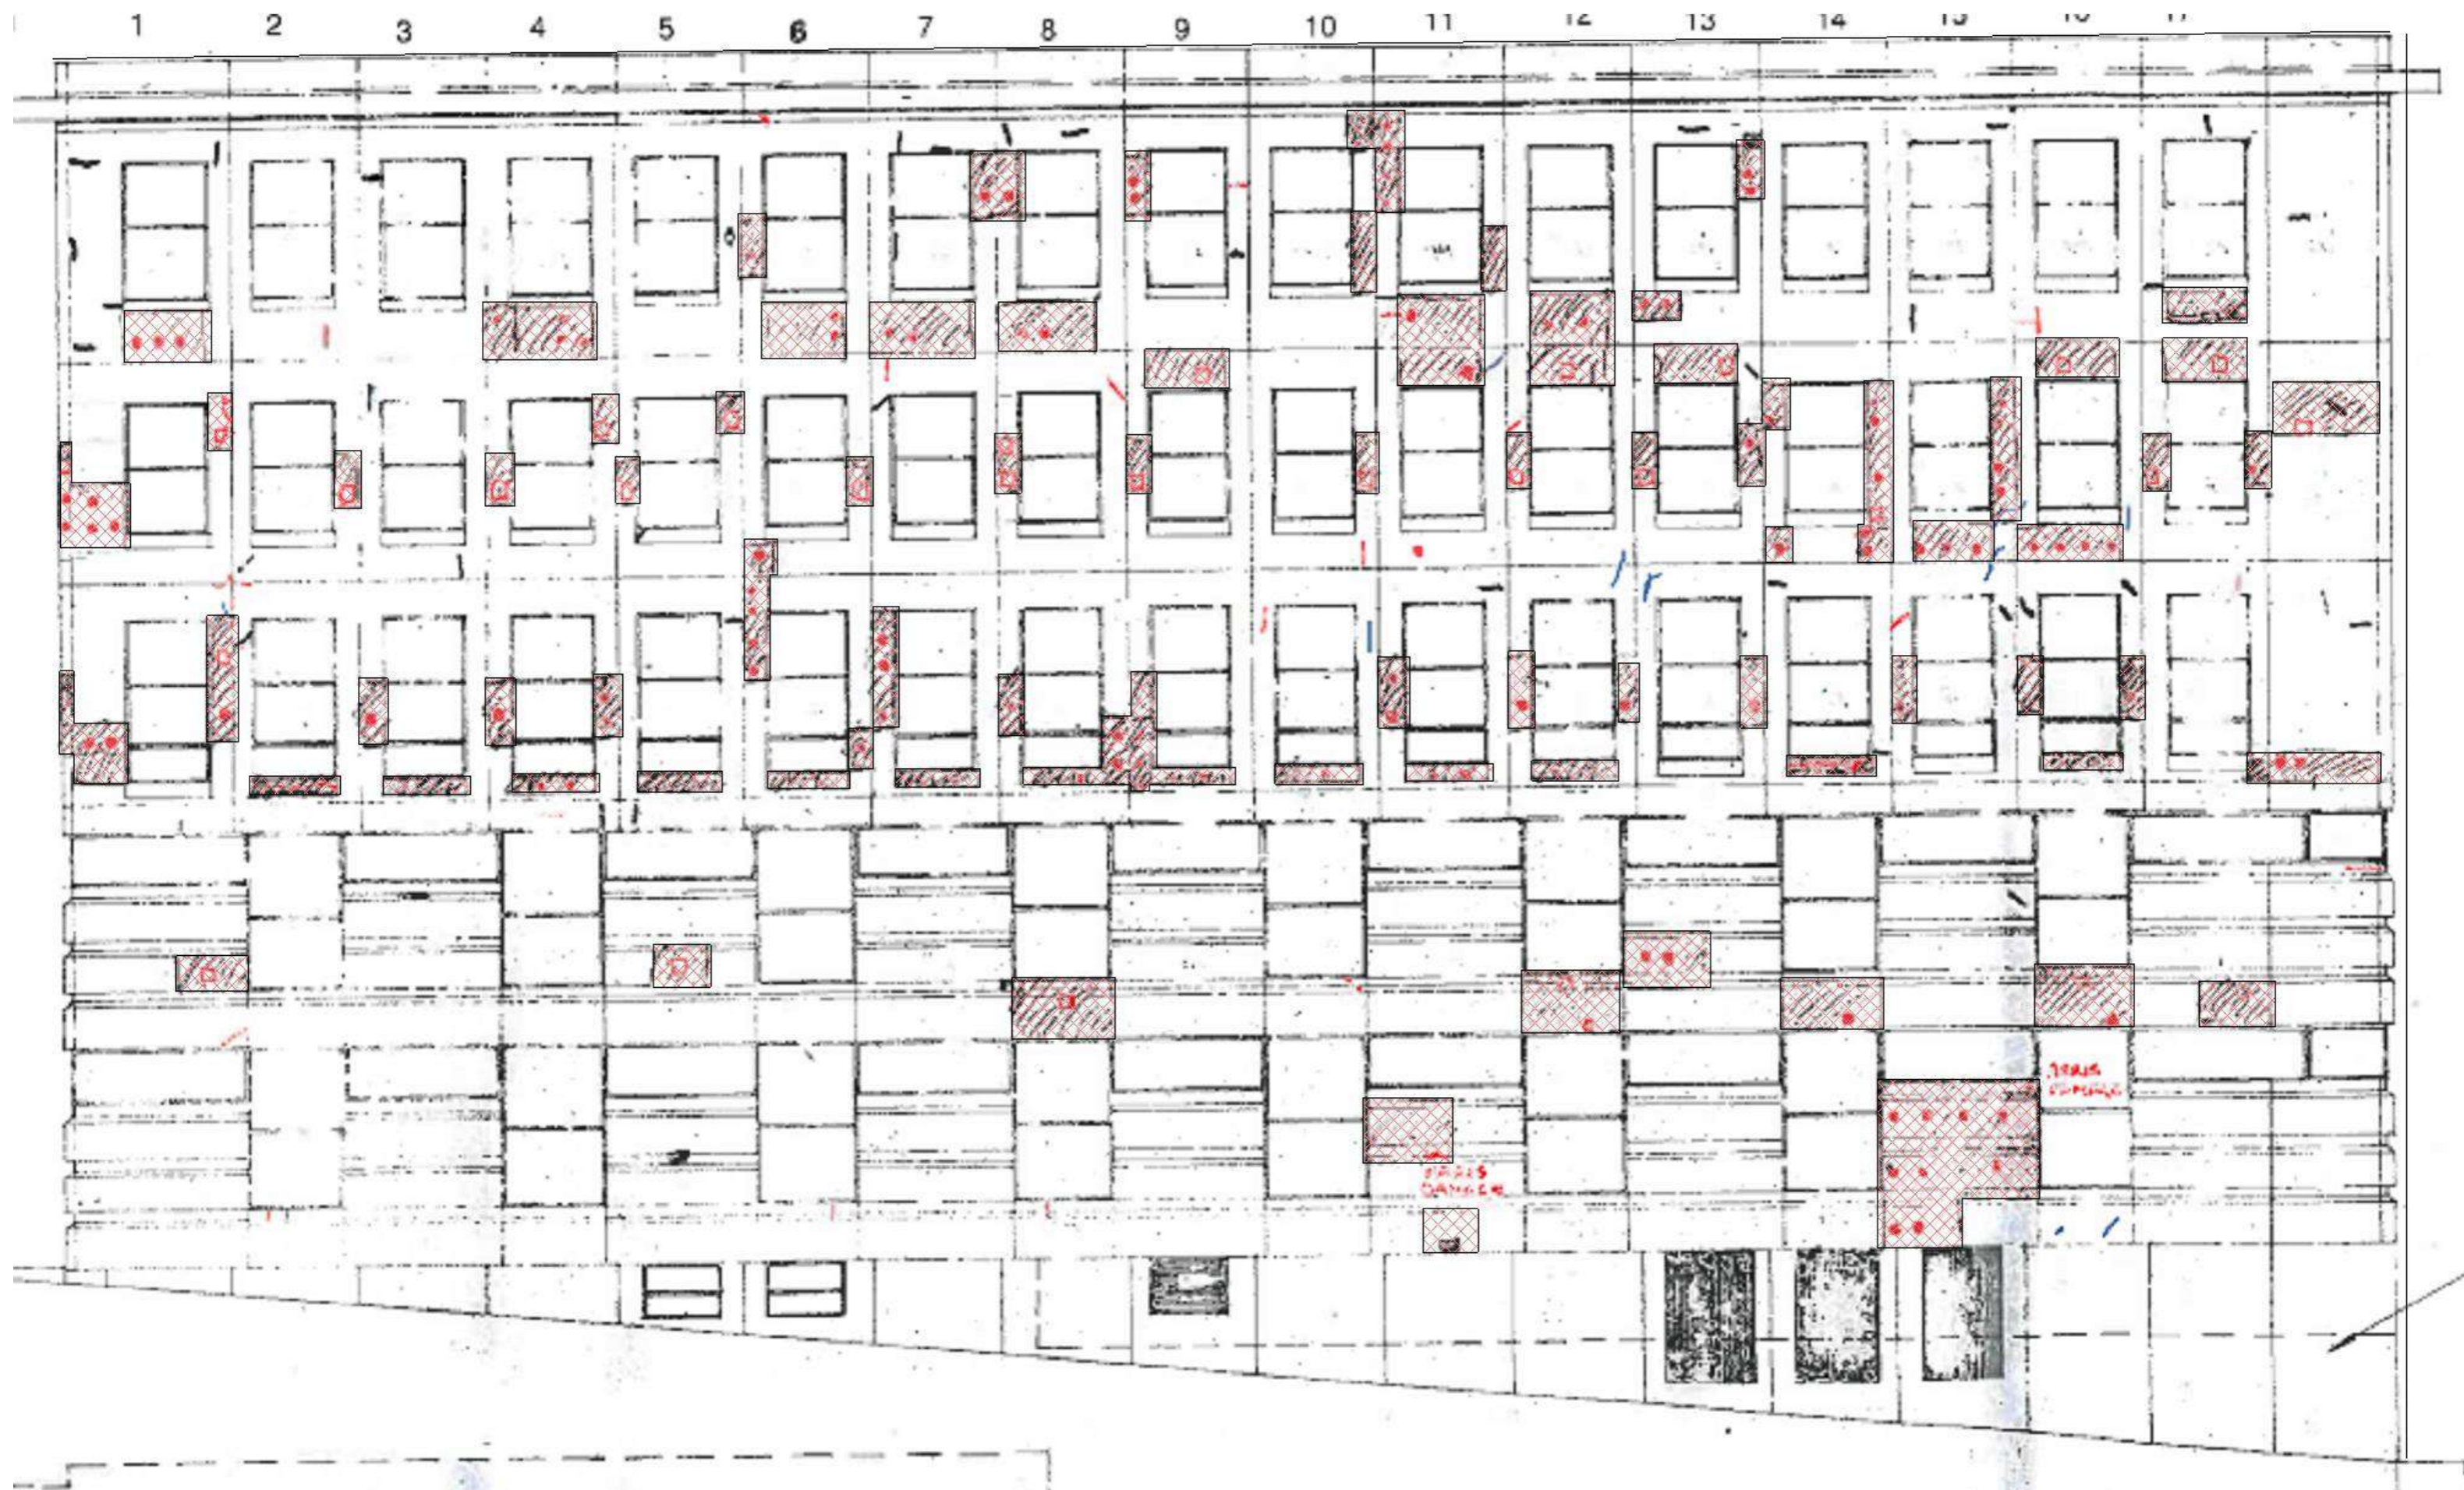
Blythwood Street Elevation - Pinned Area Mark-up

Using the same method, the pinned area on Blythswood Street will take roughly 432 min. (7.2 h) to be removed, while the fully bonded area of the façade will need to take around 38170 min. (637 h) to be removed.

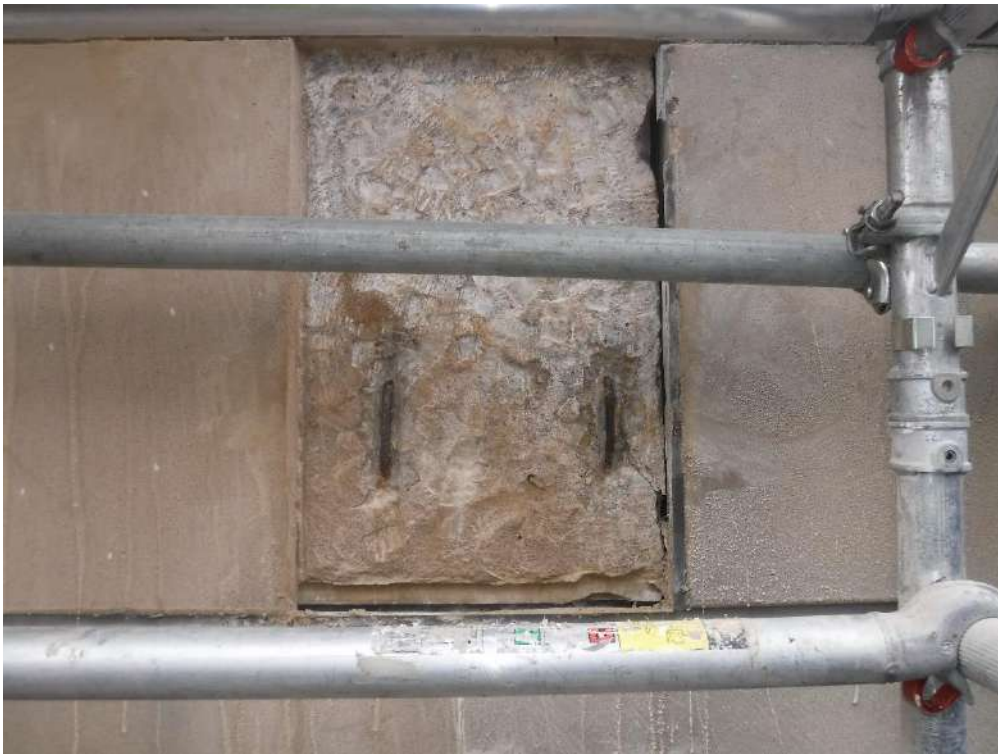
Plate 3 – Showing a general view of Bottom Panel breakout.

The sandstone facing could not be removed intact but broke into numerous small fragments (see plates 3 to 5). There was no evidence of bossing to the sandstone facing at this location.

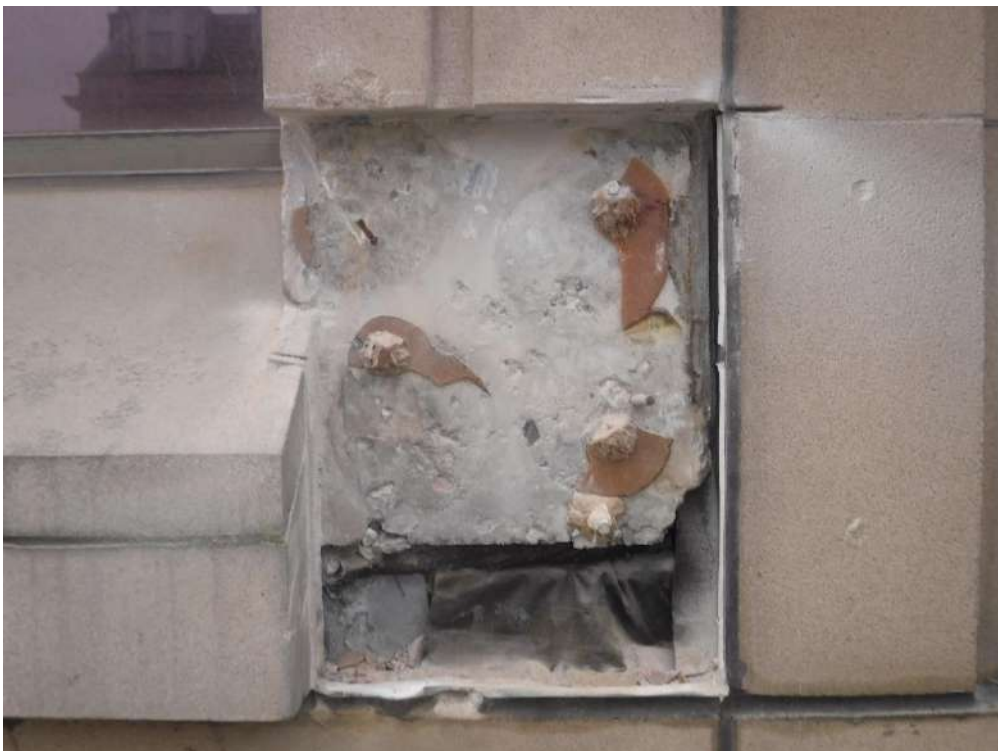
Plate 6 – General Shot of Top right-hand side panel breakout.

Despite these attempts to “tie back” the sandstone to the concrete both panels were easily removed with only a few blows of the hammer action drill. At both of these locations the panels were debonded from the concrete substrate (see plates 6 to 9).

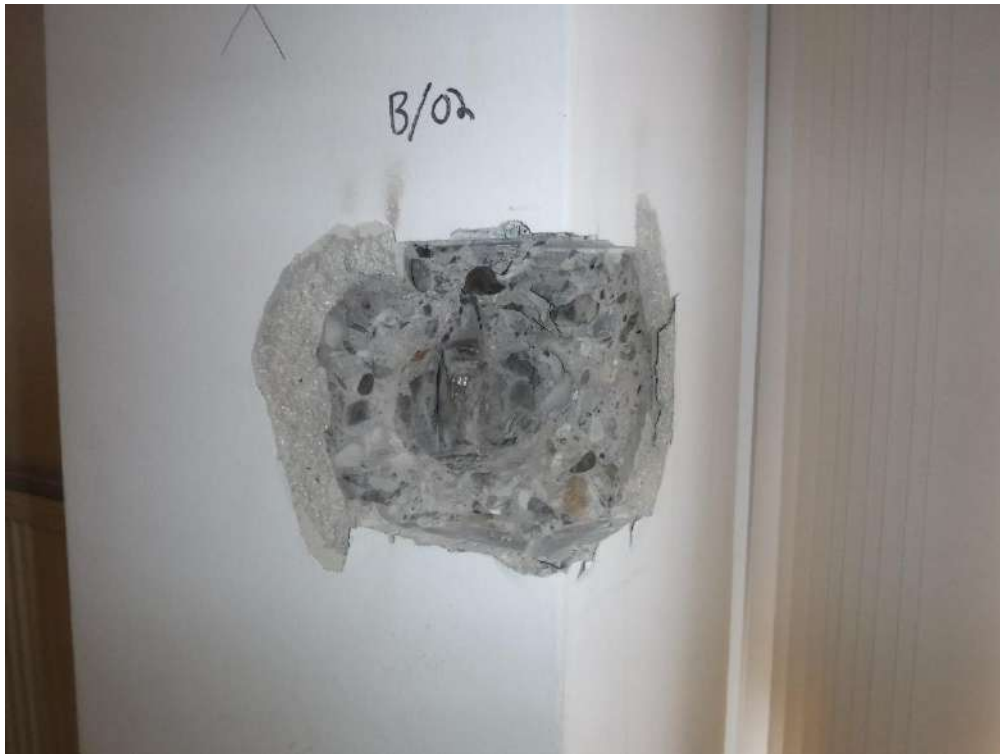
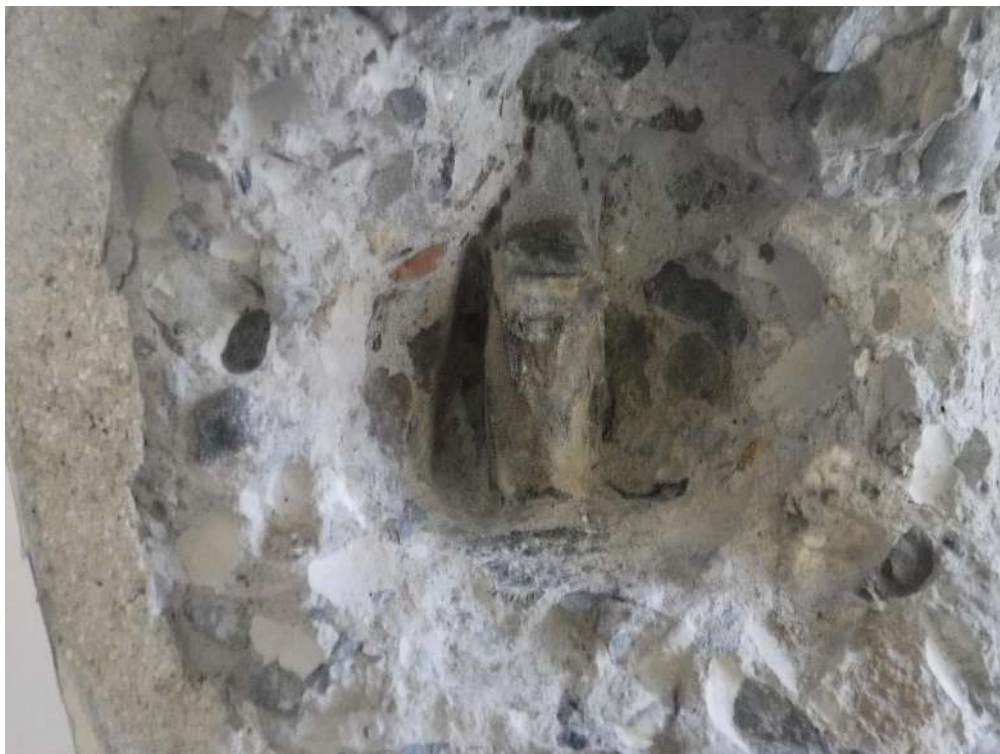
Plate 15 – Showing a general view of breakout B/O2 (perimeter column 1st floor).

- 1st floor Internal Column -> B/01 -> 75 mm nominal cover of vertical bar
- 1st Floor External Column -> B/02 -> 65 mm nominal cover of vertical bar
- 2nd Floor Slab Soffit -> B/03 -> 15 mm nominal cover to face of main bars
- 3rd Floor Waffle Slab Rib -> B/05 -> 23 mm nominal cover to face of main bars (the 2 bars are not centred on rib – see Plate 20 picture) -> side cover is less than 23 mm from picture at this location.
- 5th floor Internal Column -> B/07 -> 40 mm nominal cover of vertical bar
- Roof Slab Soffit -> B/08 -> 11 mm nominal cover to face of main bars

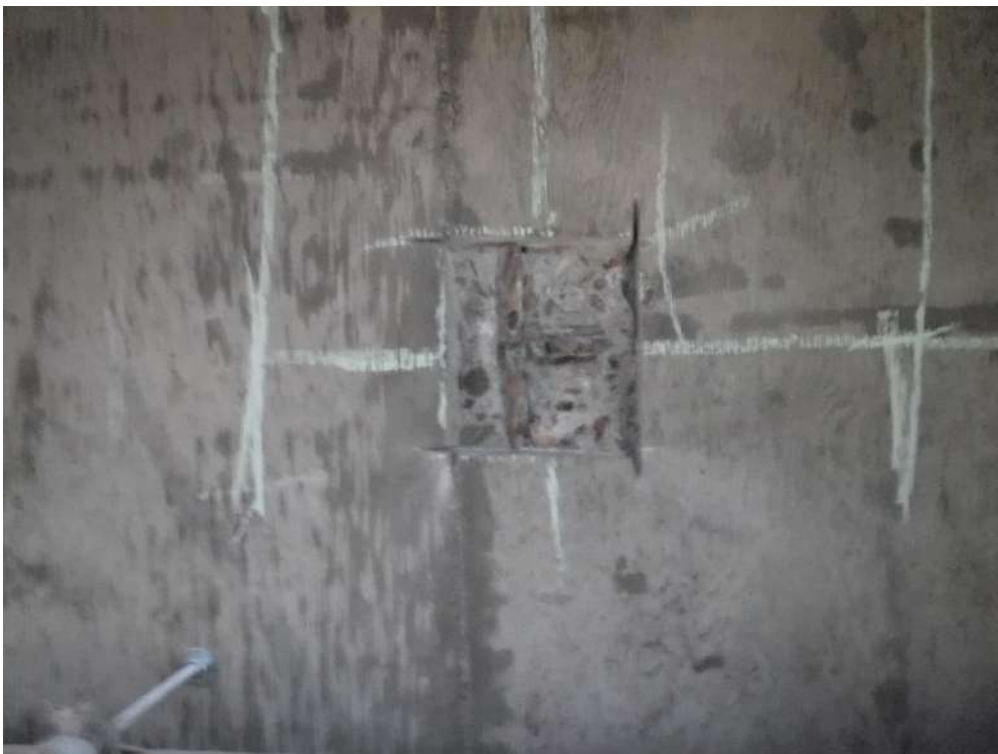
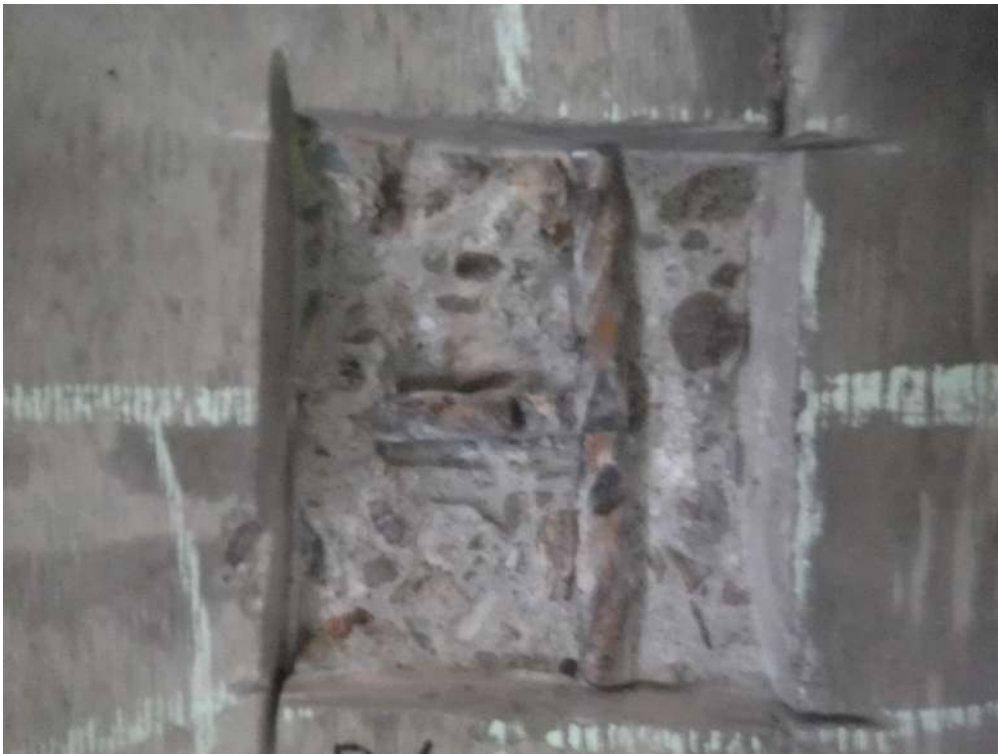
Plate 26 – Showing a general view of breakout B/O8 (underside of roof slab).

In addition, the minimum cover for slabs is 20 mm which is more than the 11 mm found on site, therefore the 30 min fire resistance will not be achieved.
