Condition Survey of Barn off Elvington Lane York

Introduction

Tidworth Consultants were appointed to carry out a visual condition survey of the barn off Elvington Lane, York

The survey took place on Thursday 30th June 2022

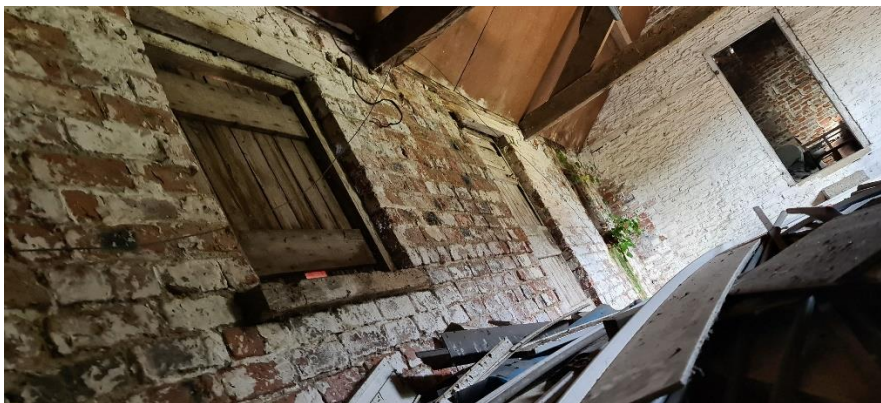
Pic 10 – Window to the front elevation

At first floor level, there is a door and window. The window opening has been boarded up.
