21 Freeman Avenue
Henley
IPSWICH
IP6 0RZ

INSURANCE CLAIM

CONCERNING SUBSIDENCE DAMAGE

ENGINEERING APPRAISAL REPORT

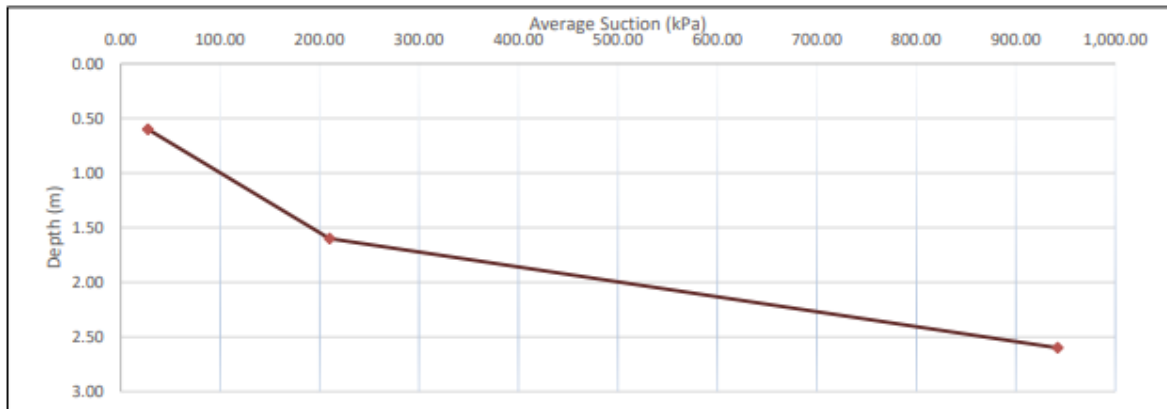
The values reported for heave above only apply to the strata the suction and plasticity have been performed on. The shallowest depth reported is assumed to be a strata thickness to GL and Heave is calculated based on that layer thickness, if the next sample is in 0.5m increments the heave is calculated based on the layer thickness of 0.5m and depths 1m from the sample above will include heave over 1m.

Consideration should be made for other stratas where values are not reported and when working out the heave potential over the entire trial hole.
