Arboricultural method statement to install a root barrier.

October 3, 2023

POLICY HOLDER ADDRESS: 21 Freeman Avenue, Henley, Ipswich. IP6 0RZ
CLIENT REFERENCE: 9255790 / D141112170
OUR REFERENCE: 7423
PROJECT MANAGER: Spencer Caizley

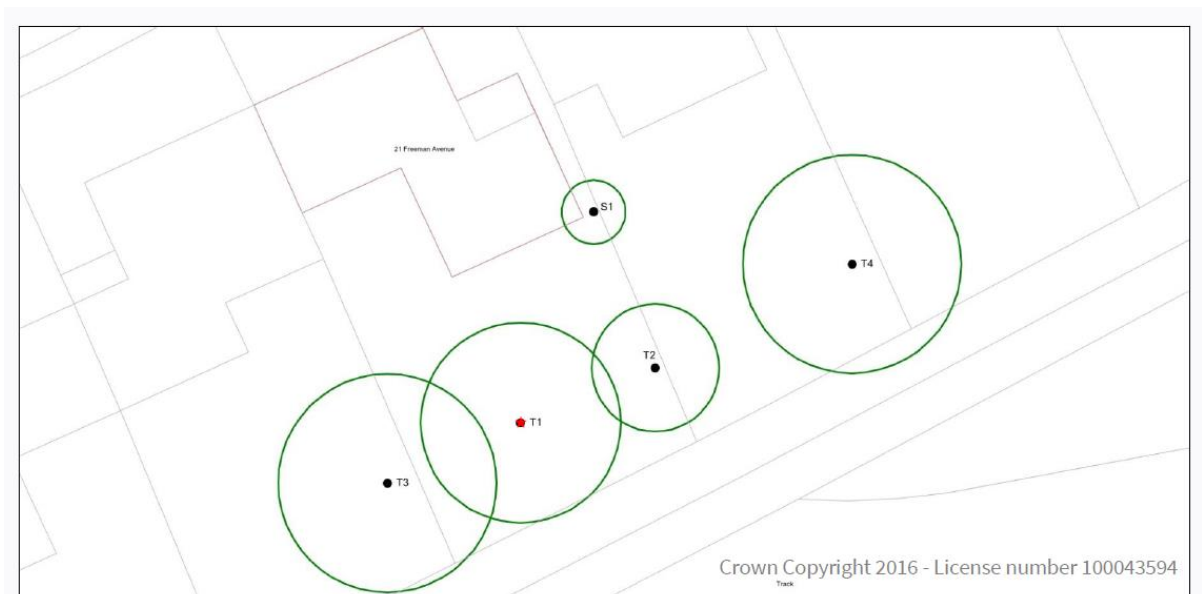
The arborist report from 2022 recommended the removal T1 Lime which is in the policyholder's garden but is subject to a tree preservation order. We suspect this is in part to lime tree roots being detected below the foundation in this area and it is undeniable that it will be having an influence. The barrier needs to extend into the left-hand neighbour's garden to defend against T4.
