87 Woolverstone Close
Ipswich
IP2 9RX

Structural Inspection Report

- 1.1 J P Chick & Partners Limited were appointed by Orwell Housing to undertake a structural inspection to report on crack damage. Our initial report IG22/340 dated 15 November 2022 refers. This is contained within Appendix A for completeness.
- 1.2 Within our report we made recommendations with regard to further investigations to be undertaken in order to understand and identify the mechanism of movement and likely cause. We were subsequently appointed by Orwell Housing to undertake these investigations.
- 1.3 Intrusive site Investigations were undertaken Soil Investigation Eastern Limited on 05 June 2023 following an initial aborted attempt on 04 May 2023 where access could not be permitted. The factual Report for the investigations is contained within Appendix B to the rear of this Report.

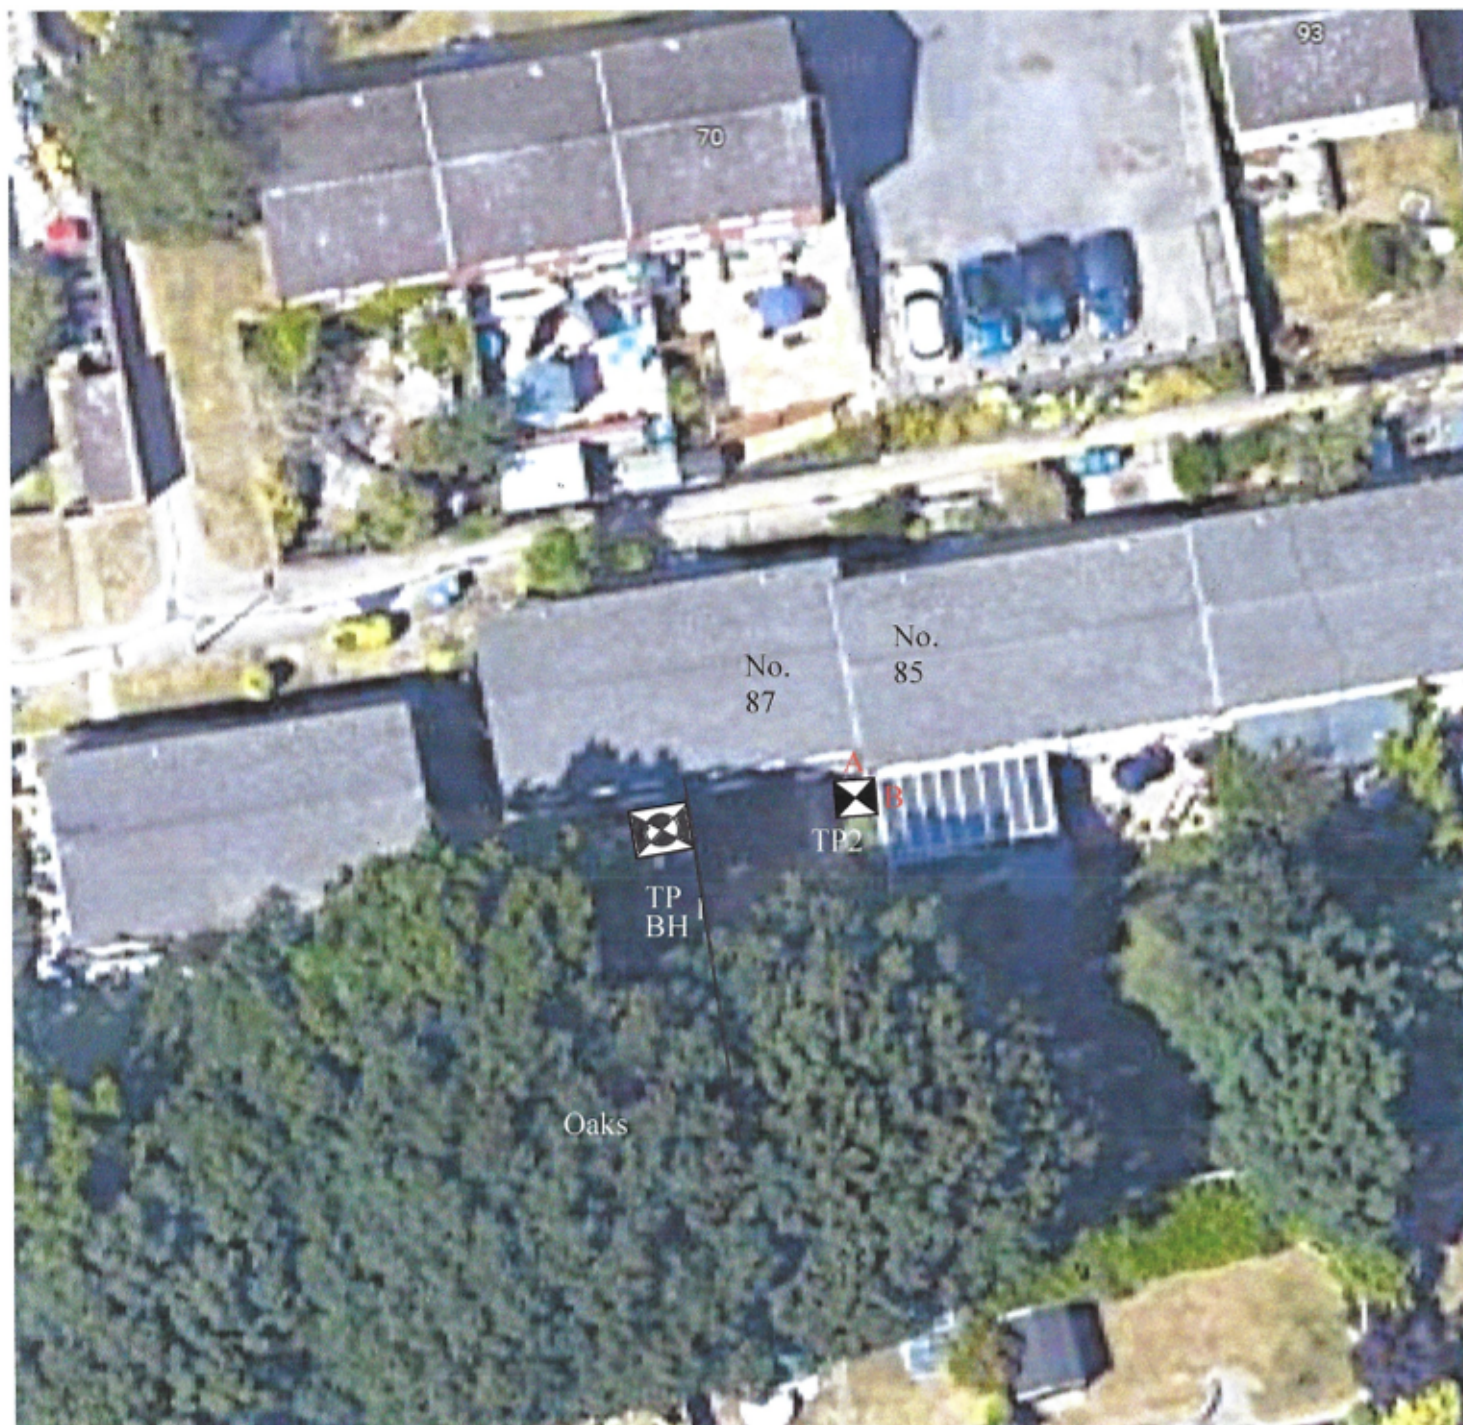
Remarks: ON SITE TREE IDENTIFICATION FOR GUIDANCE ONLY.
NOT AUTHENTICATED

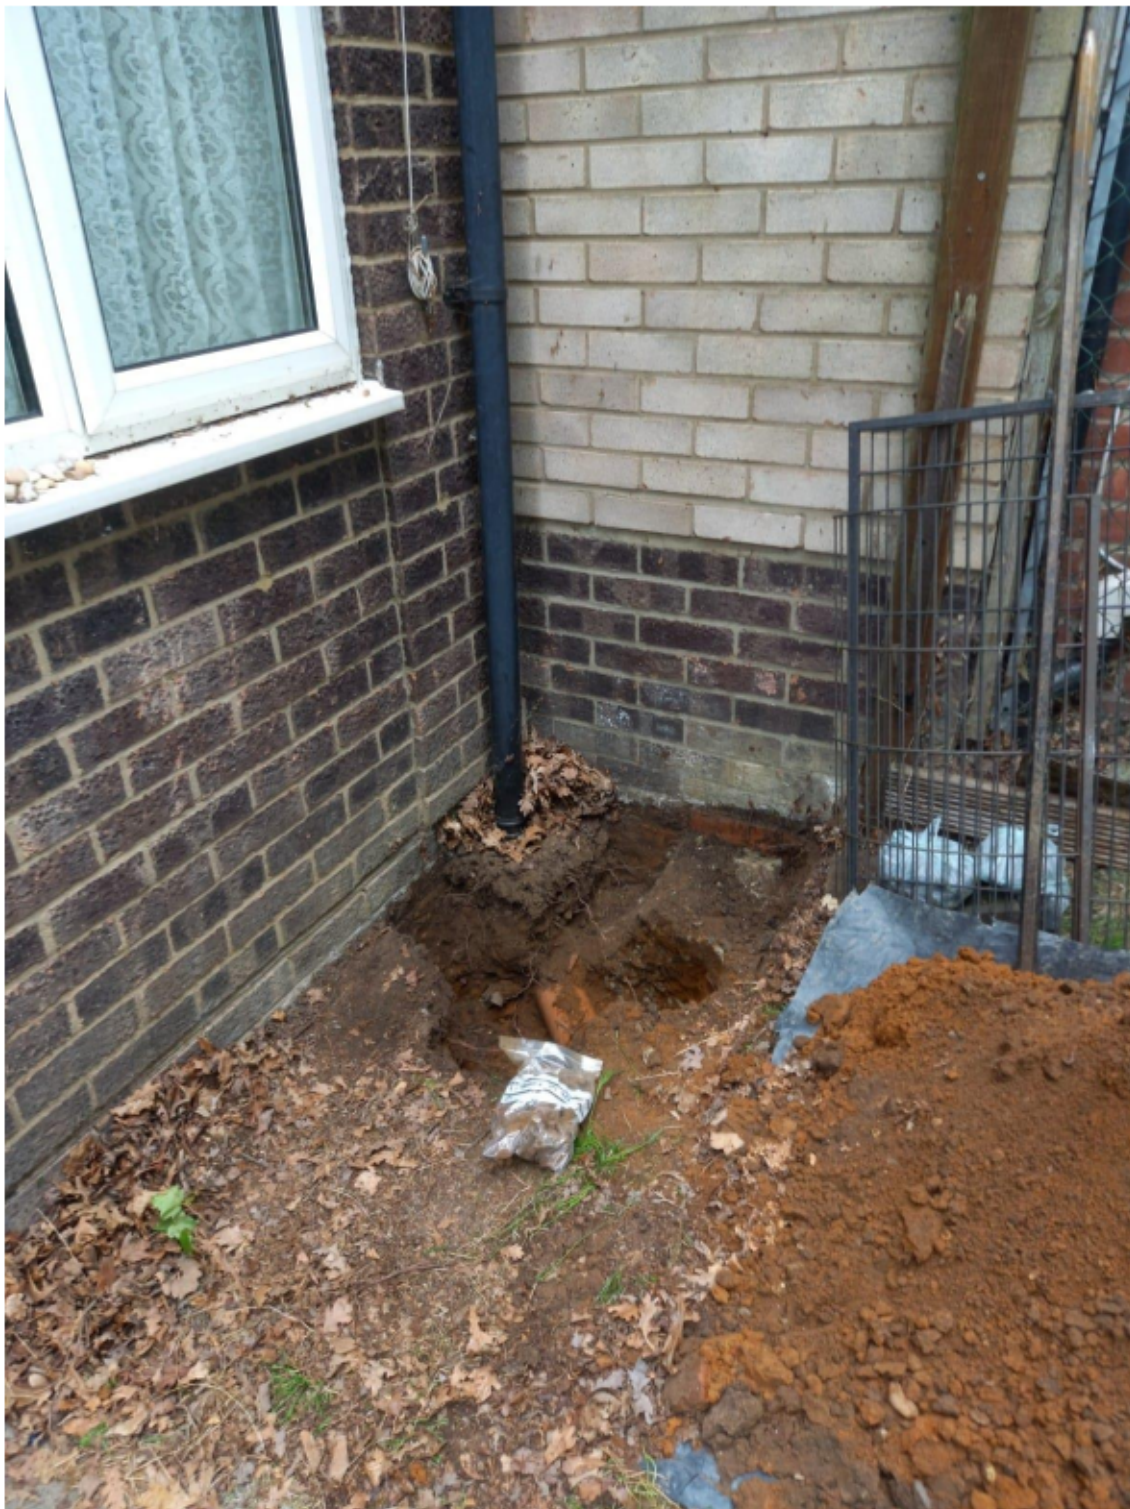
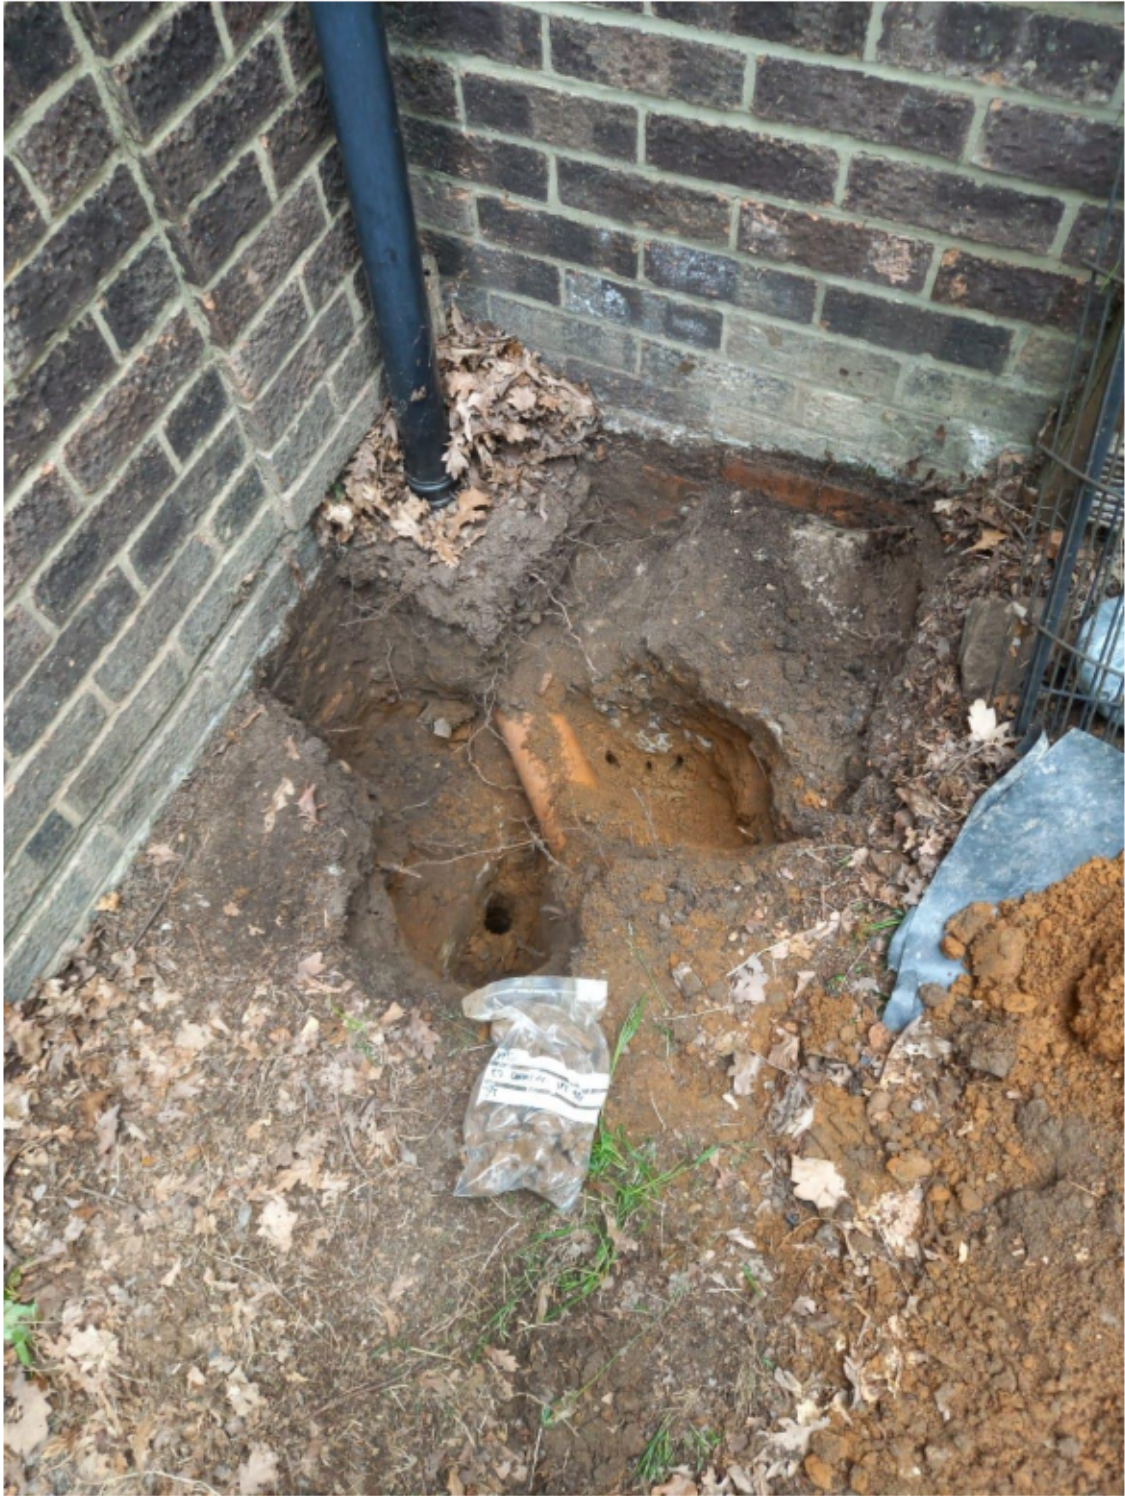
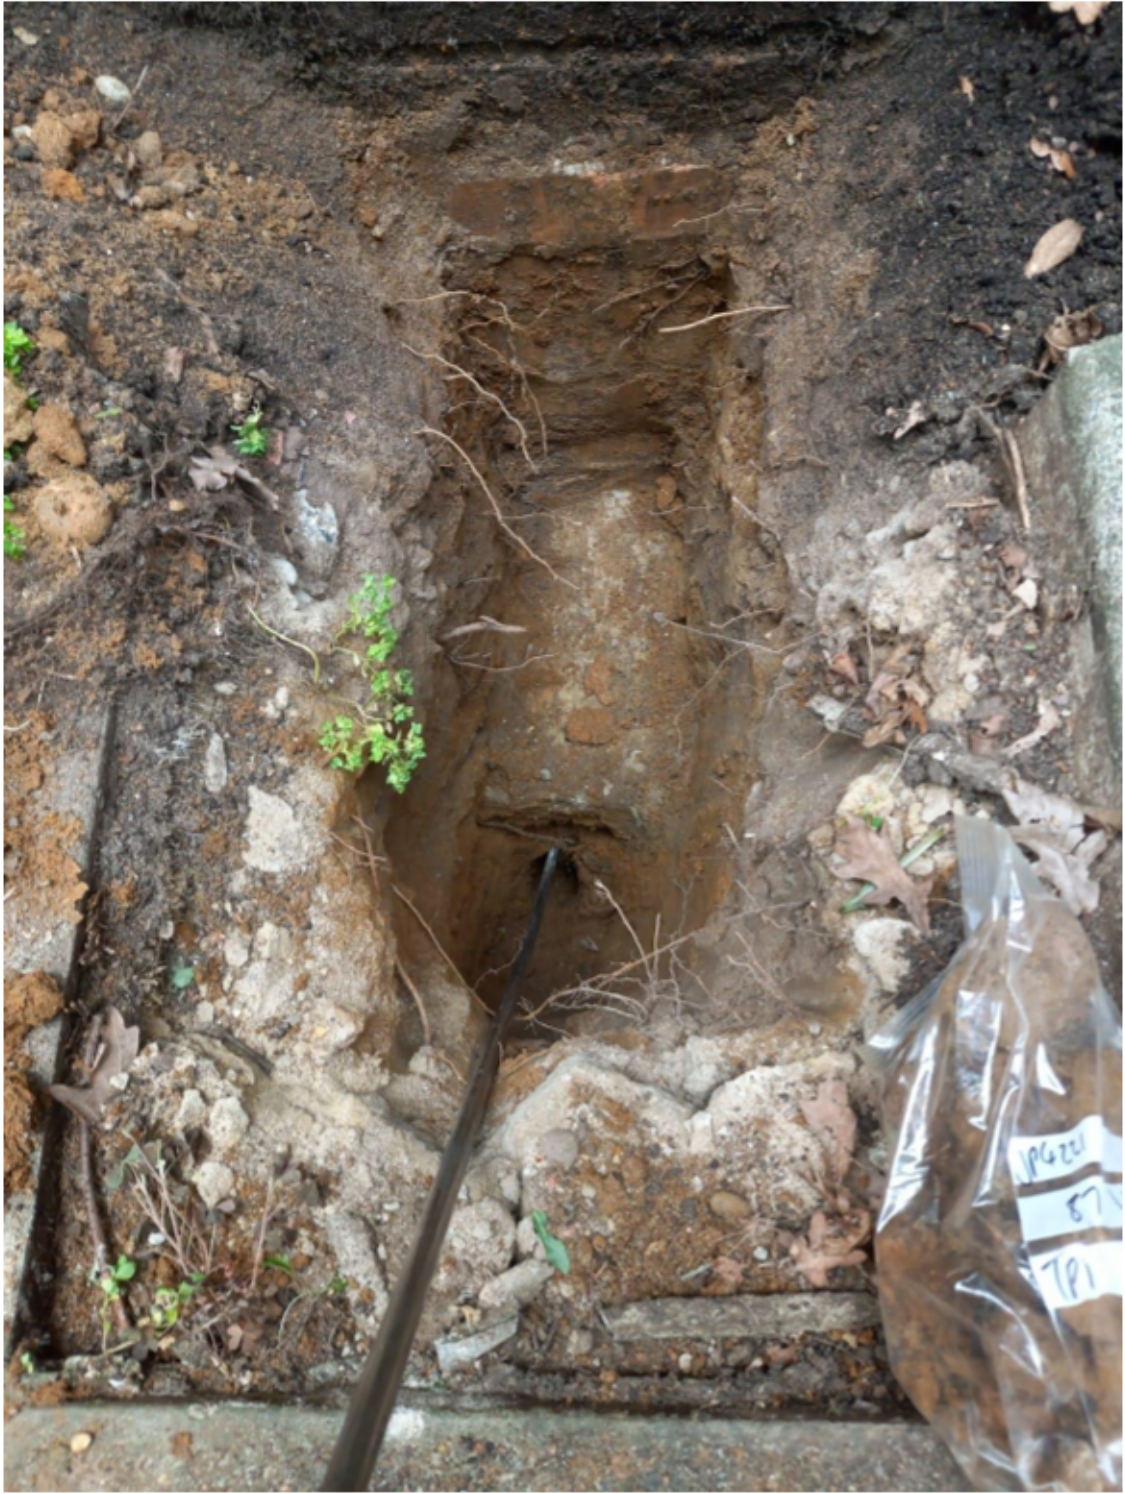
Trial Pit 1

- 3.1 In trial Pit 1, the foundation is a concrete strip footing 300mm thick with a toe projection of 350mm, situated 900mm below existing ground level in a stiff sandy silty Clay. Roots of up to 7mm diameter were noted to the underside of the foundation. This clayey material remained unchanged but became stiffer continuing to 2.8m depth. From 2.8m through to termination at 6m the material was essentially very stiff silty Clay with silt and sand partings and roots continuing into the very stiff material at 3.6m depth. Shear vane readings obtained were consistently high, at or above 150kPa.
